# C435 Farringdon Main Station

## Monitoring Close-Out Report: Automated Total Station ATS7 and 3D Targets read by ATS7.

**CRL Document Number: C435-BFK-C2-RGN-M123-51641**

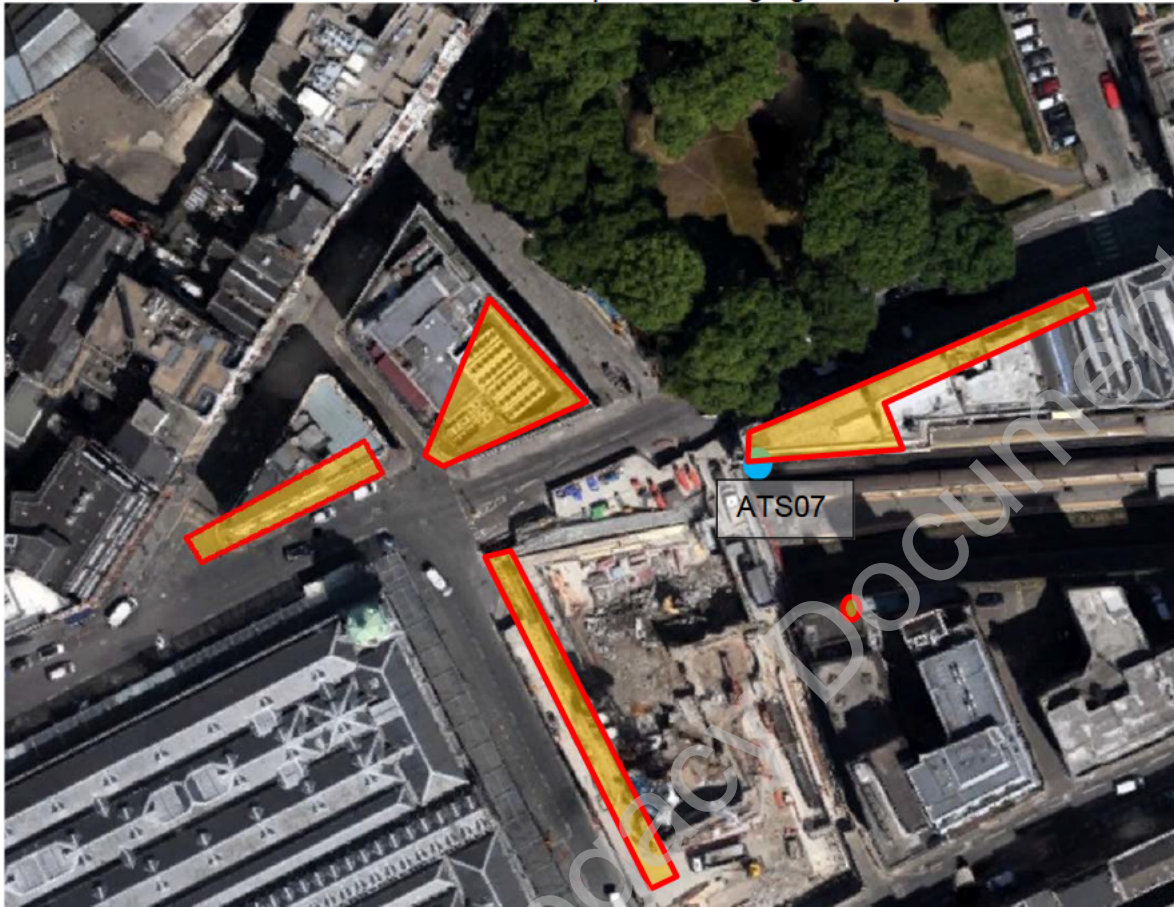
Prisms associated with ATS07 are located on the plan below highlighted in yellow.

Figure 1 – Plan showing the Location prisms read by ATS07.

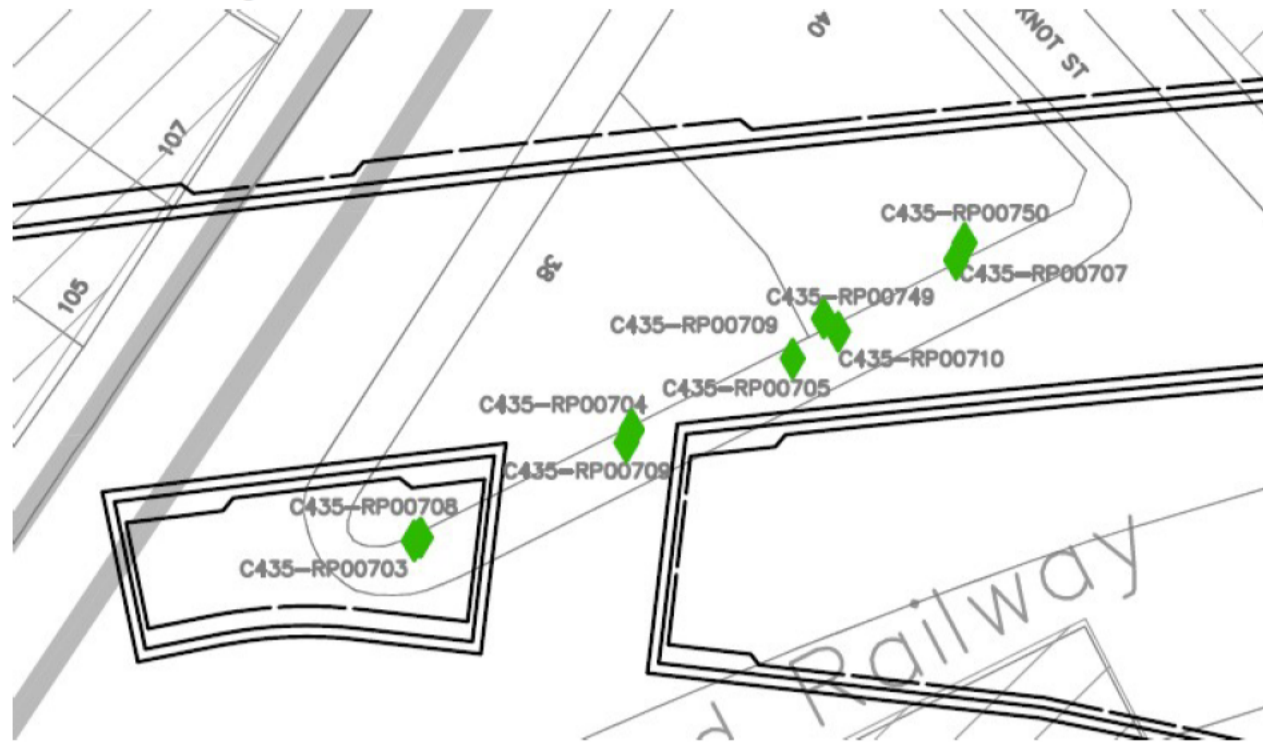
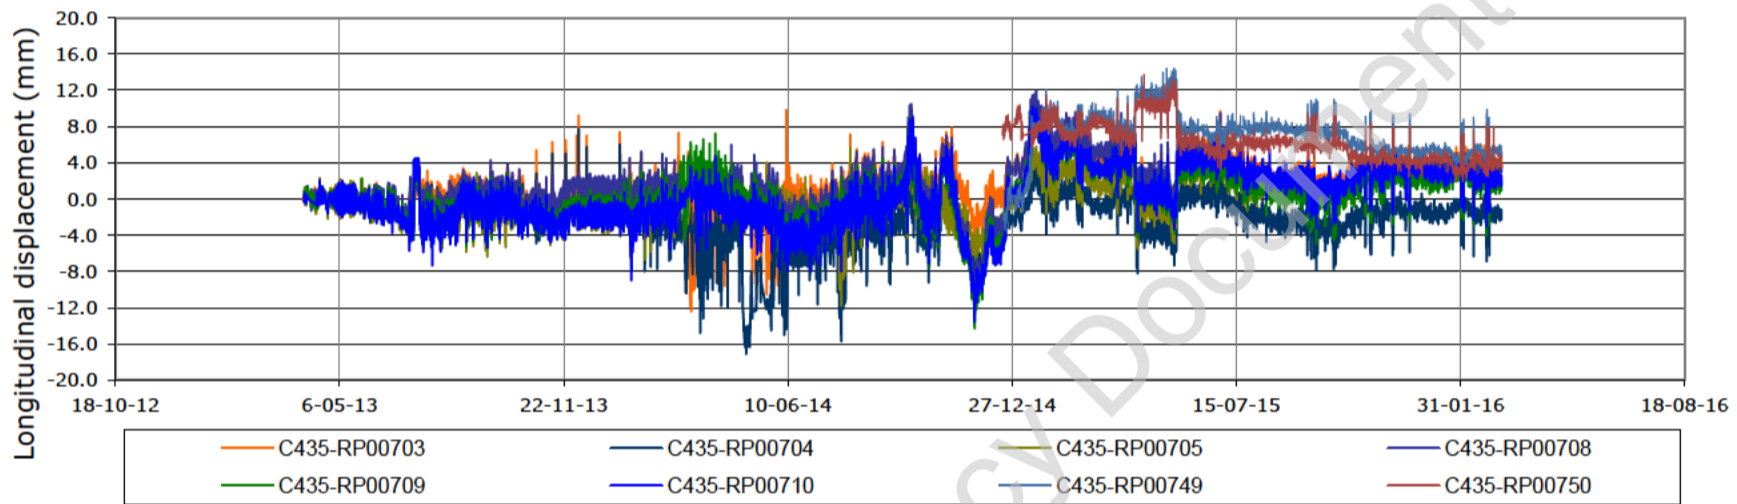
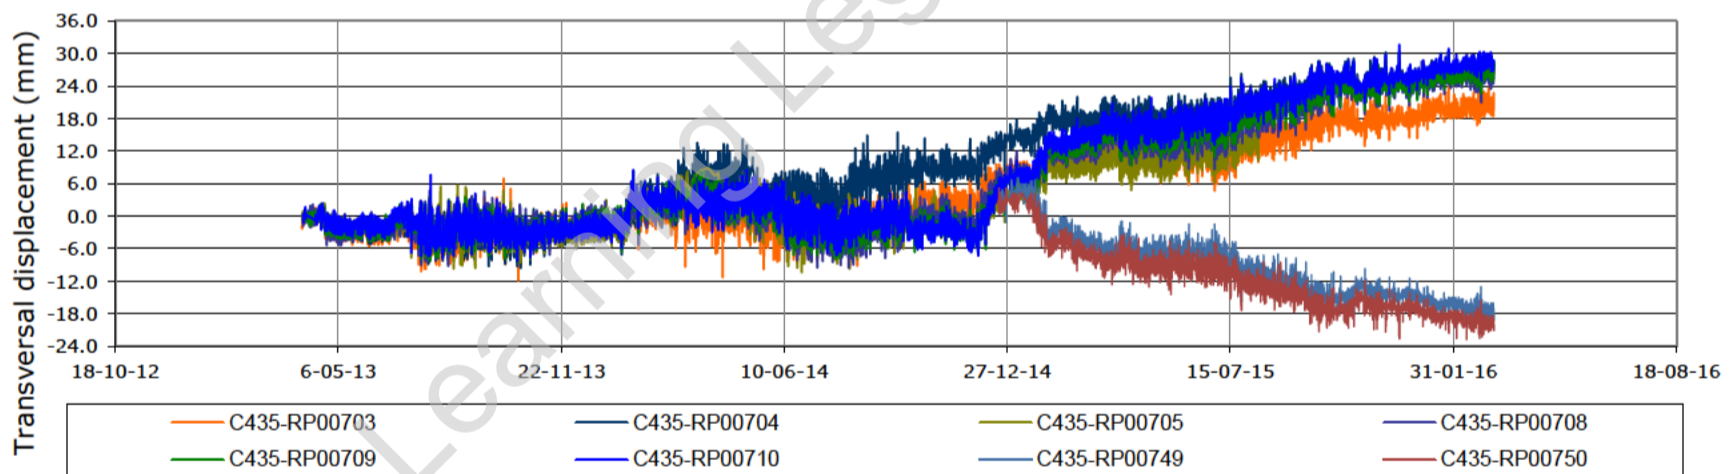
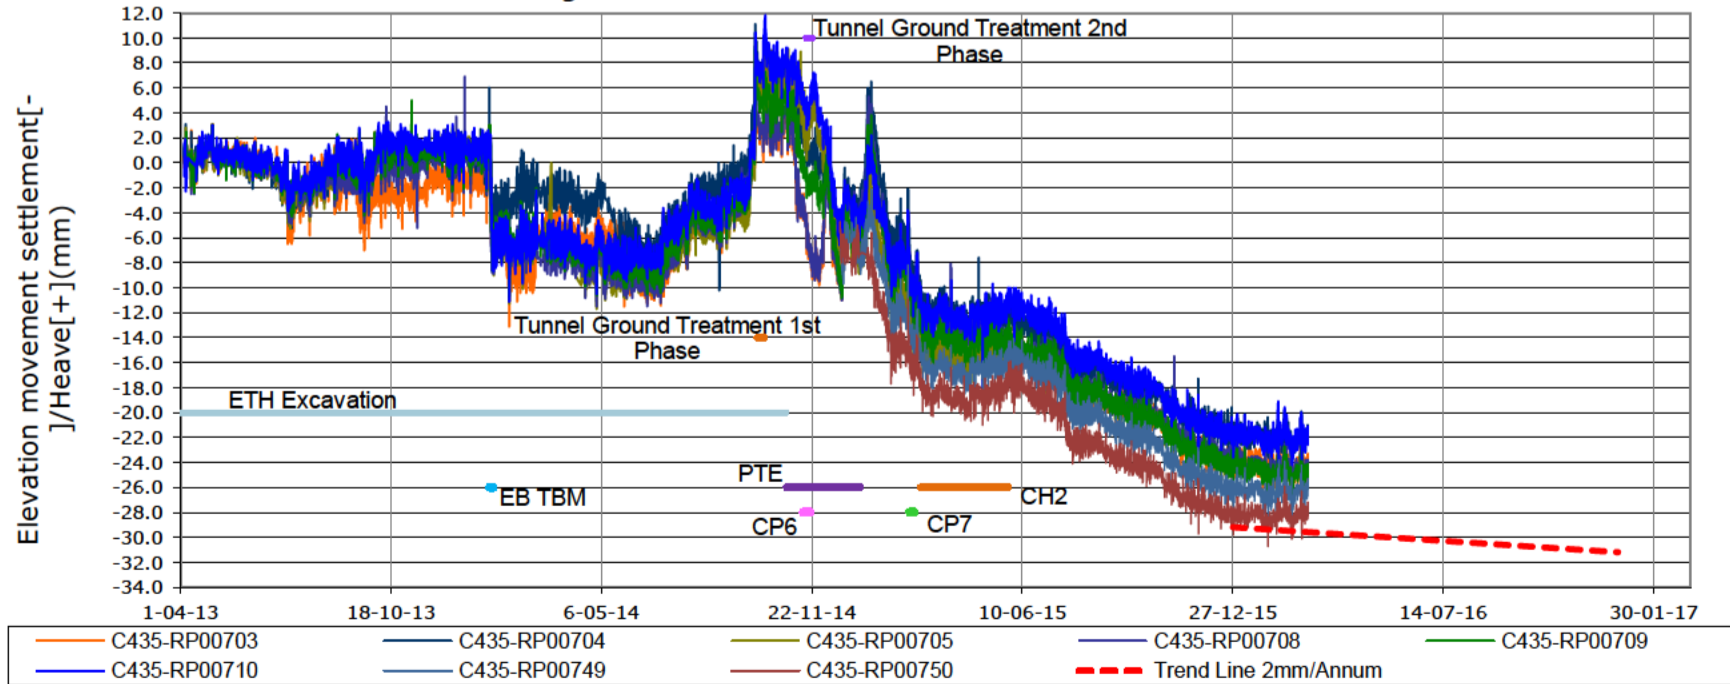
Building: 38-42 CHARTERHOUSE STREET

- ETH excavation caused 2mm of settlement from 21-03-2013 to 28-10-2014.
- Compensation grouting from Moorgate Shaft 2 caused 2mm of heave in August 2013 and September 2013.
- Eastbound TBM caused 6-8mm maximum of settlement in 20-01-2014.
- Residual settlement caused 4mm of settlement.
- Compensation grouting caused 5-6mm of heave from July 2014 to September 2014.
- Ground Treatment caused 12mm of heave in October 2014.
- PTE enlargement works caused 12-14mm of settlement between 29-10-2015 and 07-01-2015.
- Compensation grouting caused 8-10mm of heave in January 2015.
- CP7 construction caused 4-5mm of settlement from 23-02-2015 to 25-02-2015.
- CH2 construction caused 2-3mm maximum of settlement from 05-03-2015 to 28-05-2015.
- Maximum Longitudinal displacement +13mm
- Maximum Transversal displacement +28mm
- Maximum settlement at the end of the works -29mm

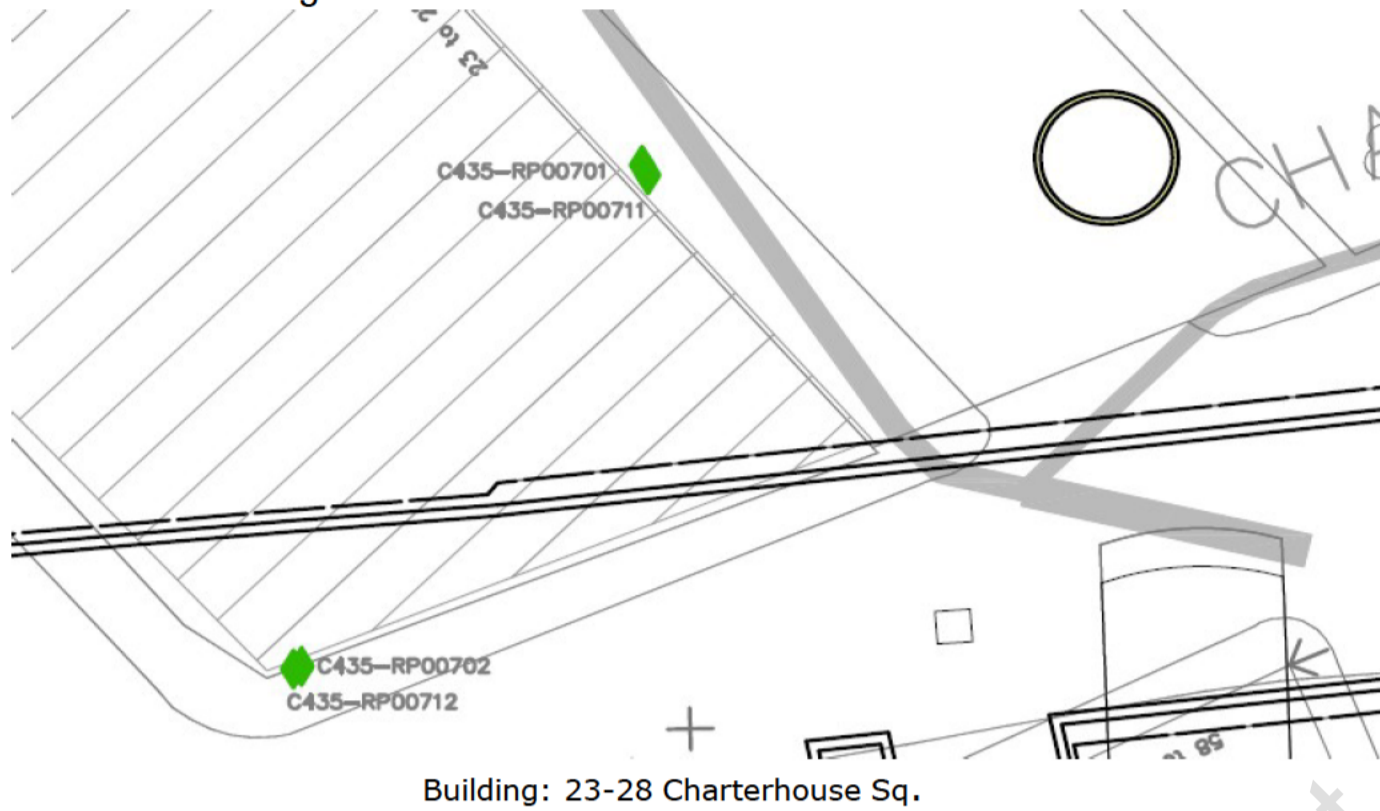
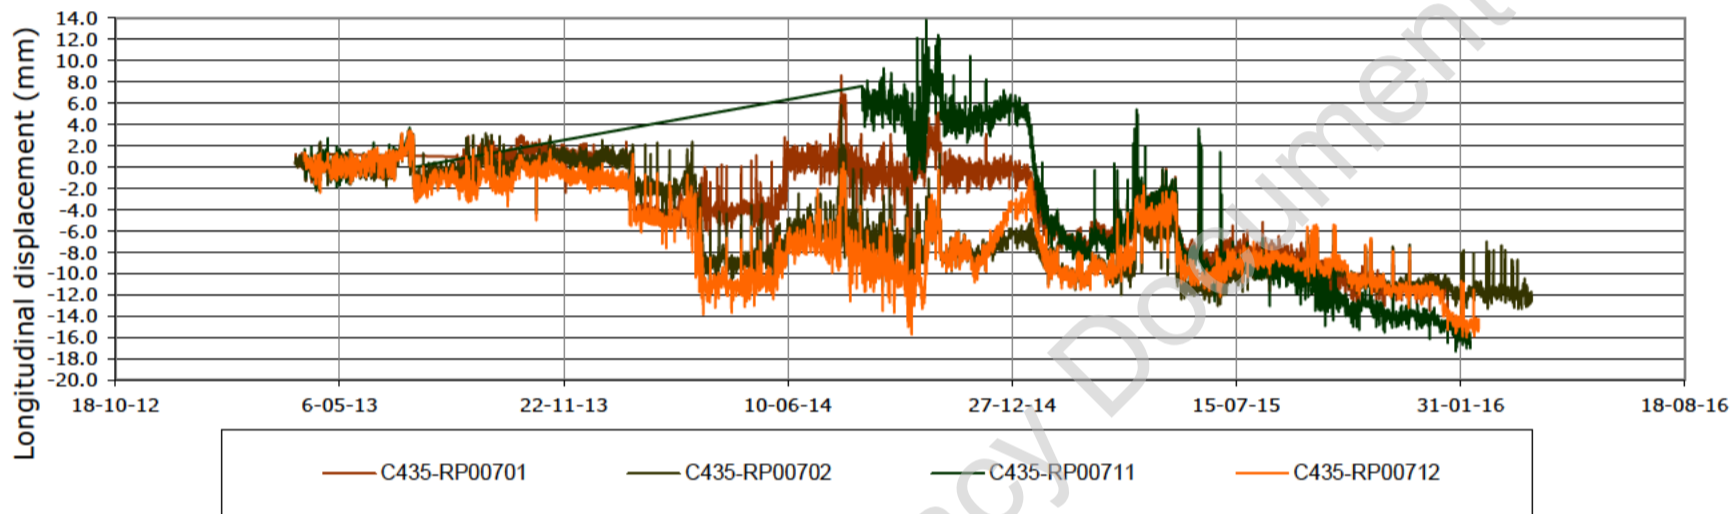
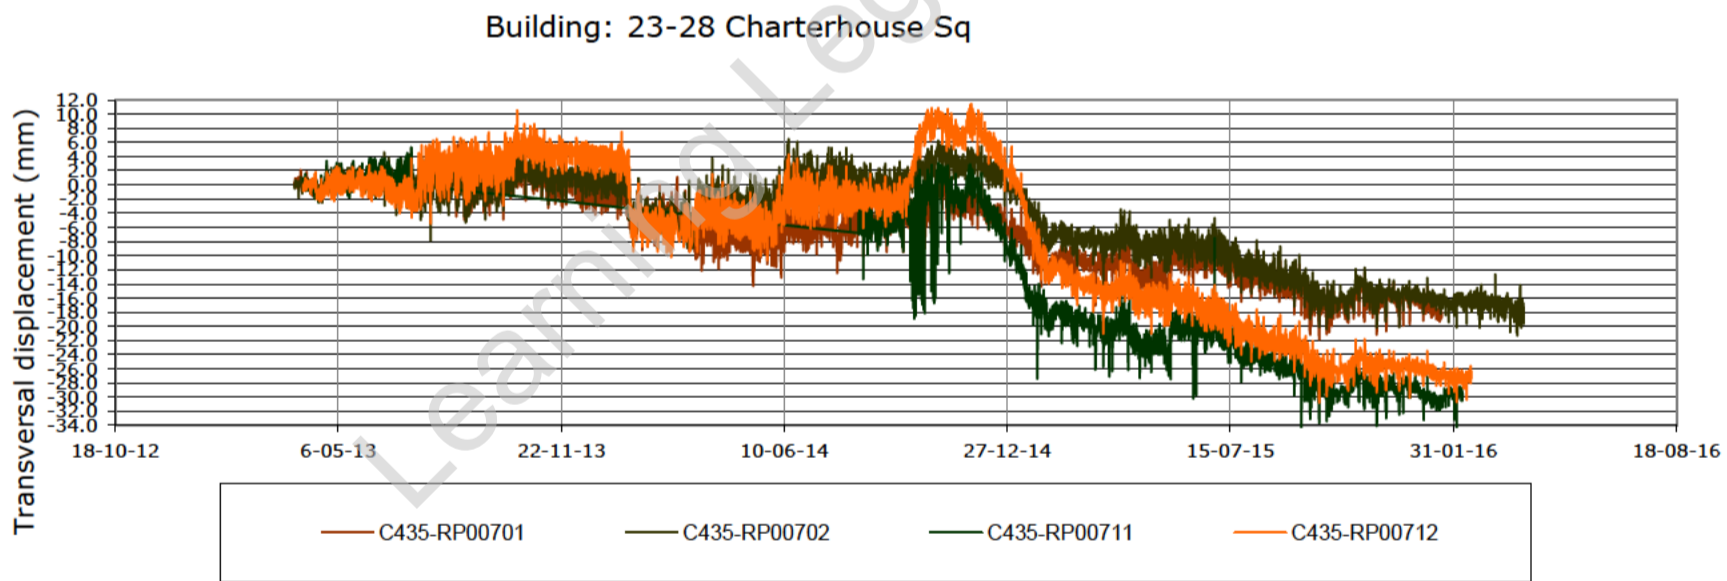
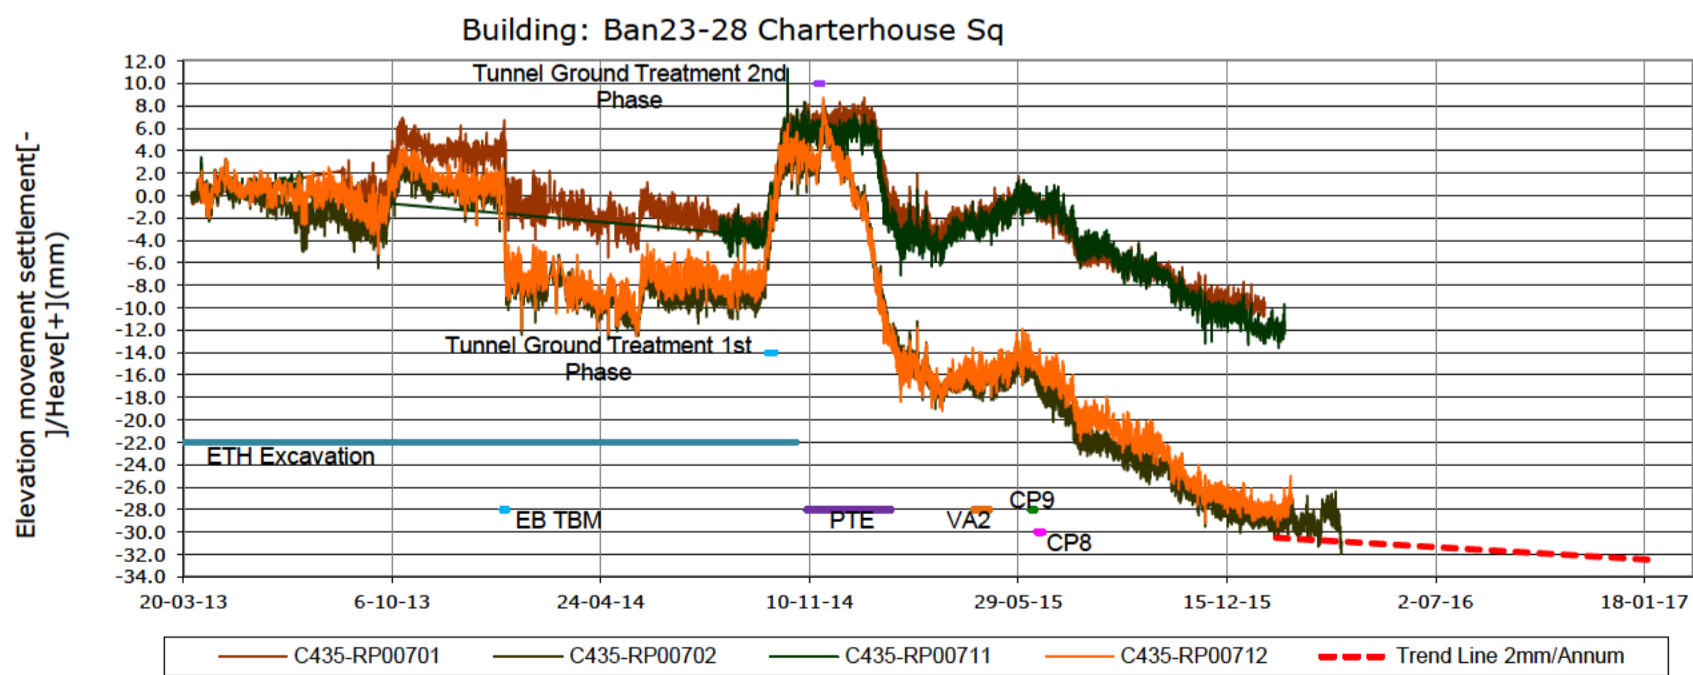
- ETH excavation caused 2-3mm of settlement from 21-03-2013 to 28-10-2013.
- Compensation grouting from Charterhouse Shaft caused 4-6mm of heave in October 2013.
- EB TBM caused 6mm maximum of settlement between 21-01-2013 and 23-01-2013.
- Ground Treatment on October 2014 caused 12mm of heave.
- PTE works caused 20mm maximum of settlement from 07-11-2014 to 27-01-2015.
- Compensation grouting caused 2mm of heave in May 2015.
- CP8 and CP9 combination works caused 6-7mm maximum of settlement.
- Maximum Longitudinal displacement -16mm
- Maximum Transversal displacement -32mm
- Maximum settlement at the end of the works -31mm

The prisms installed on the 23-28 Charterhouse Sq have been covered by a scaffold due refurbishment works.

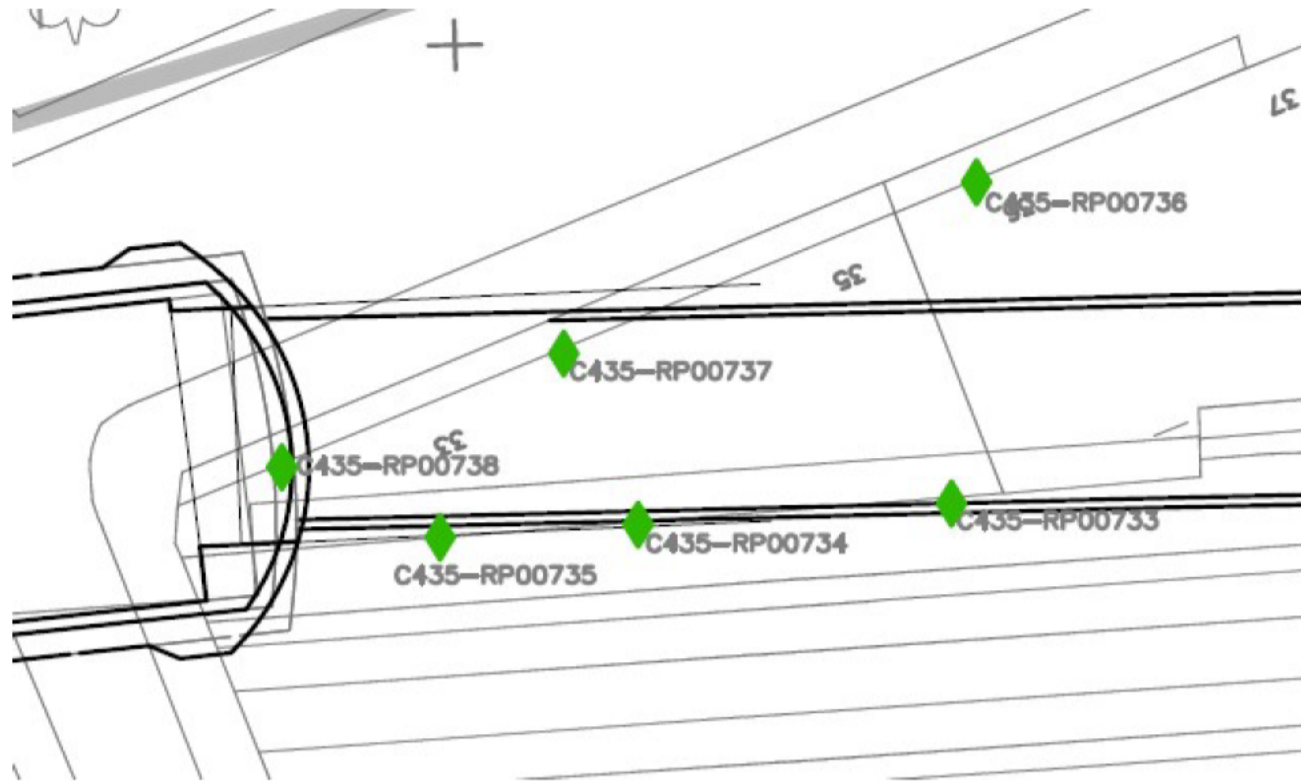
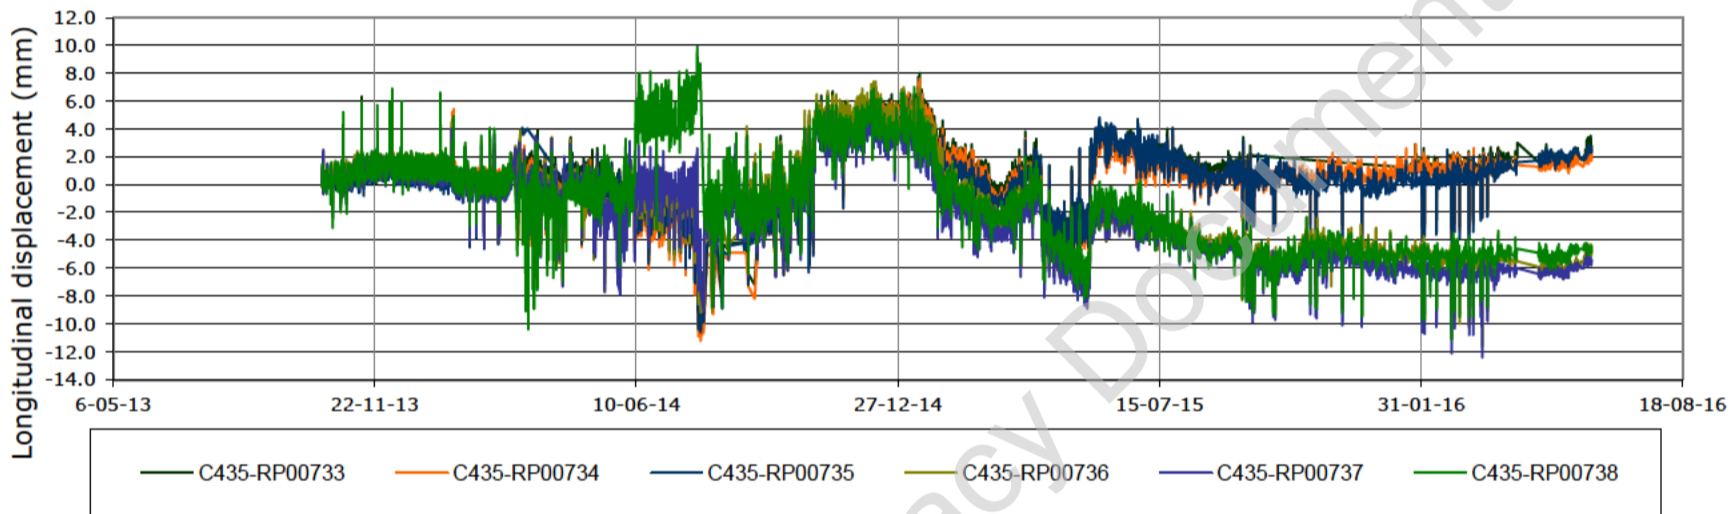
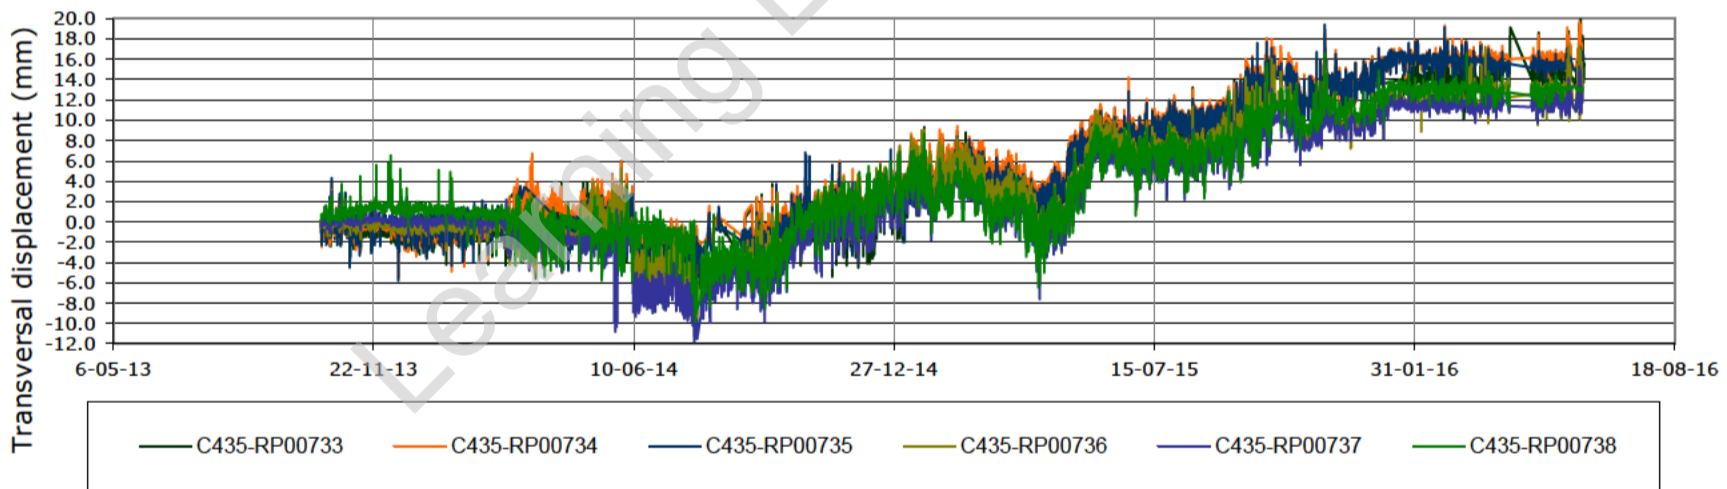
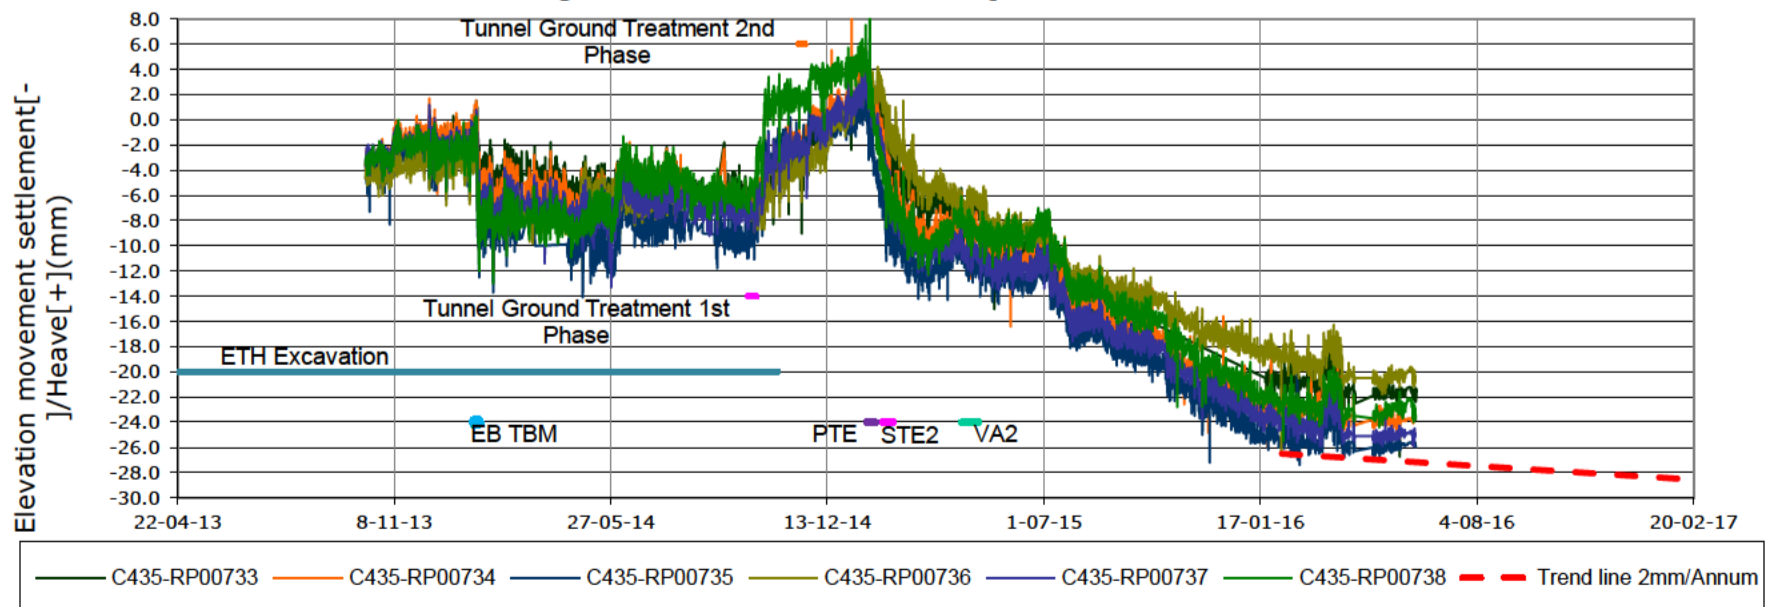
Building: 33-37 CHARTERHOUSE SQUARE

- Eastbound TBM caused 8-10mm maximum of settlement from 22-01-2014 to 24-01-2014.
- Compensation grouting from Charterhouse Shaft caused 3-4mm of heave in May 2014.
- Ground treatment on October 2014 caused 8mm maximum of heave.
- Second ground treatment caused 3-4mm of heave in November 2014.
- PTE caused 4-5mm of settlement from 18-01-2015 to 27-01-2015.
- STE2 construction caused 8-10mm maximum of settlement from 02-02-2015 to 12-02-2015.
- Compensation grouting carried out in March 2015 caused 2-3mm maximum of heave.
- VA2 construction activities caused 2-3mm of settlement from 16-04-2015 to 02-05-2015.
- Maximum Longitudinal displacement -8mm
- Maximum Transversal displacement +14mm
- Maximum settlement at the end of the works -26mm

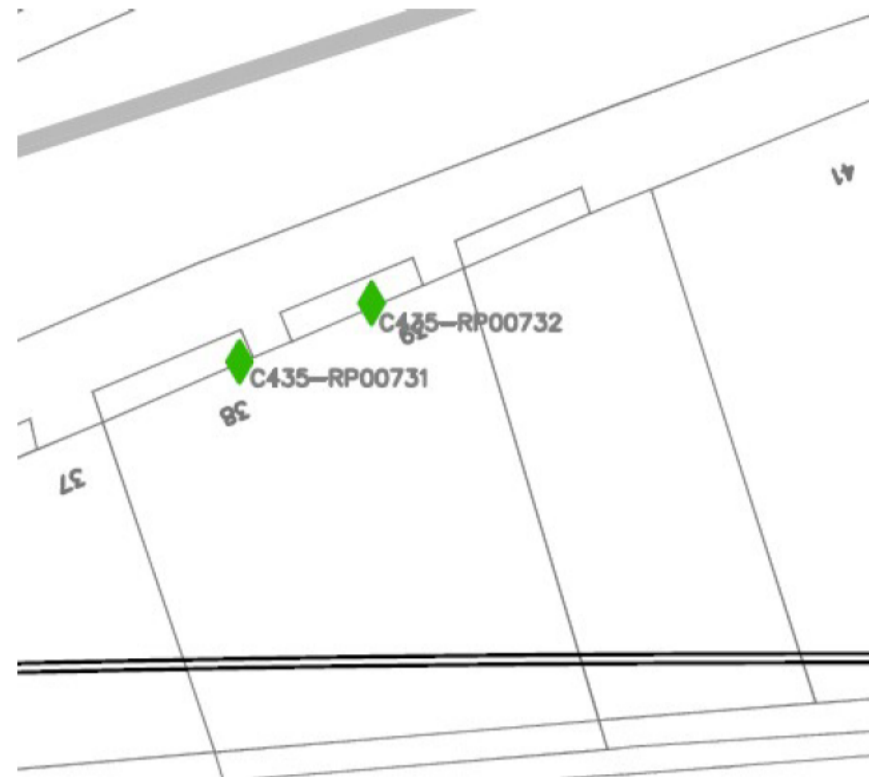
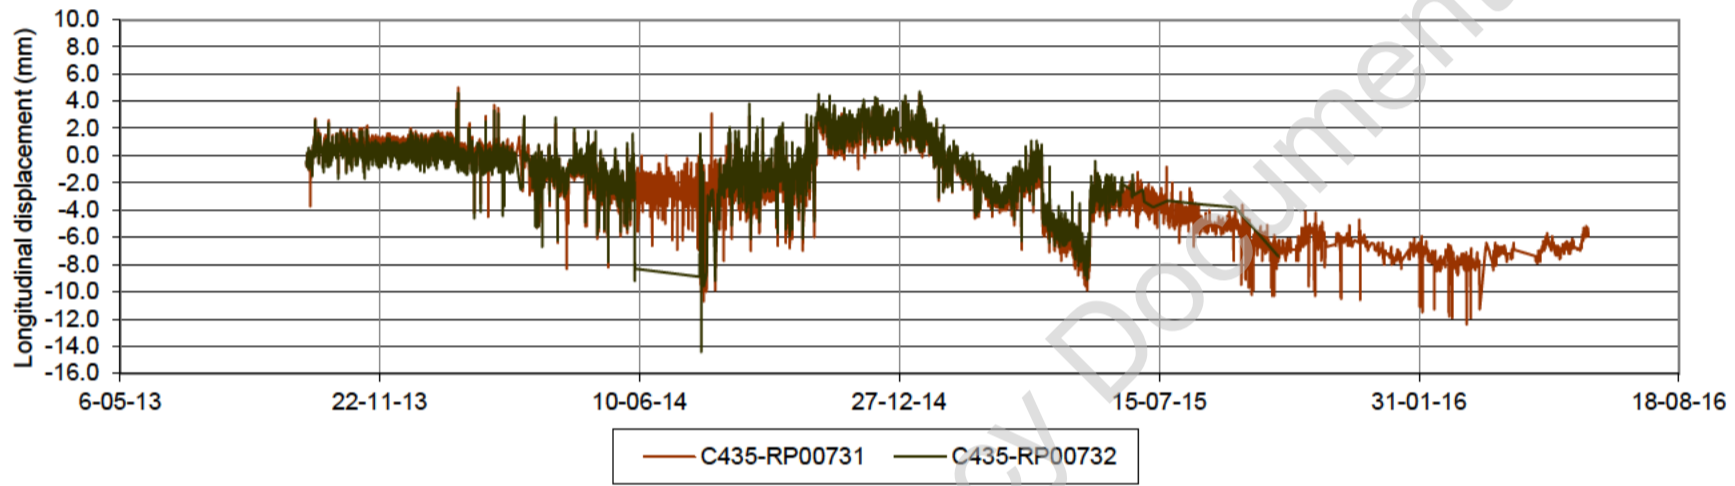
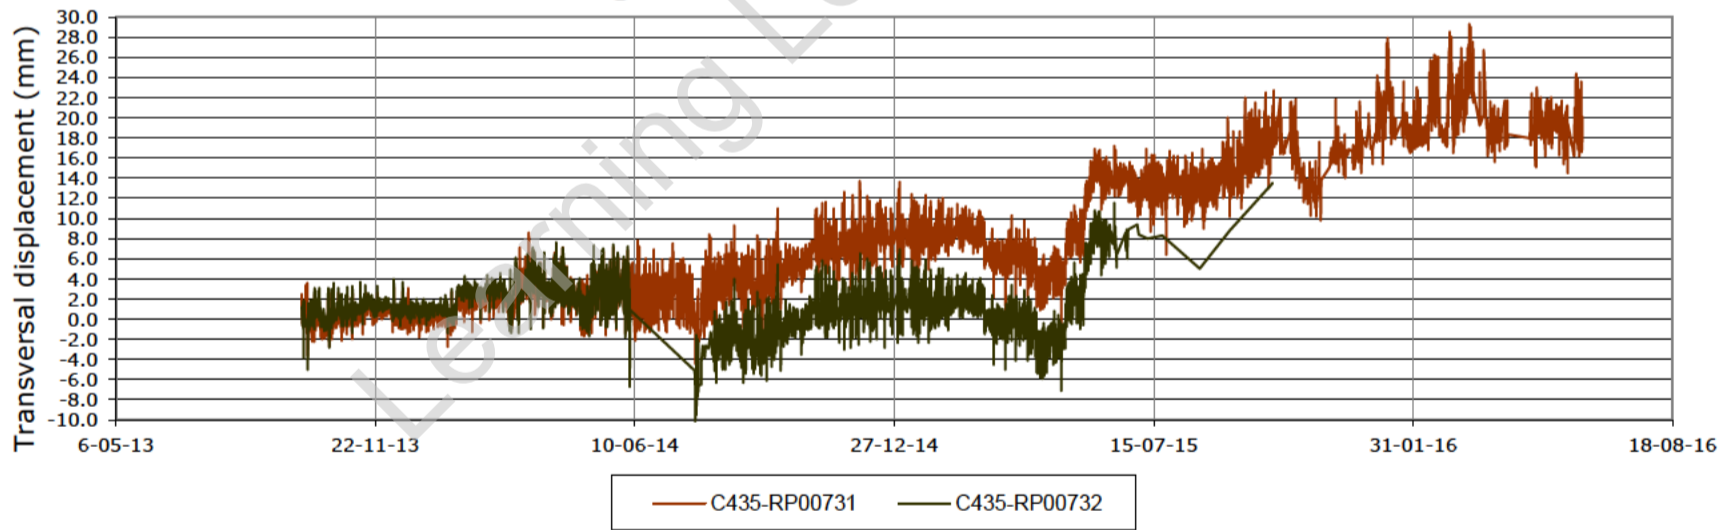
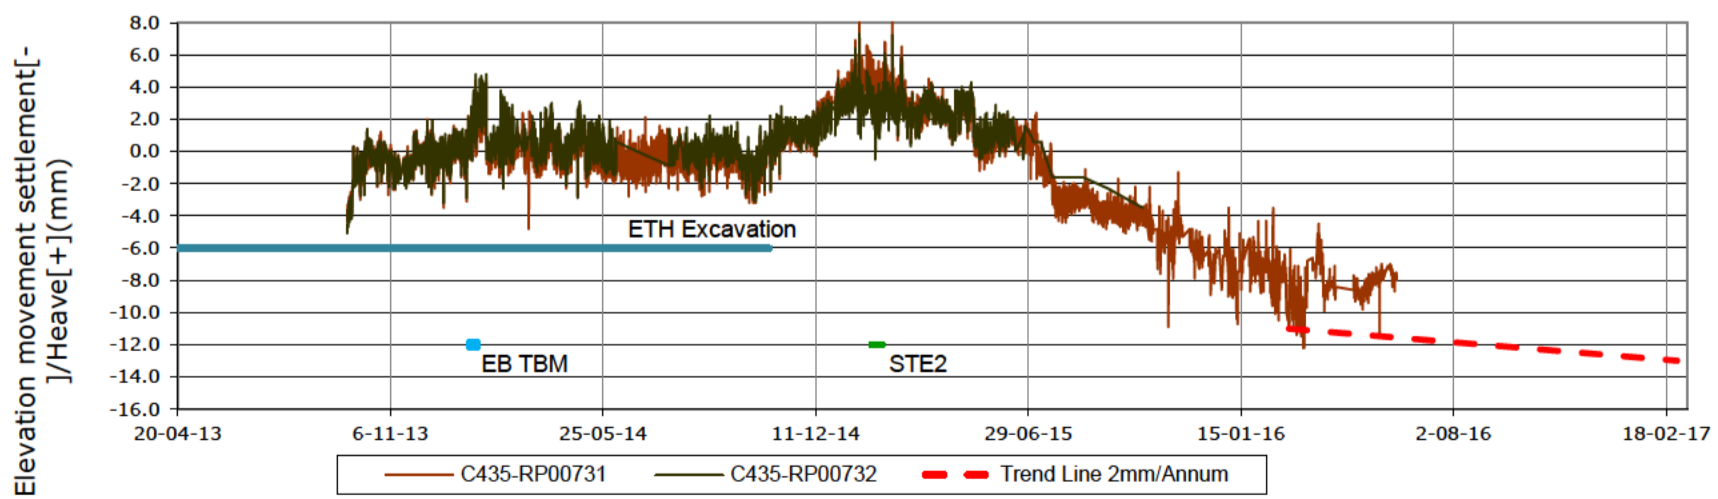
Building: 38-40 CHARTERHOUSE SQUARE

- Compensation grouting carried out in January 2014 caused 3-4mm of heave.
- EB TBM caused maximum 2-3mm of settlement from 22-01-2014 to 24-01-2014.
- Residual settlement caused 1-2mm of settlement.
- Compensation grouting from Charterhouse Shaft caused 4-5mm of heave from October 2014 to January 2015.
- STE2 construction caused 2mm maximum of settlement from 02-02-2015 to 12-02-2015.
- Maximum Longitudinal displacement -8mm
- Maximum Transversal displacement +24mm
- Maximum settlement at the end of the works -11mm

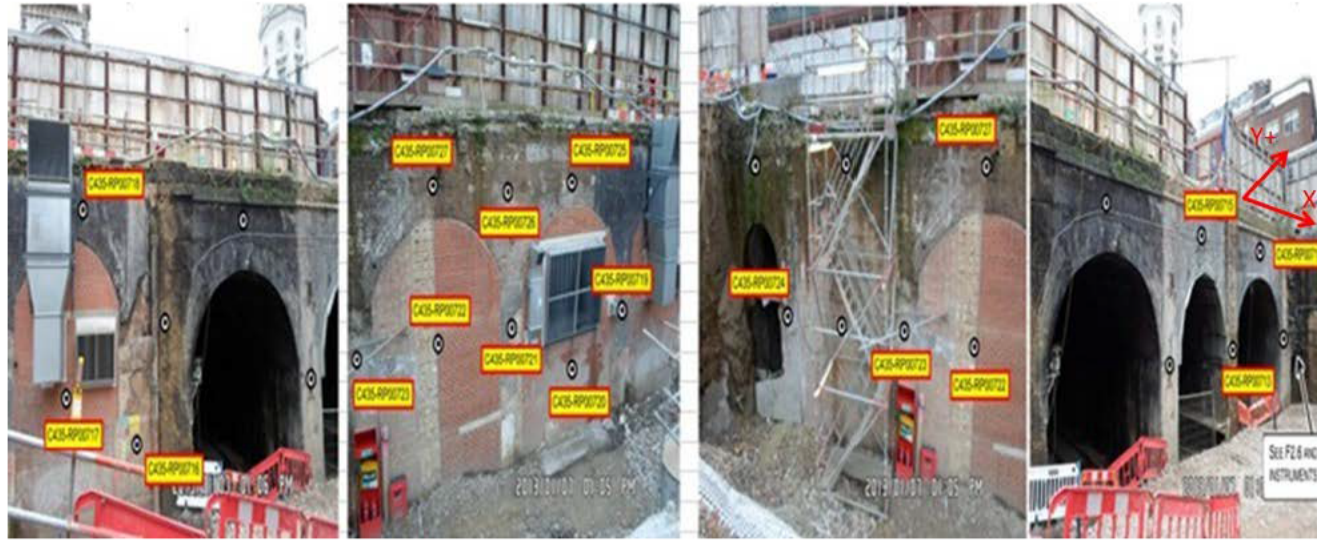
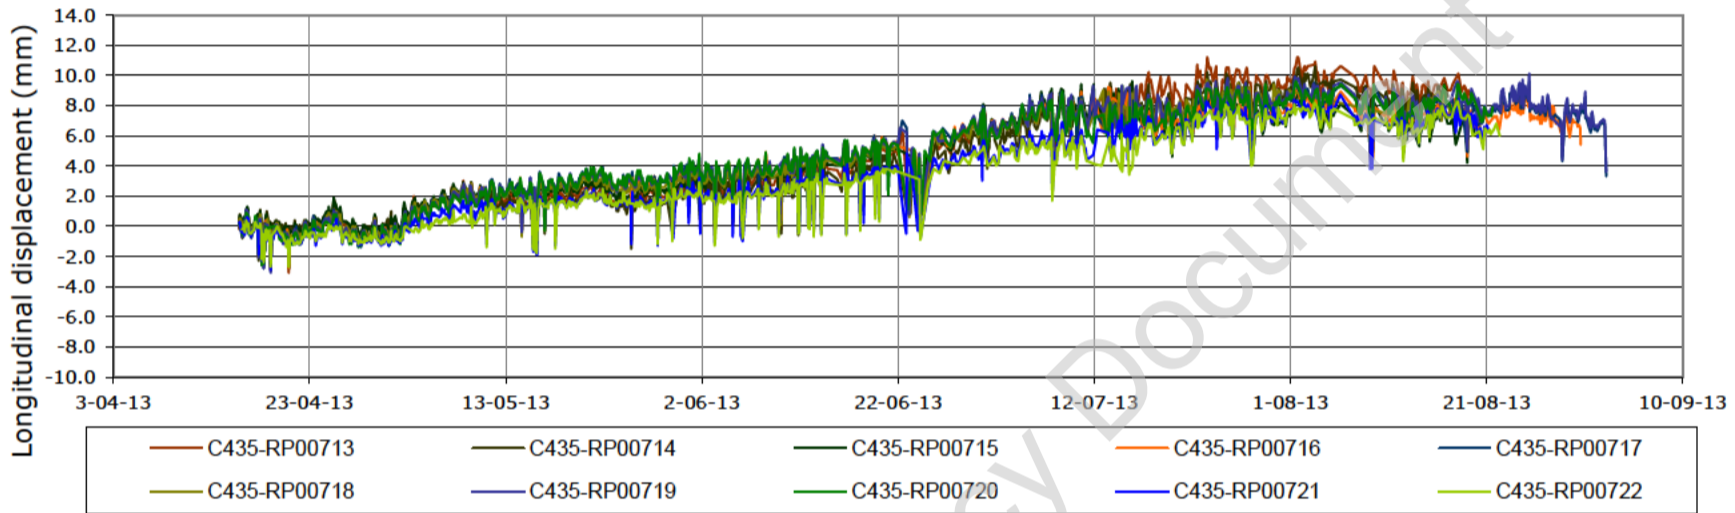
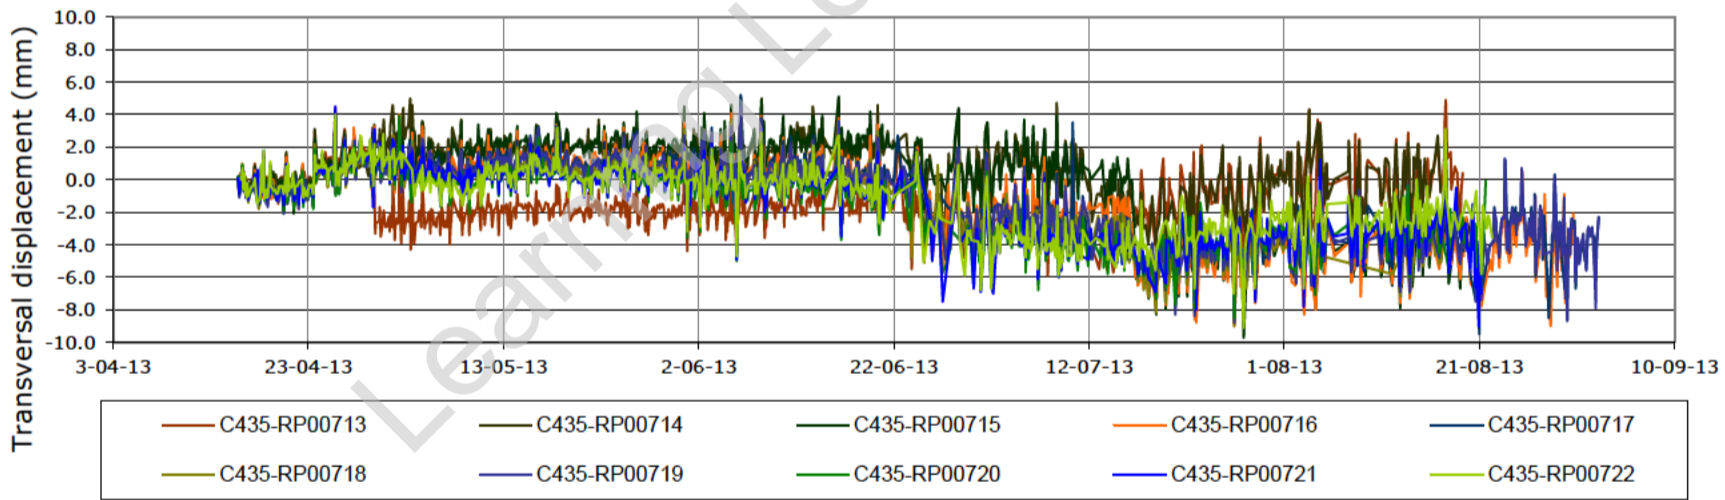
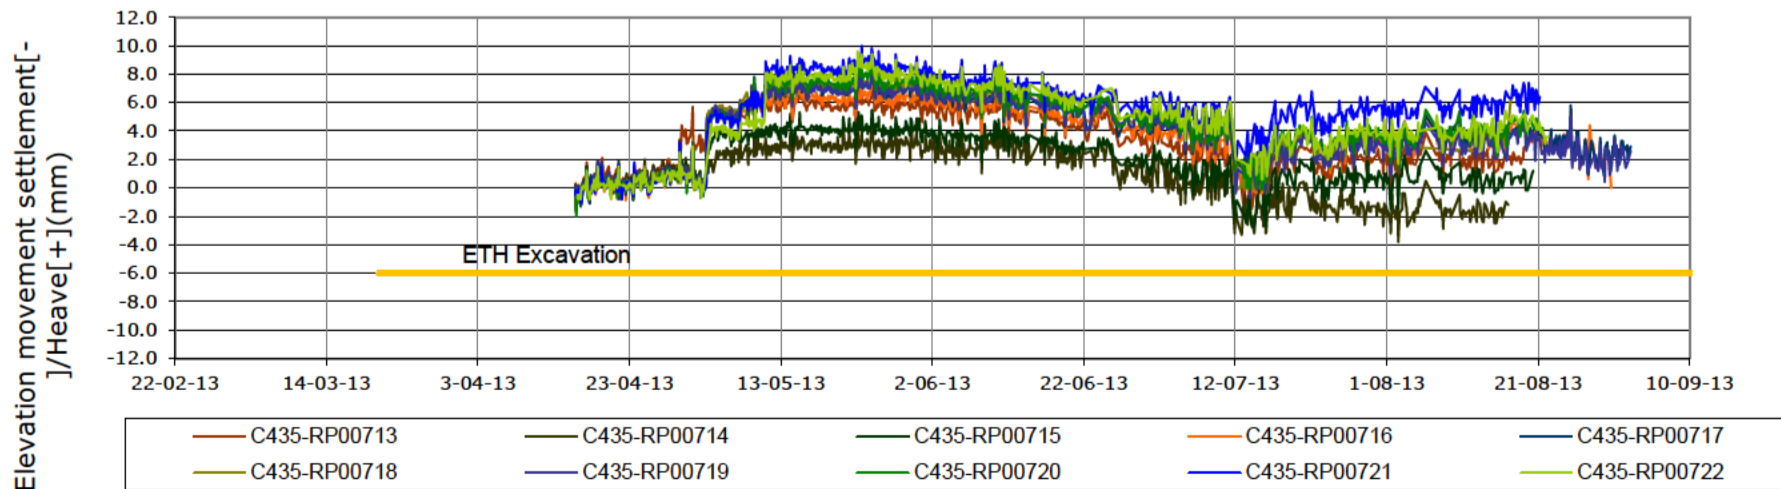
Building: Arch Lindsey Street Bridge

These prisms were removed or covered before the tunnelling works. The work affected to these prisms was the ETH Excavation and compensation grouting episodes.

- TaM's drilling from Moorgate Shaft 2 caused 7-8mm maximum of heave from 29-04-2013 to 11-05-2013.
- ETH Excavation caused maximum 5-6mm of settlement from 21-03-2013 to 28-10-2013.
- Compensation grouting from Moorgate Shaft 2 caused maximum 4-5mm of heave from 12-07-2013 to 22-07-2013.
- Maximum Longitudinal displacement +10mm
- Maximum Transversal displacement -6mm
- Maximum settlement at the end of the works -2mm
