# C435 Farringdon Main Station

## Monitoring Close-Out Report: Automated Total Station ATS7 and 3D Targets read by ATS7.

**CRL Document Number: C435-BFK-C2-RGN-M123-51641**

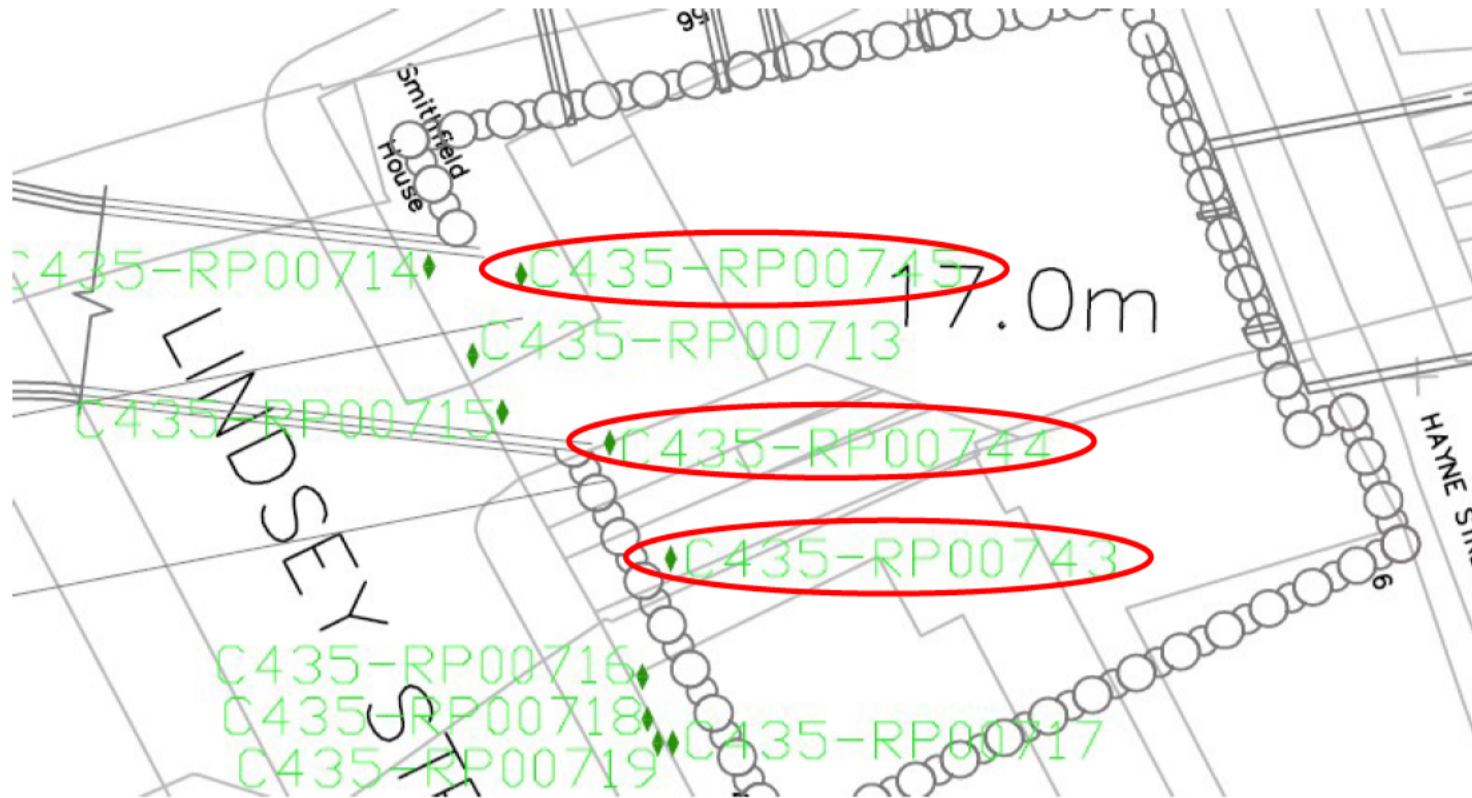
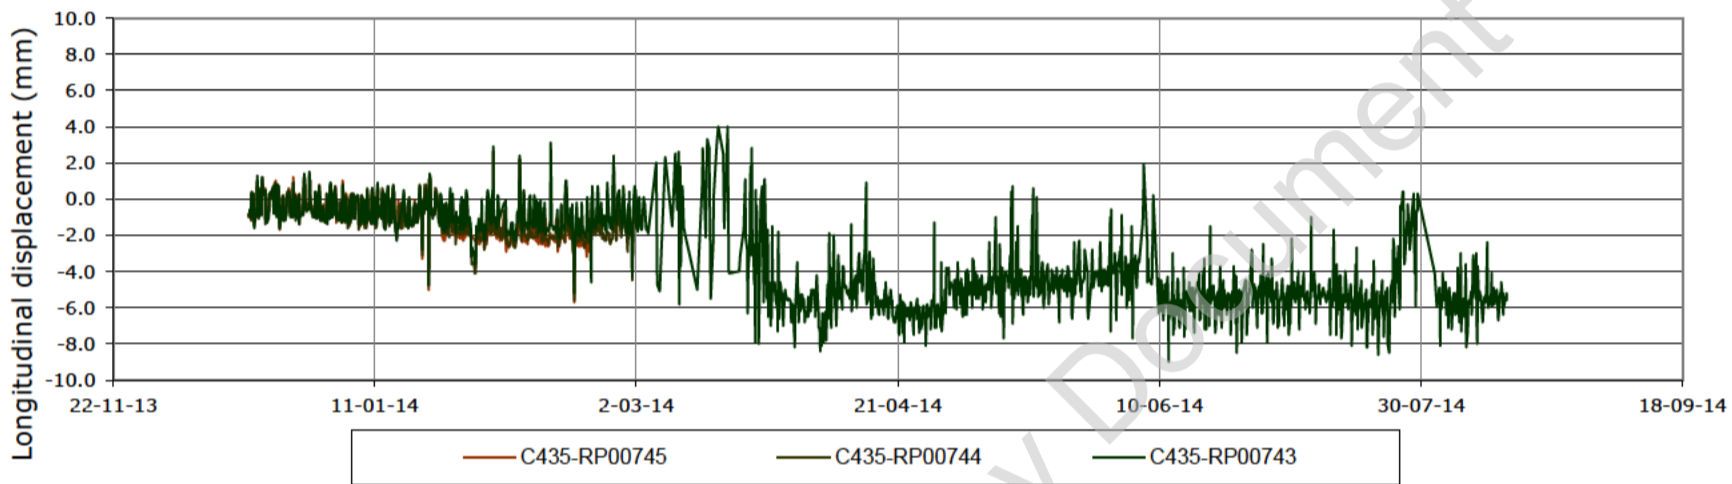
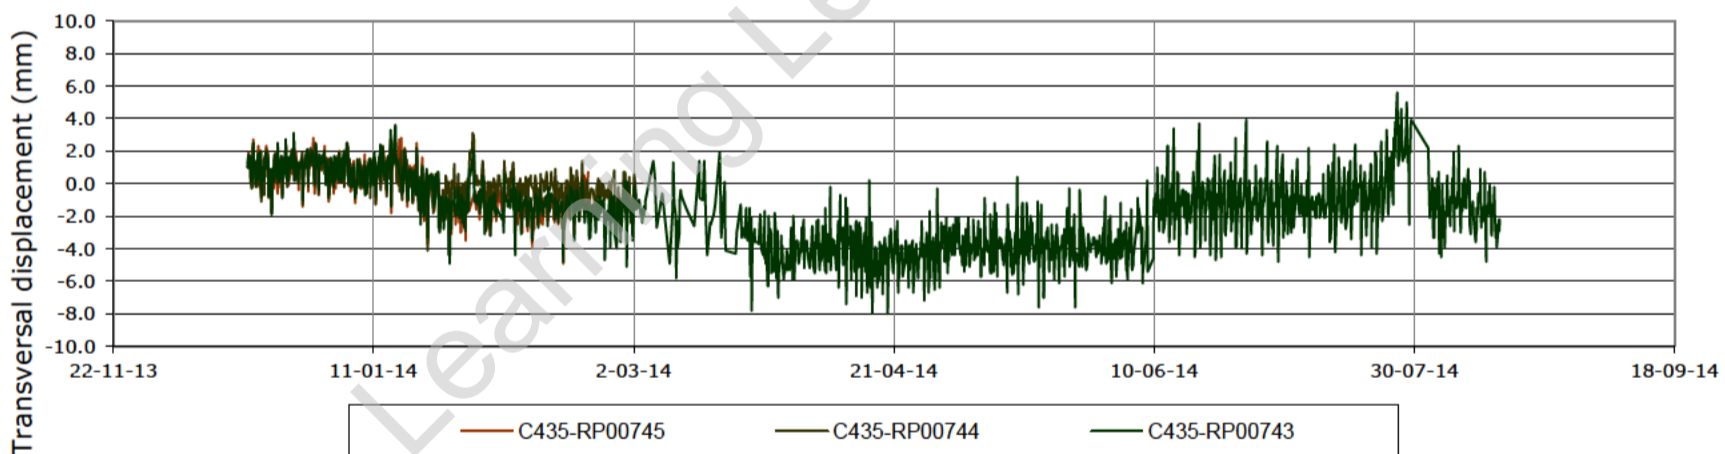
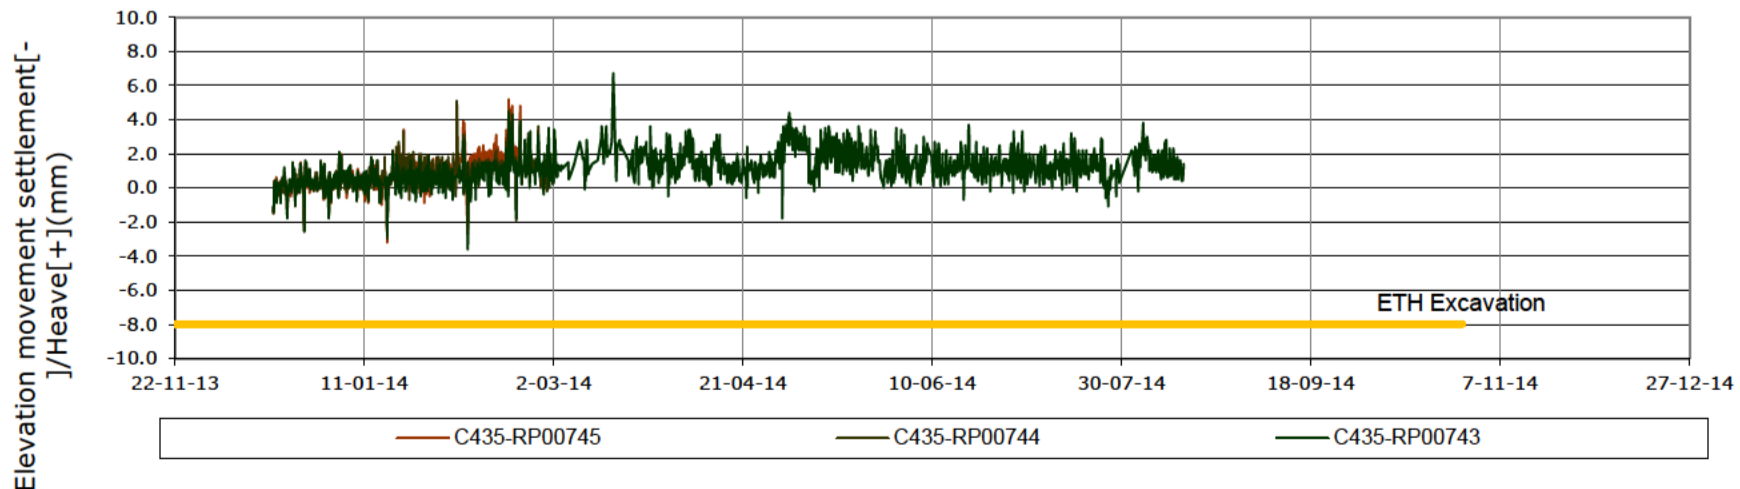
Building: ETH - Trapezoidal Shaft

These prisms were removed or covered before the tunnelling works. The work affected to these prisms was the ETH Excavation.

- No significant movement in Z direction during the ETH Excavations works from 21-03-2013 to 28-10-2013.
- Maximum Longitudinal displacement -6mm
- Maximum Transversal displacement -5mm
- Maximum settlement at the end of the works +1mm

02-03-2014: Prisms C435-RP00744 and C435-RP00745 covered due to safety net installation.

Prisms installed on Hayne Street Bridge and on Trapezoidal shaft were covered by the different structures (Scaffolds, safety nets, props, etc.) during the excavation of the shaft.

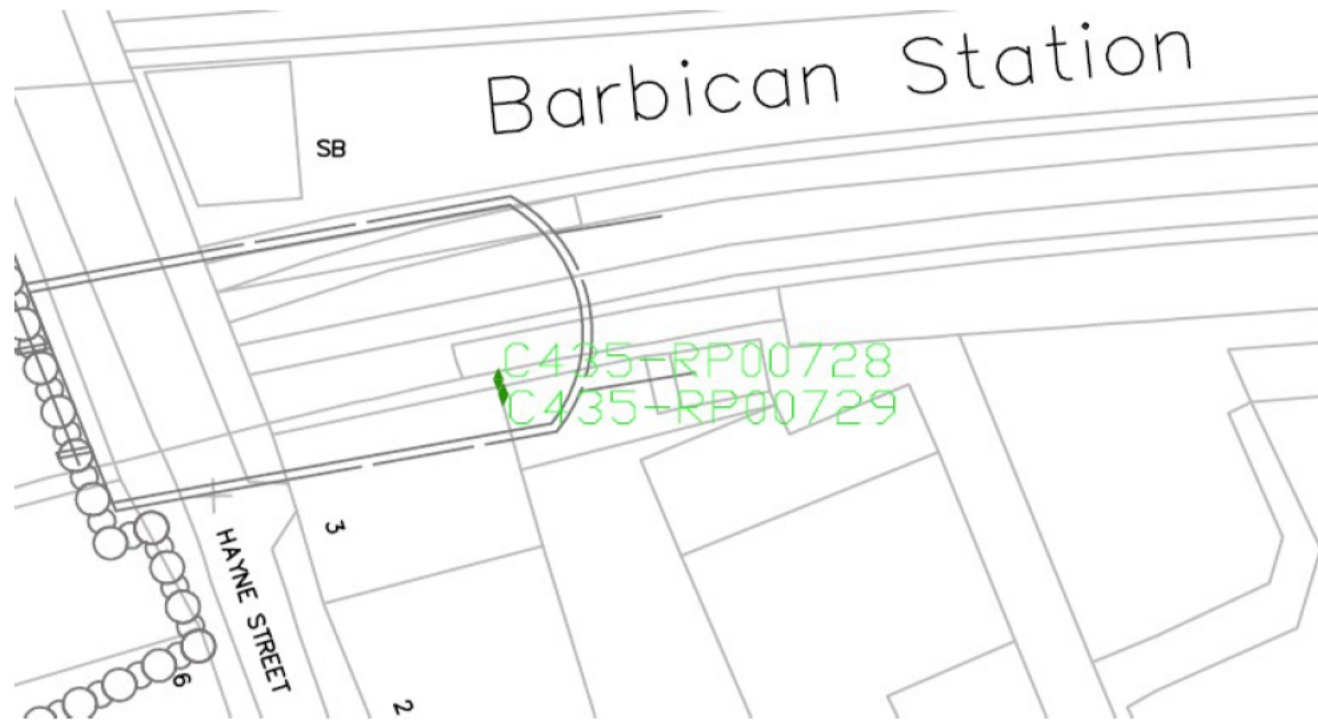
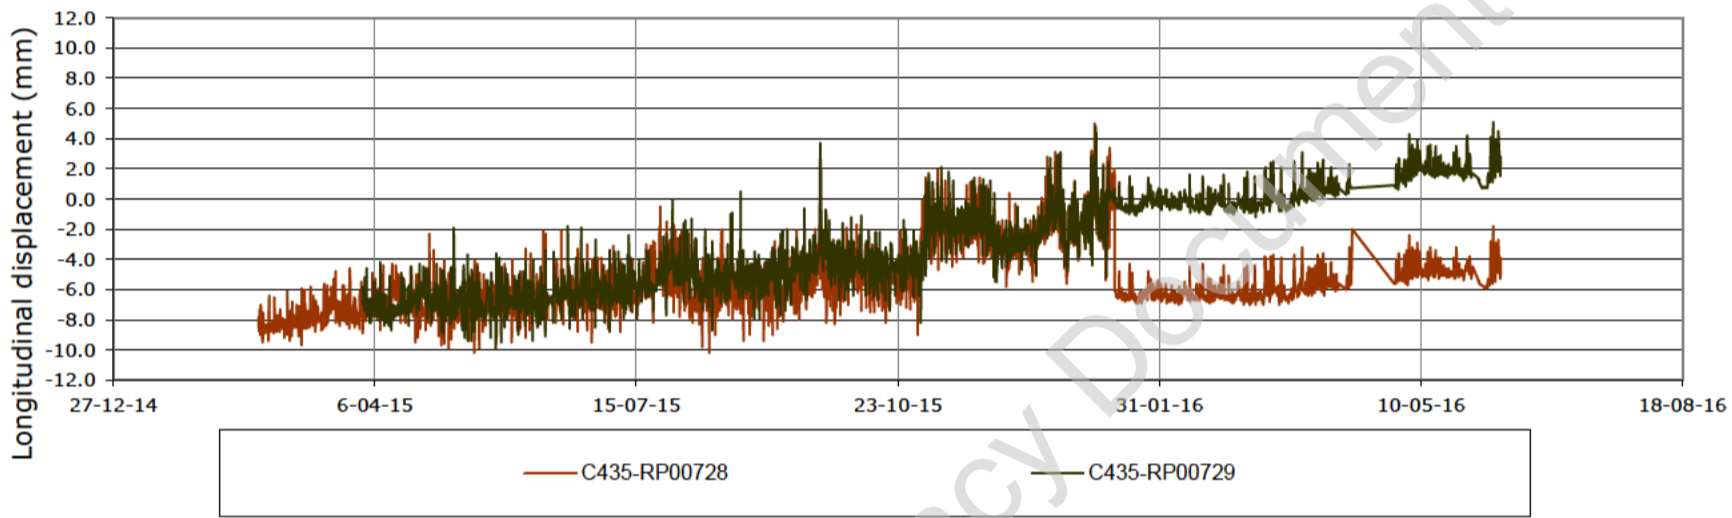
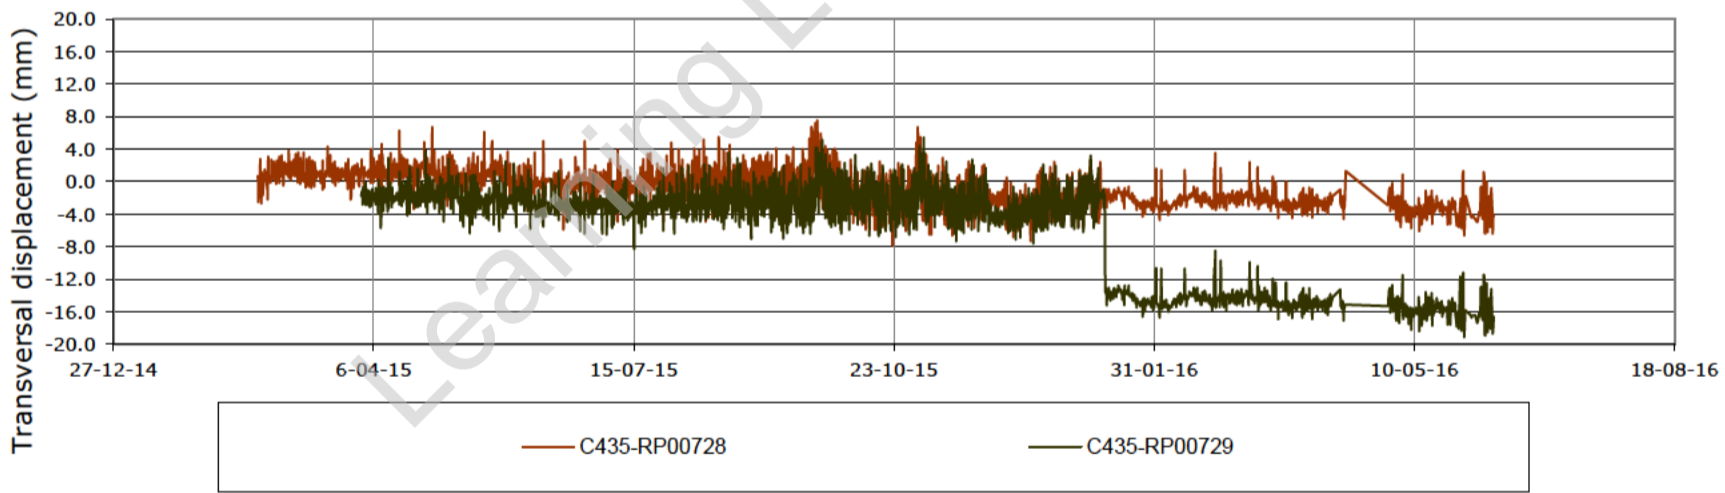
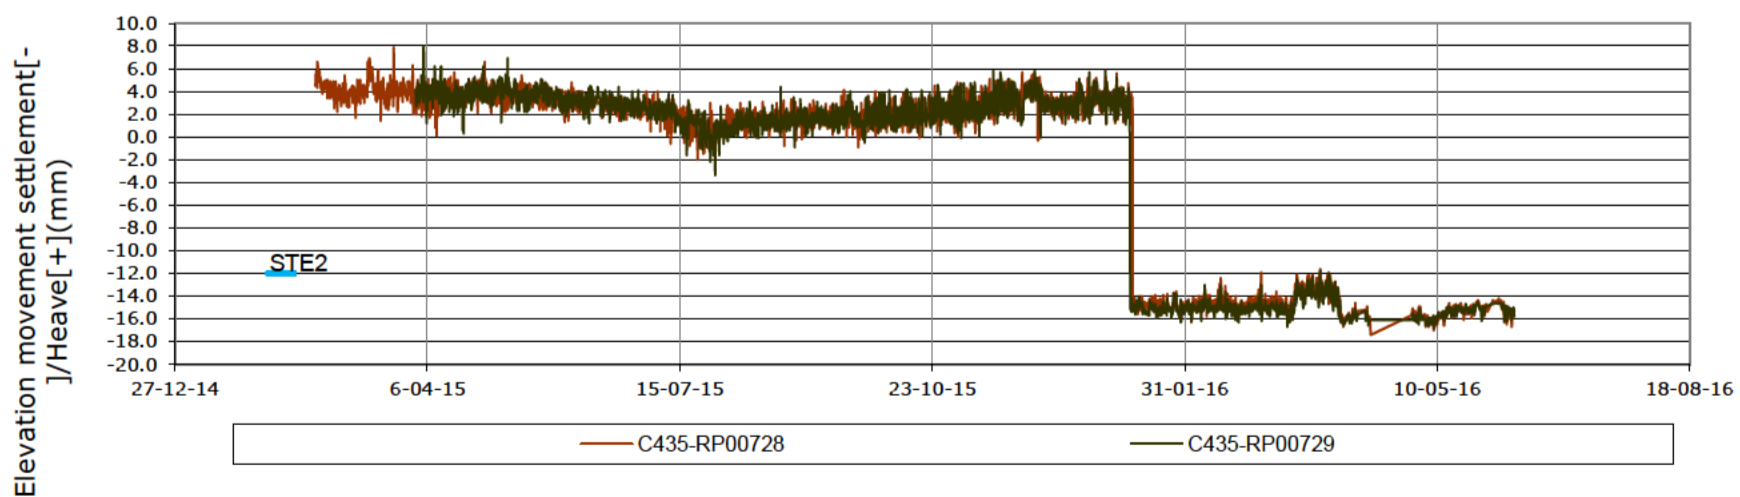
Building: Barbican Station Retaining Wall South

These prisms were installed by C704. C435 monitoring these prisms to verify that C704 was working. These prisms did not show any significant movement by the Crossrail works. The only work affected to these prisms was STE2 construction. These prisms were re-installed by C701 on 10-01-2016. For this reason both prisms showed a jump in the data.

- Maximum Longitudinal displacement +6mm
- Maximum Transversal displacement -4mm
- Maximum settlement at the end of the works -4mm
