# C435 Farringdon Main Station

## Monitoring Close-Out Report: Automated Total Station ATS 08 and 3D Targets read by ATS 08.

**CRL Document Number: C435-BFK-C2-RGN-M123-51642**

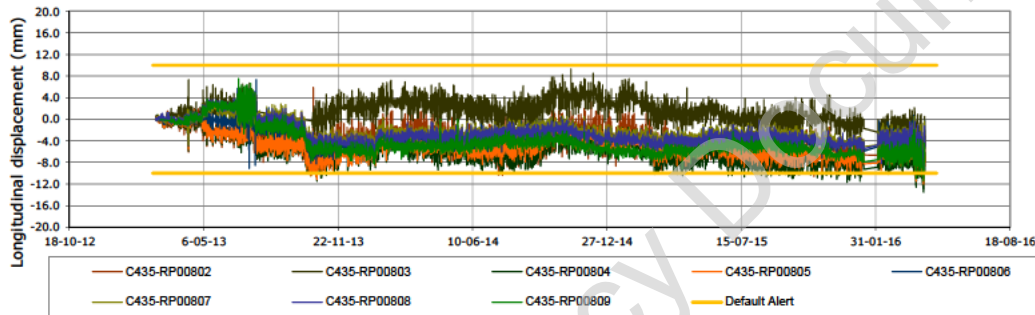
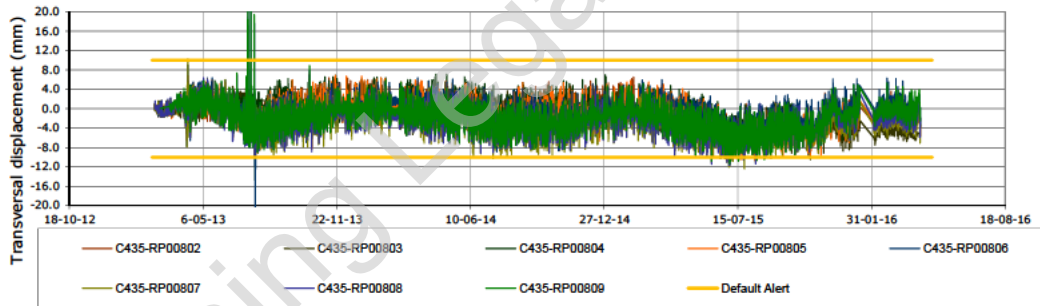
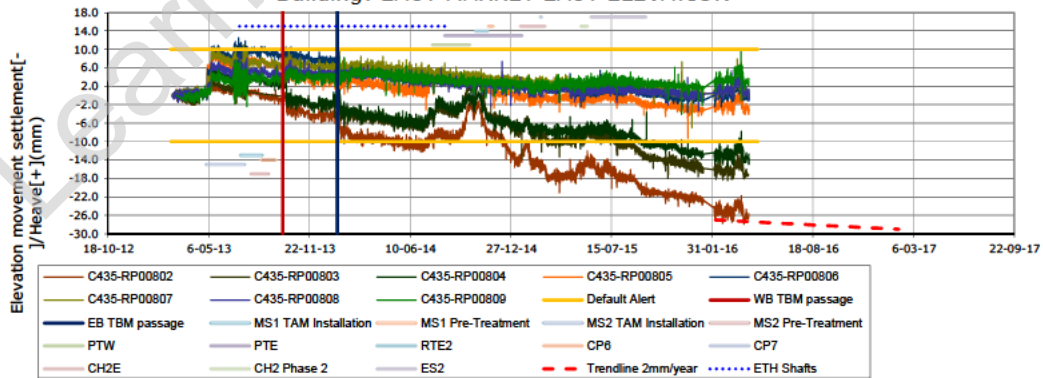
Building: EAST MARKET EAST ELEVATION

- TAM's drilling from Moorgate Shaft 2 caused 8-10mm of heave in May 2013.
- WB TBM caused 4mm of settlement on 30-09-2013
- EB TBM caused 9mm maximum of settlement on 16-01-2014
- PTW construction caused 3mm of settlement from 24-07-2014 to 06-10-2014.
- PTE enlargement caused 2-3mm maximum of settlement between 17-08-2014 to 18-01-2015.
- Compensation grouting caused 6mm maximum of heave from 02-09-2014 to 13-10-2014.
- RTE2 and CP6 combination caused 13-14mm of settlement from 18-10-2014 to 17-01-2015.
- Compensation grouting caused maximum 4-5mm of heave from 12-01-2015 to 30-01-2015.
- CH2 construction caused 5-6mm of settlement from 05-03-2015 to 28-05-2015.
- ES2 caused maximum 5-6mm of settlement from 04-06-2015 to 21-09-2015

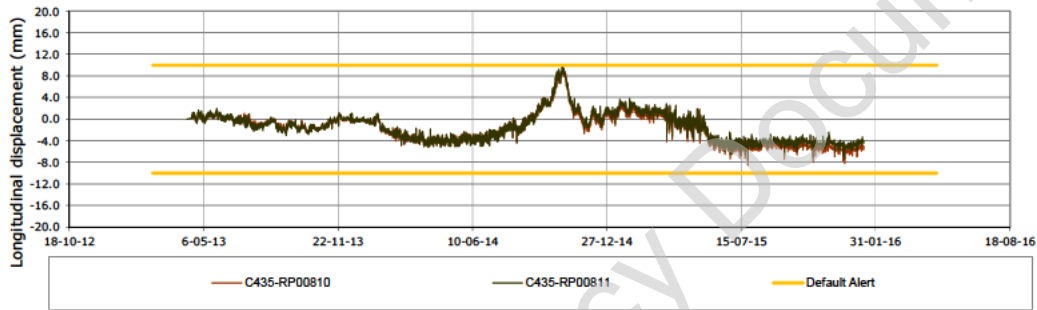
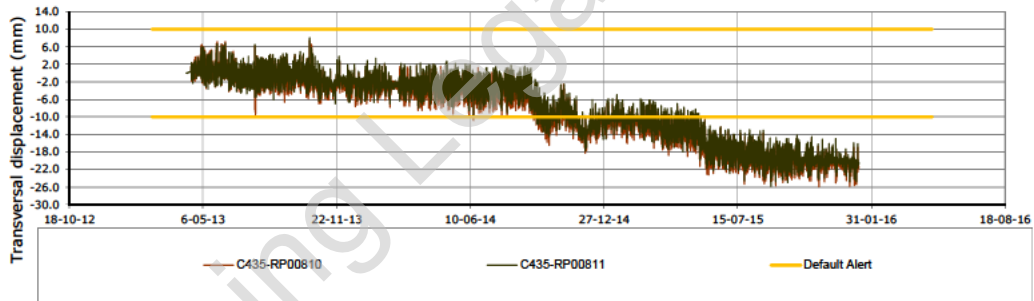
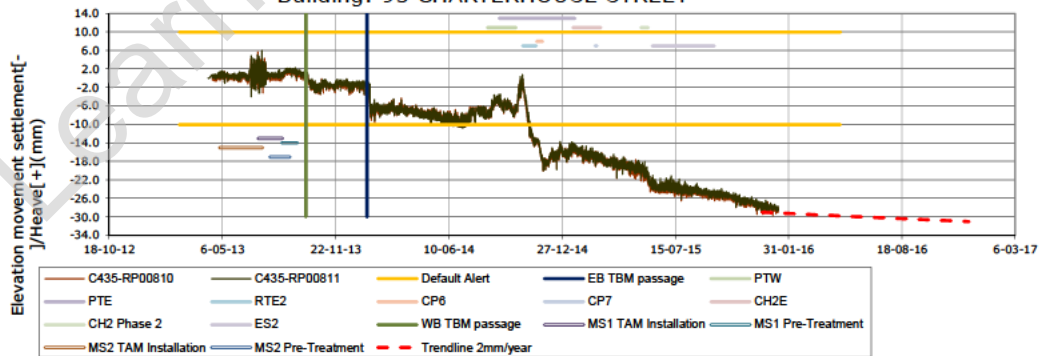
Building: 93 CHARTERHOUSE STREET

- WB TBM caused maximum 4mm of settlement on 30-09-2013
- EB TBM caused 6mm of settlement on 16-01-2014
- Residual settlement caused 2mm.
- Compensation grouting from Moorgate Shaft 2 caused maximum 5mm of heave between 08-07-2014 and 03-09-2014
- PTW construction caused 2mm of settlement from 17-08-2014 to 06-10-2014.
- Ground treatment caused 4-5mm of heave in October 2014.
- PTE enlargement caused 16mm of settlement from 09-09-2014 to 18-01-2015
- CP6 and RTE2 combination caused 4mm of settlement from 18-10-2014 to 22-11-2014.
- CH2 construction caused 7mm of settlement from 15-01-2015 to 05-03-2015.

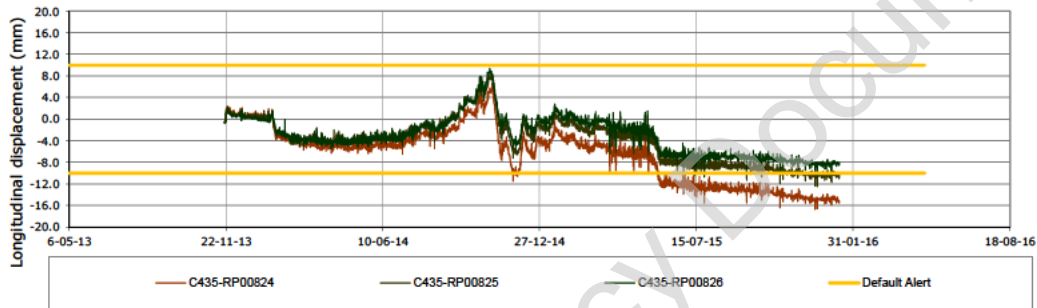
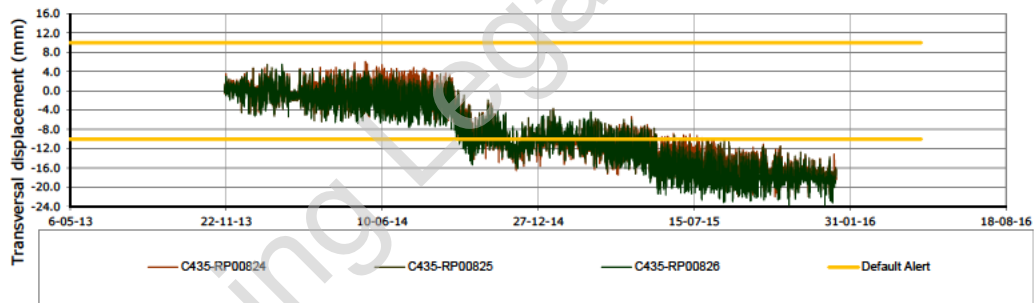
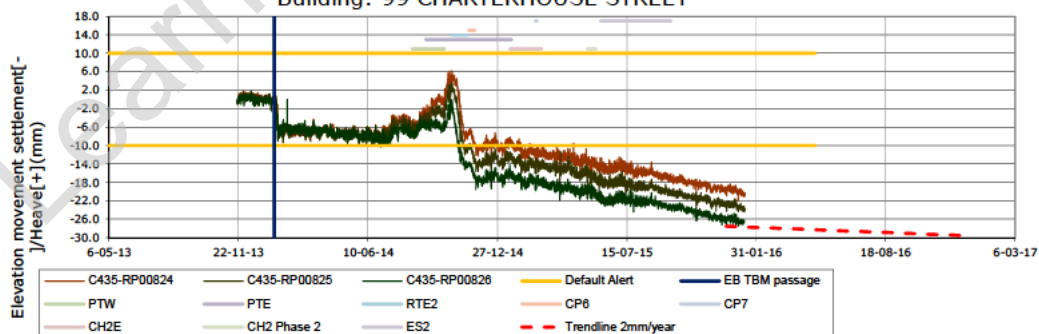
Building: 99 CHARTERHOUSE STREET

- EB TBM caused maximum 8mm of settlement on 16-01-2014.
- Residual settlement caused 4mm.
- Compensation grouting from Moorgate Shaft 2 caused maximum 6-7mm of heave from 08-07-2014 to 06-10-2014.
- Ground treatment caused maximum 6-8mm of heave in October 2014
- PTE construction caused 14-15mm of settlement from 07-09-2014 to 18-01-2015.
- CP6 and RTE2 combination caused 3-4mm of settlement from 18-10-2014 to 22-11-2014.
- CH2 and ES2 combination caused 6mm maximum of settlement from 15-05-2015 to 21-09-2015.

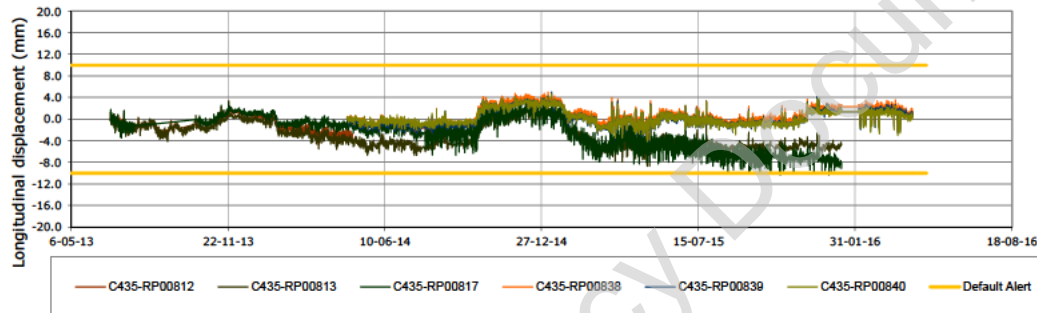
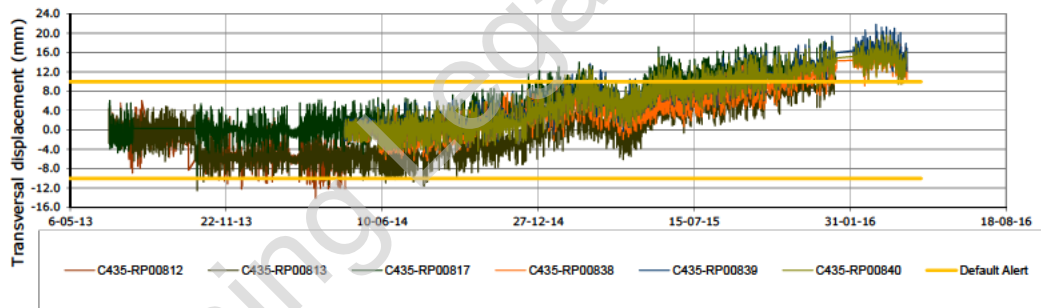
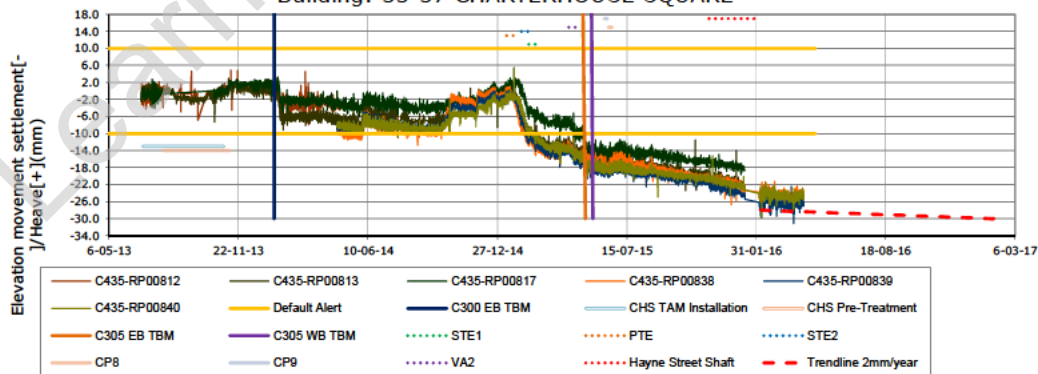
Building: 33-37 CHARTERHOUSE SQUARE

- TAM's drilling from Charterhouse Shaft caused 3-4mm of heave from 14-10-2013 to 22-11-2013.
- EB TBM caused maximum 10mm of settlement on 16-01-2014.
- Compensation grouting caused maximum 3-4mm of heave from 21-05-2014 to 21-06-2014
- Compensation grouting caused 10mm of heave from 02-10-2014 to 21-01-2015.
- PTE enlargement caused maximum 10mm of settlement from 10-01-2015 to 27-01-2015
- STE2 tunnel caused 4-5mm of settlement from 02-02-2015 to 12-02-2015.
- VA2 excavation caused maximum 5mm of settlement from 16-04-2015 to 02-05-2015
