Farringdon Main Station

Monitoring Close-Out Report:

Automated Total Station ATS 09 and 3D Targets read by ATS 09.

CRL Document Number: C435-BFK-C2-RGN-M123-51643

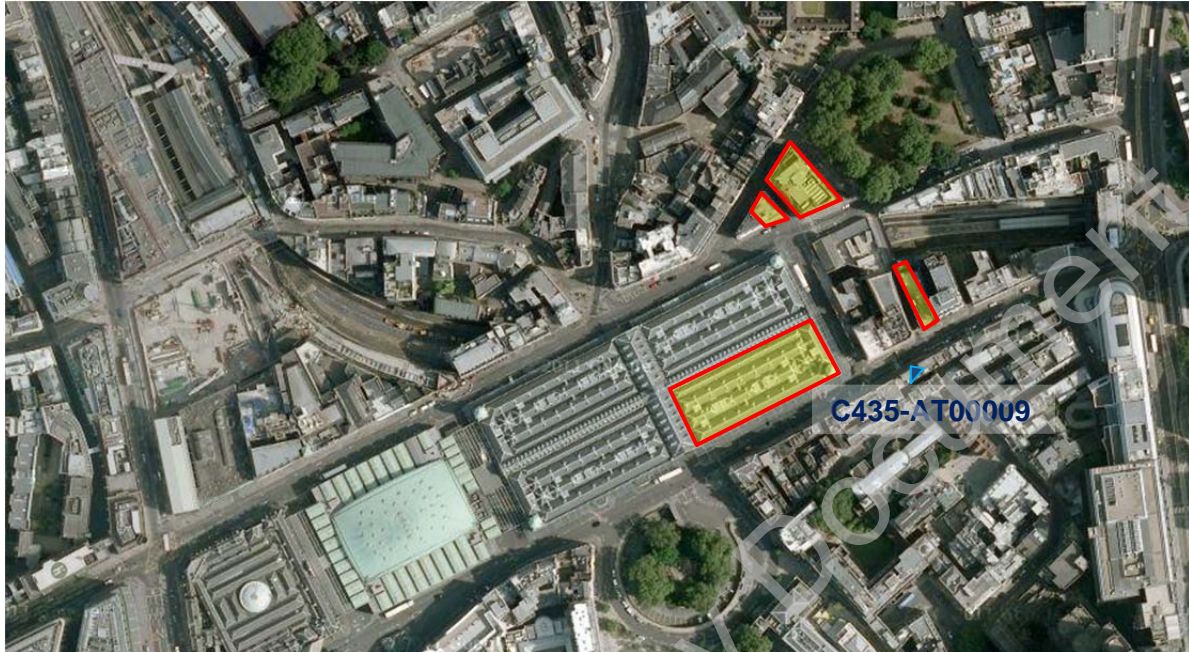
Figure 1 – Map showing the Location of ATS 09 and 3D Targets read by ATS 09.

As you can see from the Figure 1 below, the instruments described in Section B.1 are located in the eastern Charterhouse Street, Hayne Street and Long Lane areas. A drawing showing the location of these devices can be found in the Appendix A.

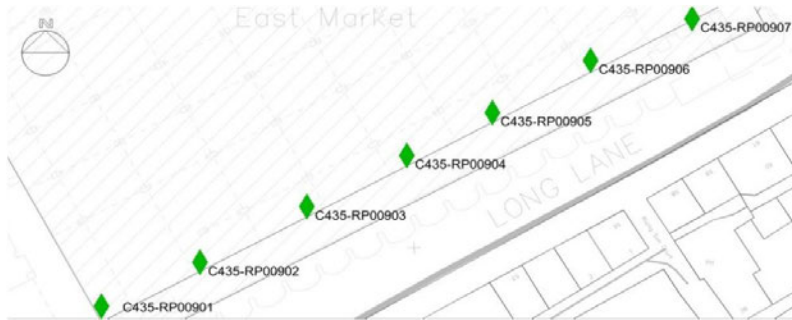
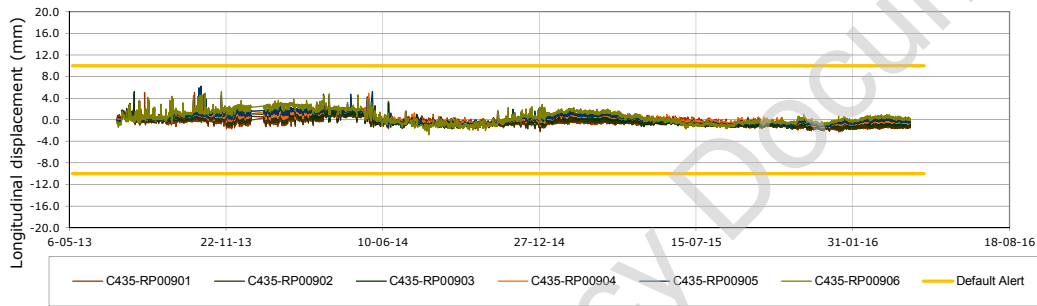
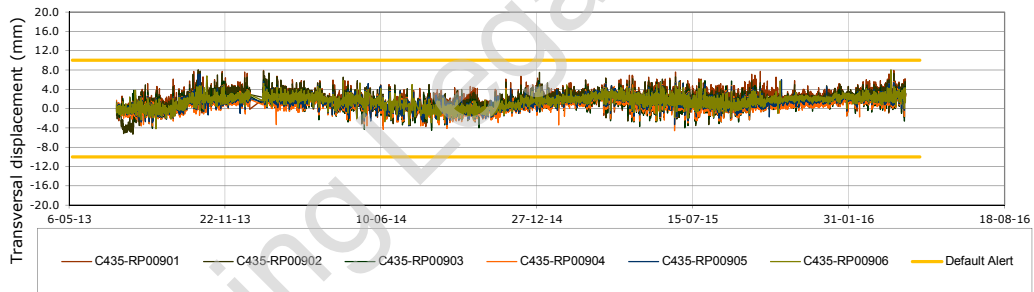
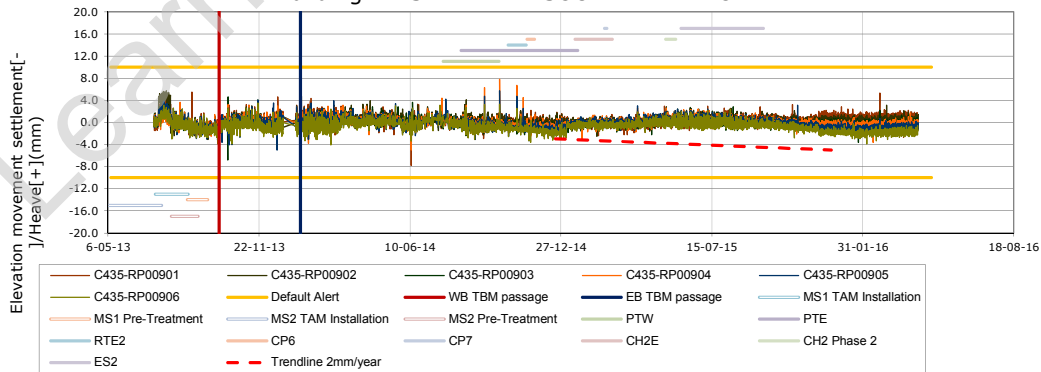
Building: EAST MARKET SOUTH ELEVATION

- Compensation Grouting works: approximately 6mm heave was recorded during Moorgate Spur Shaft No.2 TAM Installation from 01/05/2013 to 16/07/2013.
- Maximum Longitudinal displacement 1-2mm.
- Maximum Transversal displacement 4mm
- Maximum Settlement captured was -2mm

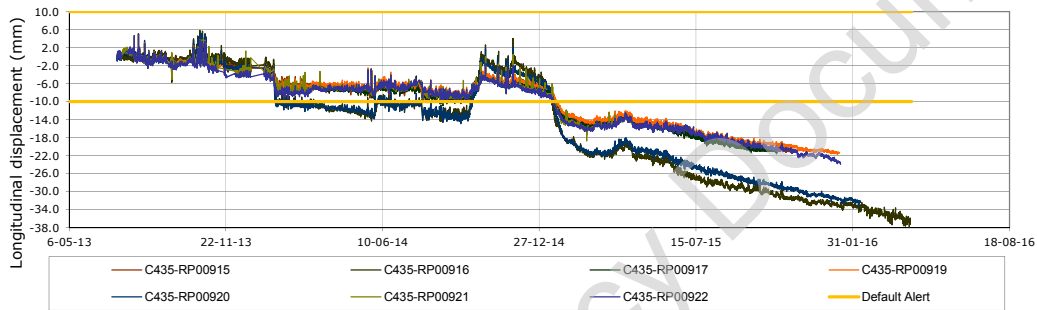
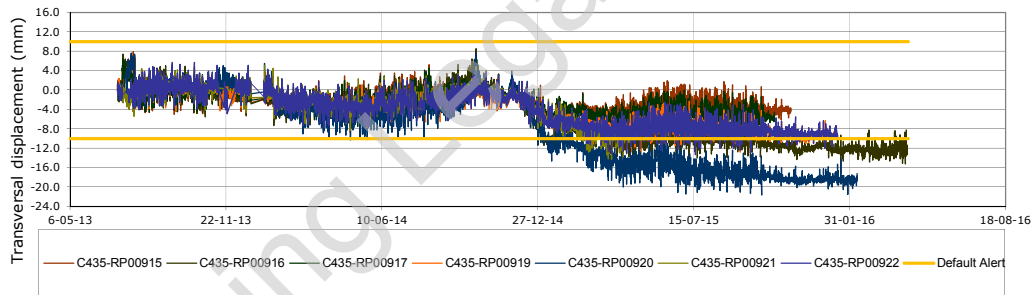
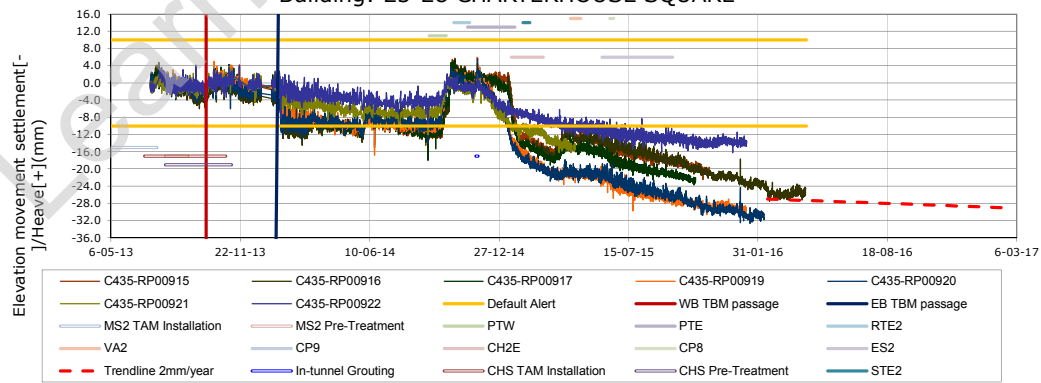
Building: 23-28 CHARTERHOUSE SQUARE

- Around 8mm settlement produced because of the EB TBM passage from 16/01/2014 to 23/01/2014.
- During the PTE enlargement and RTE2, a total of 25mm settlement was captured by these 3D Targets from 17/08/2014 to 18/01/2015.

- During the STE2 and CH2E, a settlement of 5mm was captured by these devices from 15/01/2015 to 05/03/2015.
- CP8 and ES2 caused until 8mm settlement from 04/06/2015 to 21/09/2015.

- 5mm settlement recorded as a residual settlement after last excavation activity taking place until 21/09/2015, showing a trend of settlement still ongoing when last monitoring reading was taken on 13/04/2016.

- 4mm heave was captured during Moorgate Spur Shaft No.2 TAM Installation works from 01/05/2013 to 16/07/2013.
- Compensation Grouting carried out in October 2014 caused until 16mm heave.

- Compensation Grouting carried out in February 2015 caused 6mm heave.
- 8mm heave was recorded because of the in-tunnel grouting works carried out in November 2014.

- Maximum Longitudinal displacement -38mm
- Maximum Transversal displacement -20mm
- Maximum Settlement captured -32mm

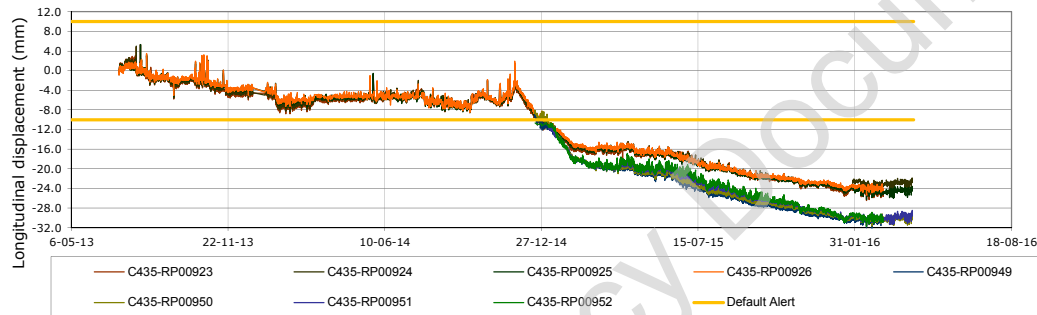
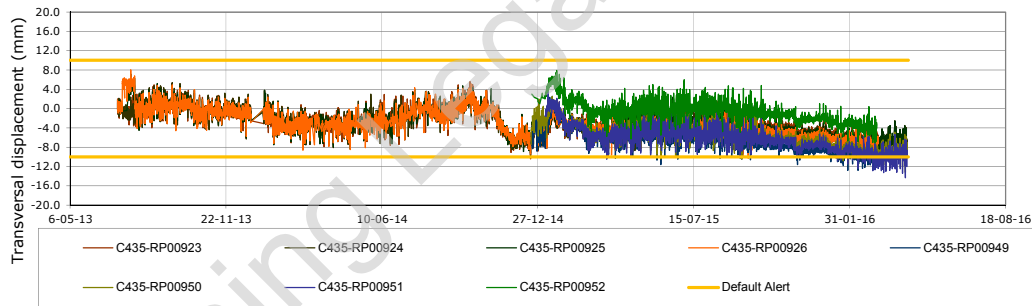
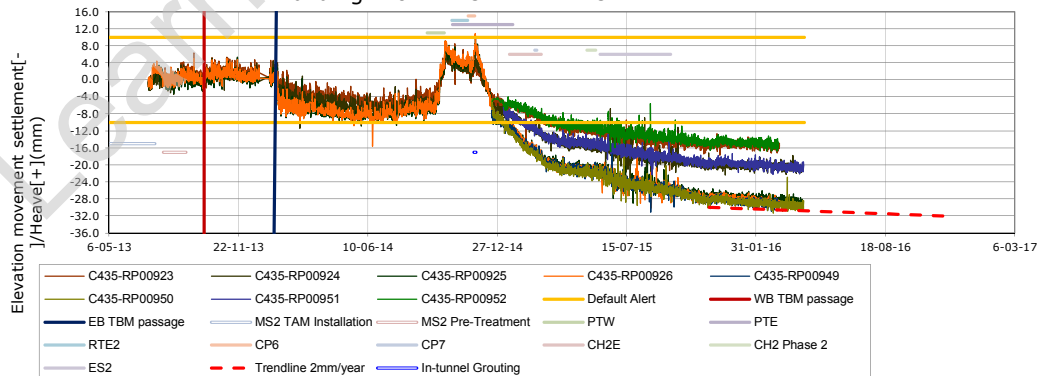
Building: 40-42 FOX AND KNOT

- Around 8mm settlement produced because of the EB TBM passage from 16/01/2014 to 23/01/2014.
- During the CP6 and RTE2, a total of 4mm settlement was captured by these 3D Targets from 18/10/2014 to 22/11/2014.

- During the PTE enlargement, a settlement of 20mm was captured by these devices from 17/08/2014 to 18/01/2015.
- During the CH2E and CP7 excavation works, 10mm settlement was recorded from 15/01/2015 to 05/03/2015.

- ES2 caused until 8mm settlement from 04/06/2015 to 21/09/2015.
- 2mm settlement recorded as a residual settlement after last excavation activity taking place until 21/09/2015, showing a trend of settlement still ongoing when last reading was taken on 13/04/2016.

- 4mm heave was captured during Moorgate Spur Shaft No.2 TAM Installation works from 01/05/2013 to 16/07/2013.
- Compensation Grouting works carried out in October 2014 caused until 16mm of heave.

- 8mm heave was recorded because of the in-tunnel grouting works carried out in November 2014.
- Maximum Longitudinal displacement -32mm
- Maximum Transversal displacement -12mm

- Maximum Settlement captured -30mm

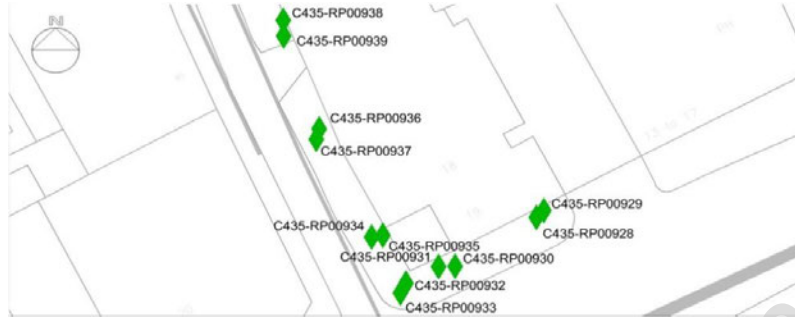
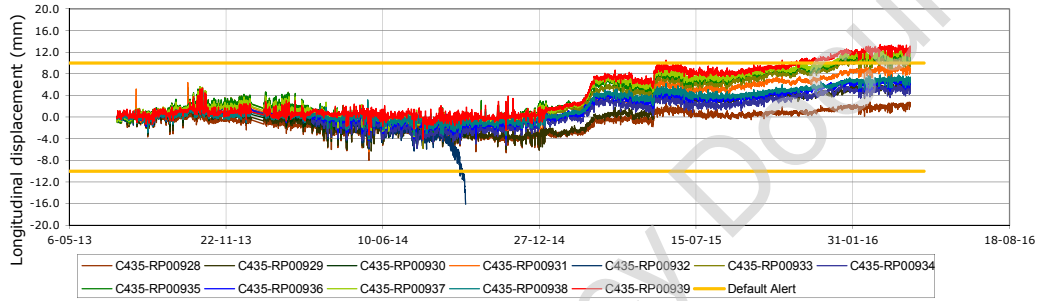
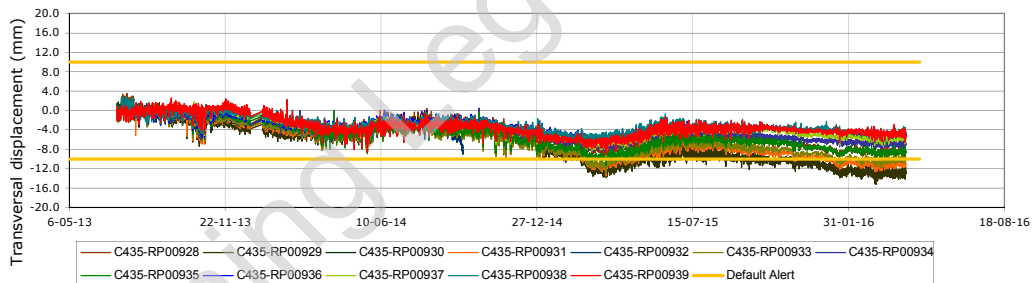
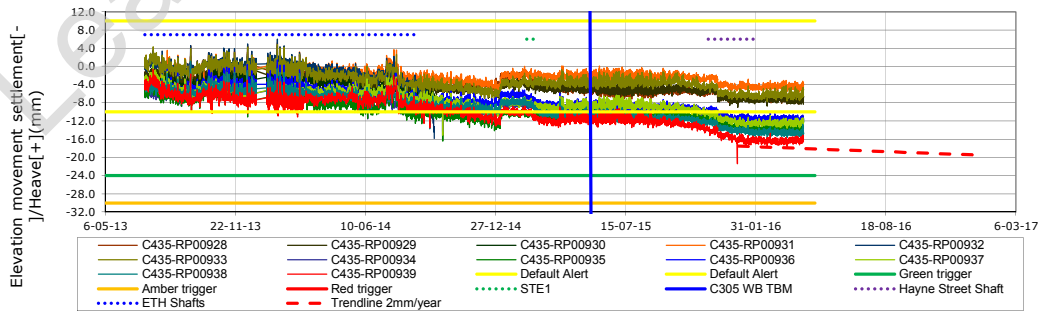
Building: 18-19 LONG LANE

- 3mm settlement recorded in these buildings during ETH excavation works from 26/04/2013 to 29/08/2014.
- During STE1 activity, settlement of 4mm was recorded in this area from 13/02/2015 to 02/03/2015.
- Hayne Street shaft excavation works caused until 4mm settlement from 19/11/2015 to 04/02/2016, showing stable conditions when last monitoring reading was taken on 12/01/2016.
- Maximum Longitudinal displacement +12mm
- Maximum Transversal displacement -14mm
- Maximum Settlement captured -18mm

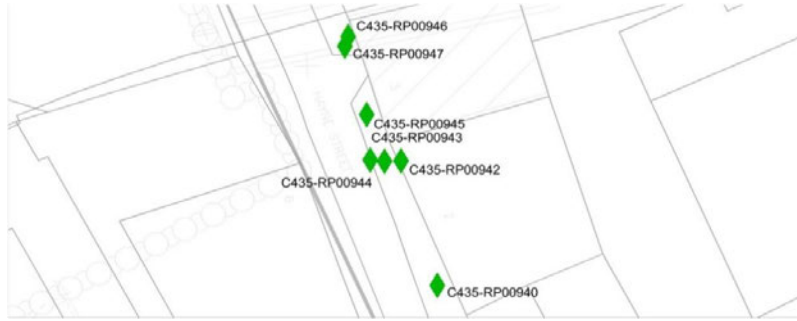
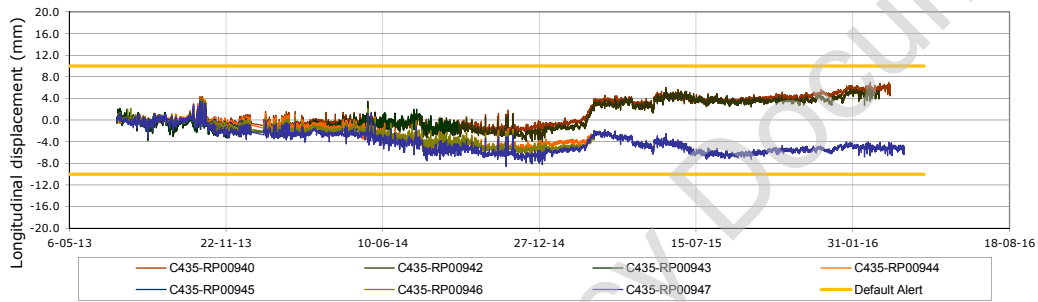
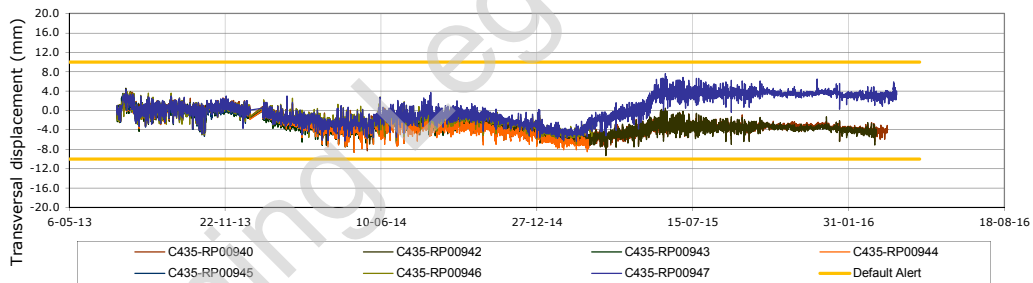
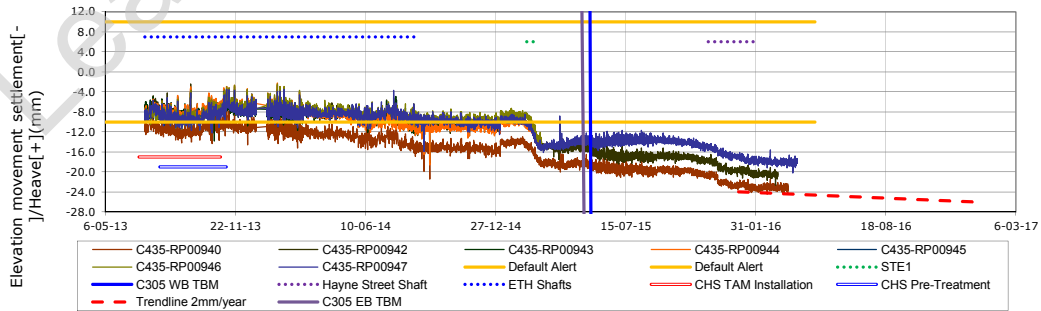
Building: 2-3 HAYNE STREET

- During the EB TBM passage, the movement recorded by these devices was negligible.
- WB TBM passage caused around 2mm settlement in the area from 30/09/2013 to 07/10/2013.
- During the STE1 excavation, a settlement of 8mm was captured by these 3D Targets from 13/02/2015 to 02/03/2015.
- Hayne Street Shaft caused 4mm settlement from 19/11/2015 to 04/02/2016, showing stable conditions when last monitoring reading was taken on 13/04/2016.
- 2mm settlement recorded during CHS shaft TAM installation from 27/06/2013 to 30/10/2013.
- Up to 4mm heave was recorded as result of CHS shaft Pre-Treatment works from 27/09/2013 to 08/11/2013.
- Compensation Grouting carried out in July 2014 caused 3mm heave.
- Compensation Grouting carried out in January 2015 caused 3mm heave.
- Maximum Longitudinal displacement +/-6mm
- Maximum Transversal displacement +/-4mm
- Maximum Settlement captured -24mm
