C435 Farringdon Main Station

Monitoring Close-Out Report: Manual prisms

CRL Document Number: C435-BFK-C2-RGN-M123-51661

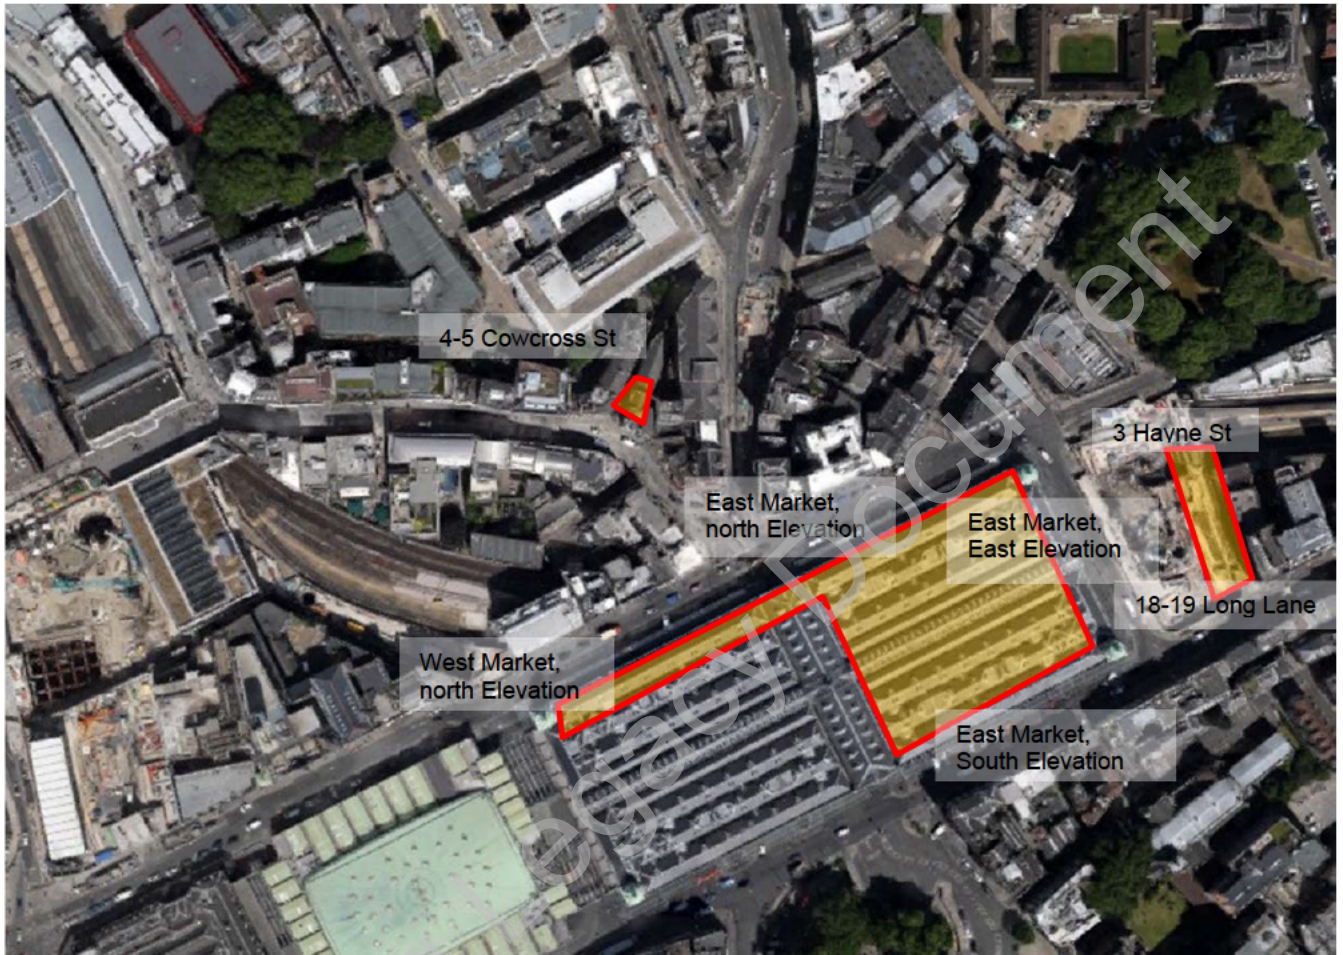
Figure 1 – Map showing the Location for the manual prisms

Prisms read manually are located on the plan below highlighted in yellow.

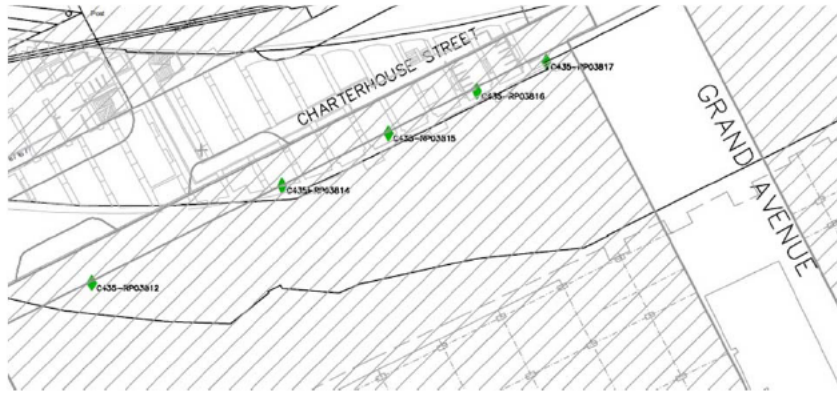
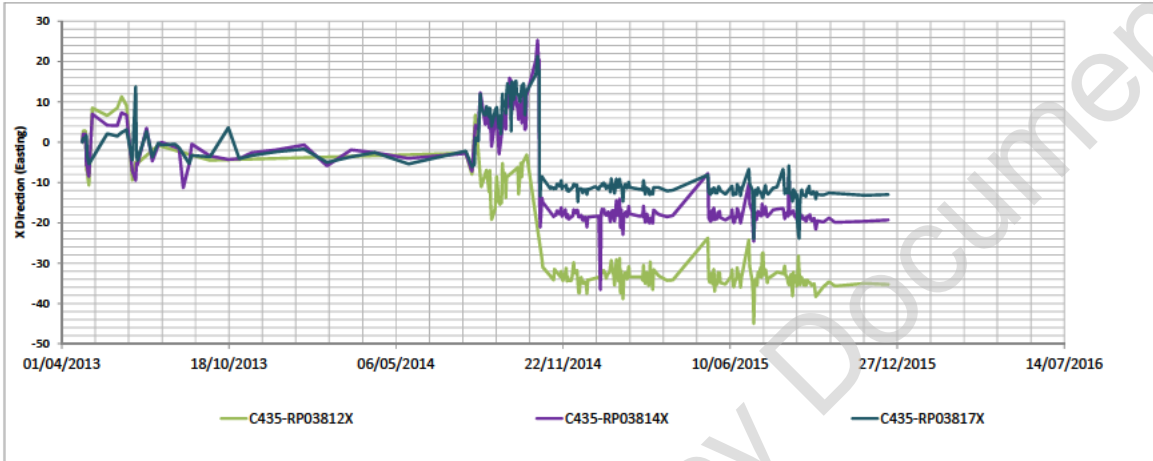
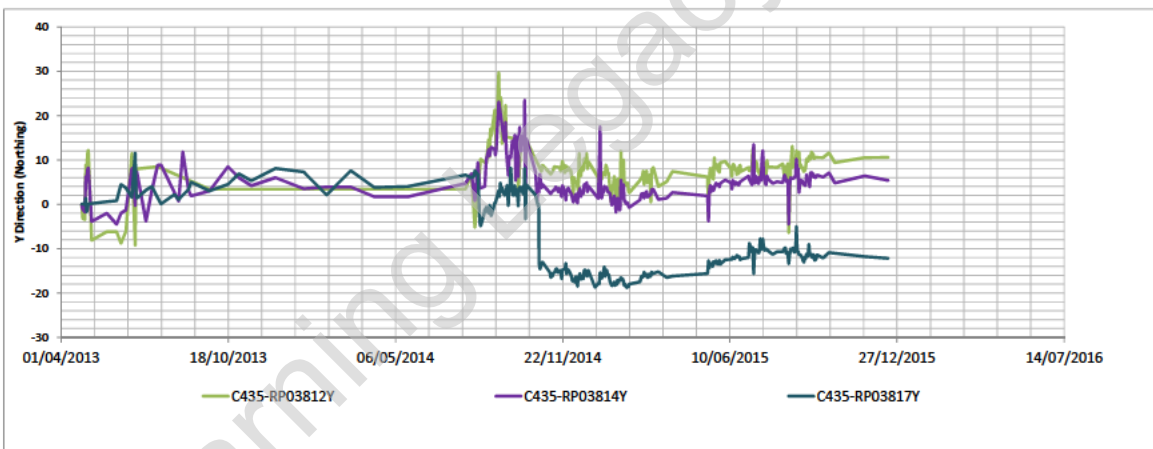
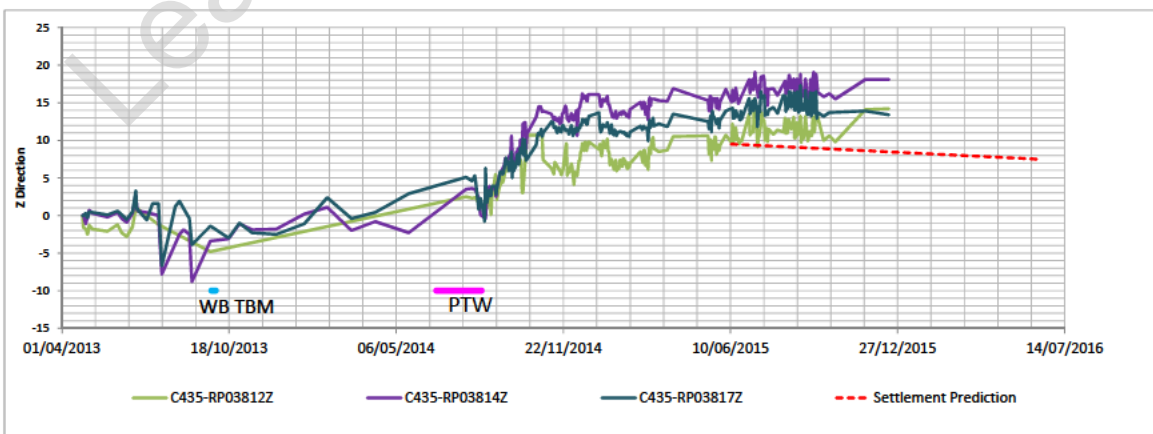
- WB TBM caused 3-4mm of settlement maximum from 27-09-2013 to 02-10-2013
- Compensation grouting from Moorgate Shaft 3 caused 5mm maximum of heave between 17-10-2013 and 28-07-2014.
- PTW works caused maximum 3-4mm of settlement from 23-06-2014 to 16-08-2014.
- Compensation grouting caused 8-9mm of heave from 19-08-2014 to 27-10-2014
- Maximum movement in X direction -35mm
- Maximum movement in Y direction -20mm
- Maximum movement in Z direction +18mm

Remarks: Prisms C435-RP03815 and C435-RP03816 were installed but never reading because lack of visual from the set-up point.

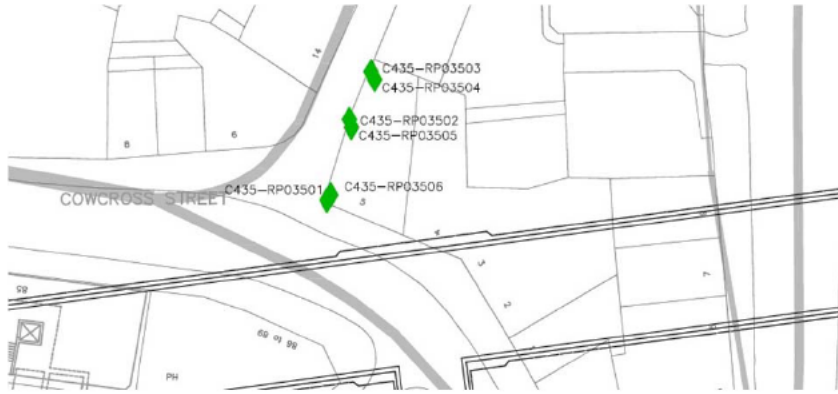
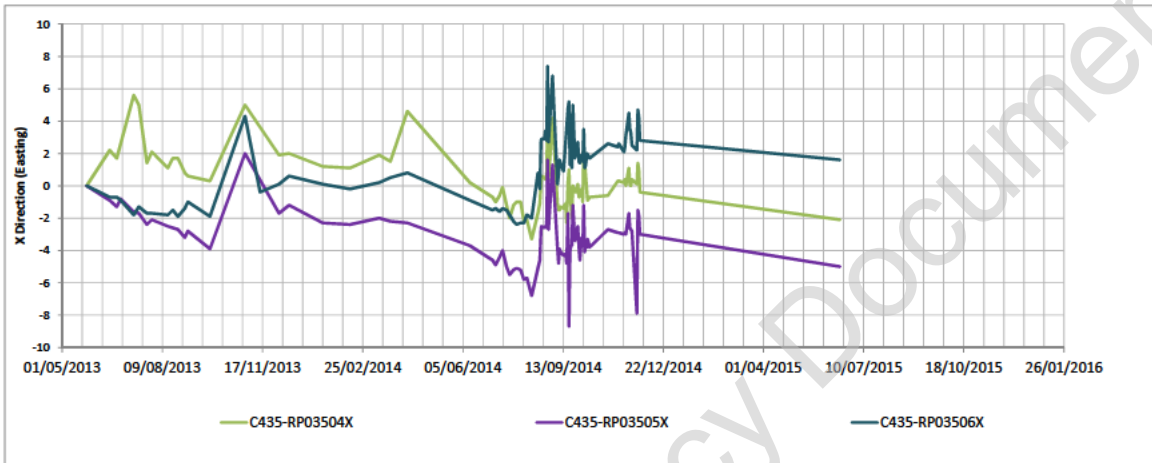
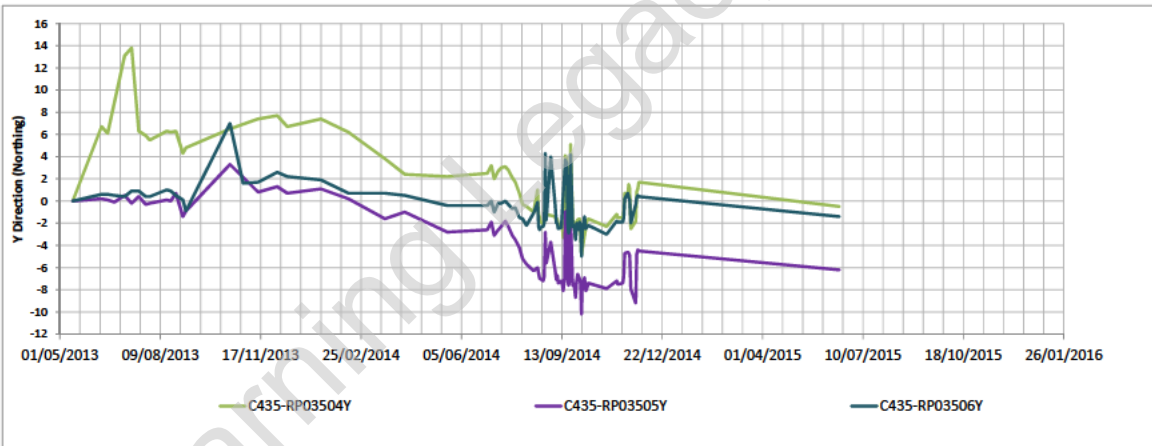
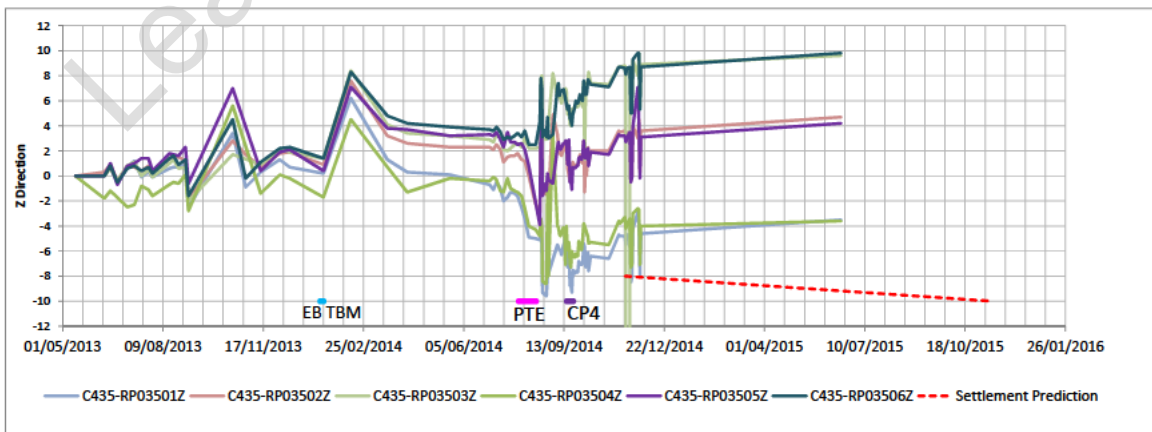
- EB TBM caused maximum 3mm of settlement from 13-01-2014 to 16-01-2014
- PTE enlargement works caused 8mm of settlement from 30-07-2014 to 16-08-2014.
- CP4 construction caused 2-3mm of settlement from 16-09-2014 to 22-09-2014
- Maximum movement in X direction -6mm
- Maximum movement in Y direction -8mm
- Maximum movement in Z direction +10mm

Remarks: Prisms C435-RP03501, C435-RP03502 and C435-RP03503 were never installed.
