C435 Farringdon Main Station

Monitoring Close-Out Report: Tiltmeters installed on West Wall on WTH site.

CRL Document Number: C435-BFK-C2-RGN-M123-51673

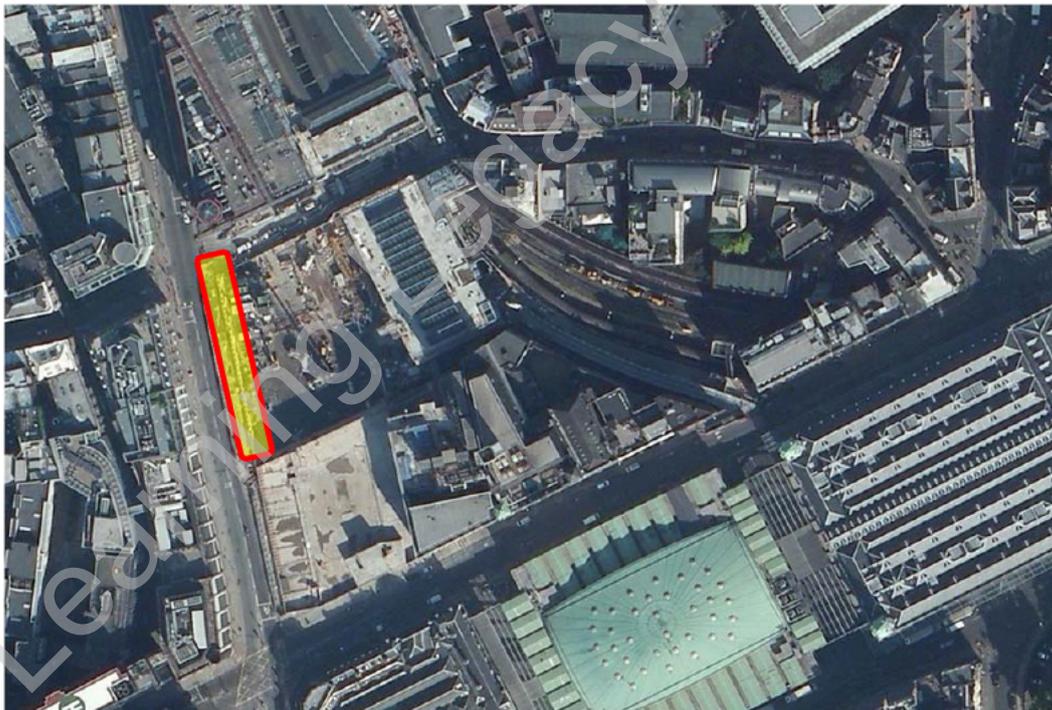
Figure 1 – Plan showing the Location for the Tiltmeters.

The tiltmeters installed on the Retaining Wall is located on the plan below highlighted in yellow. The tiltmeters were installed by the C430.

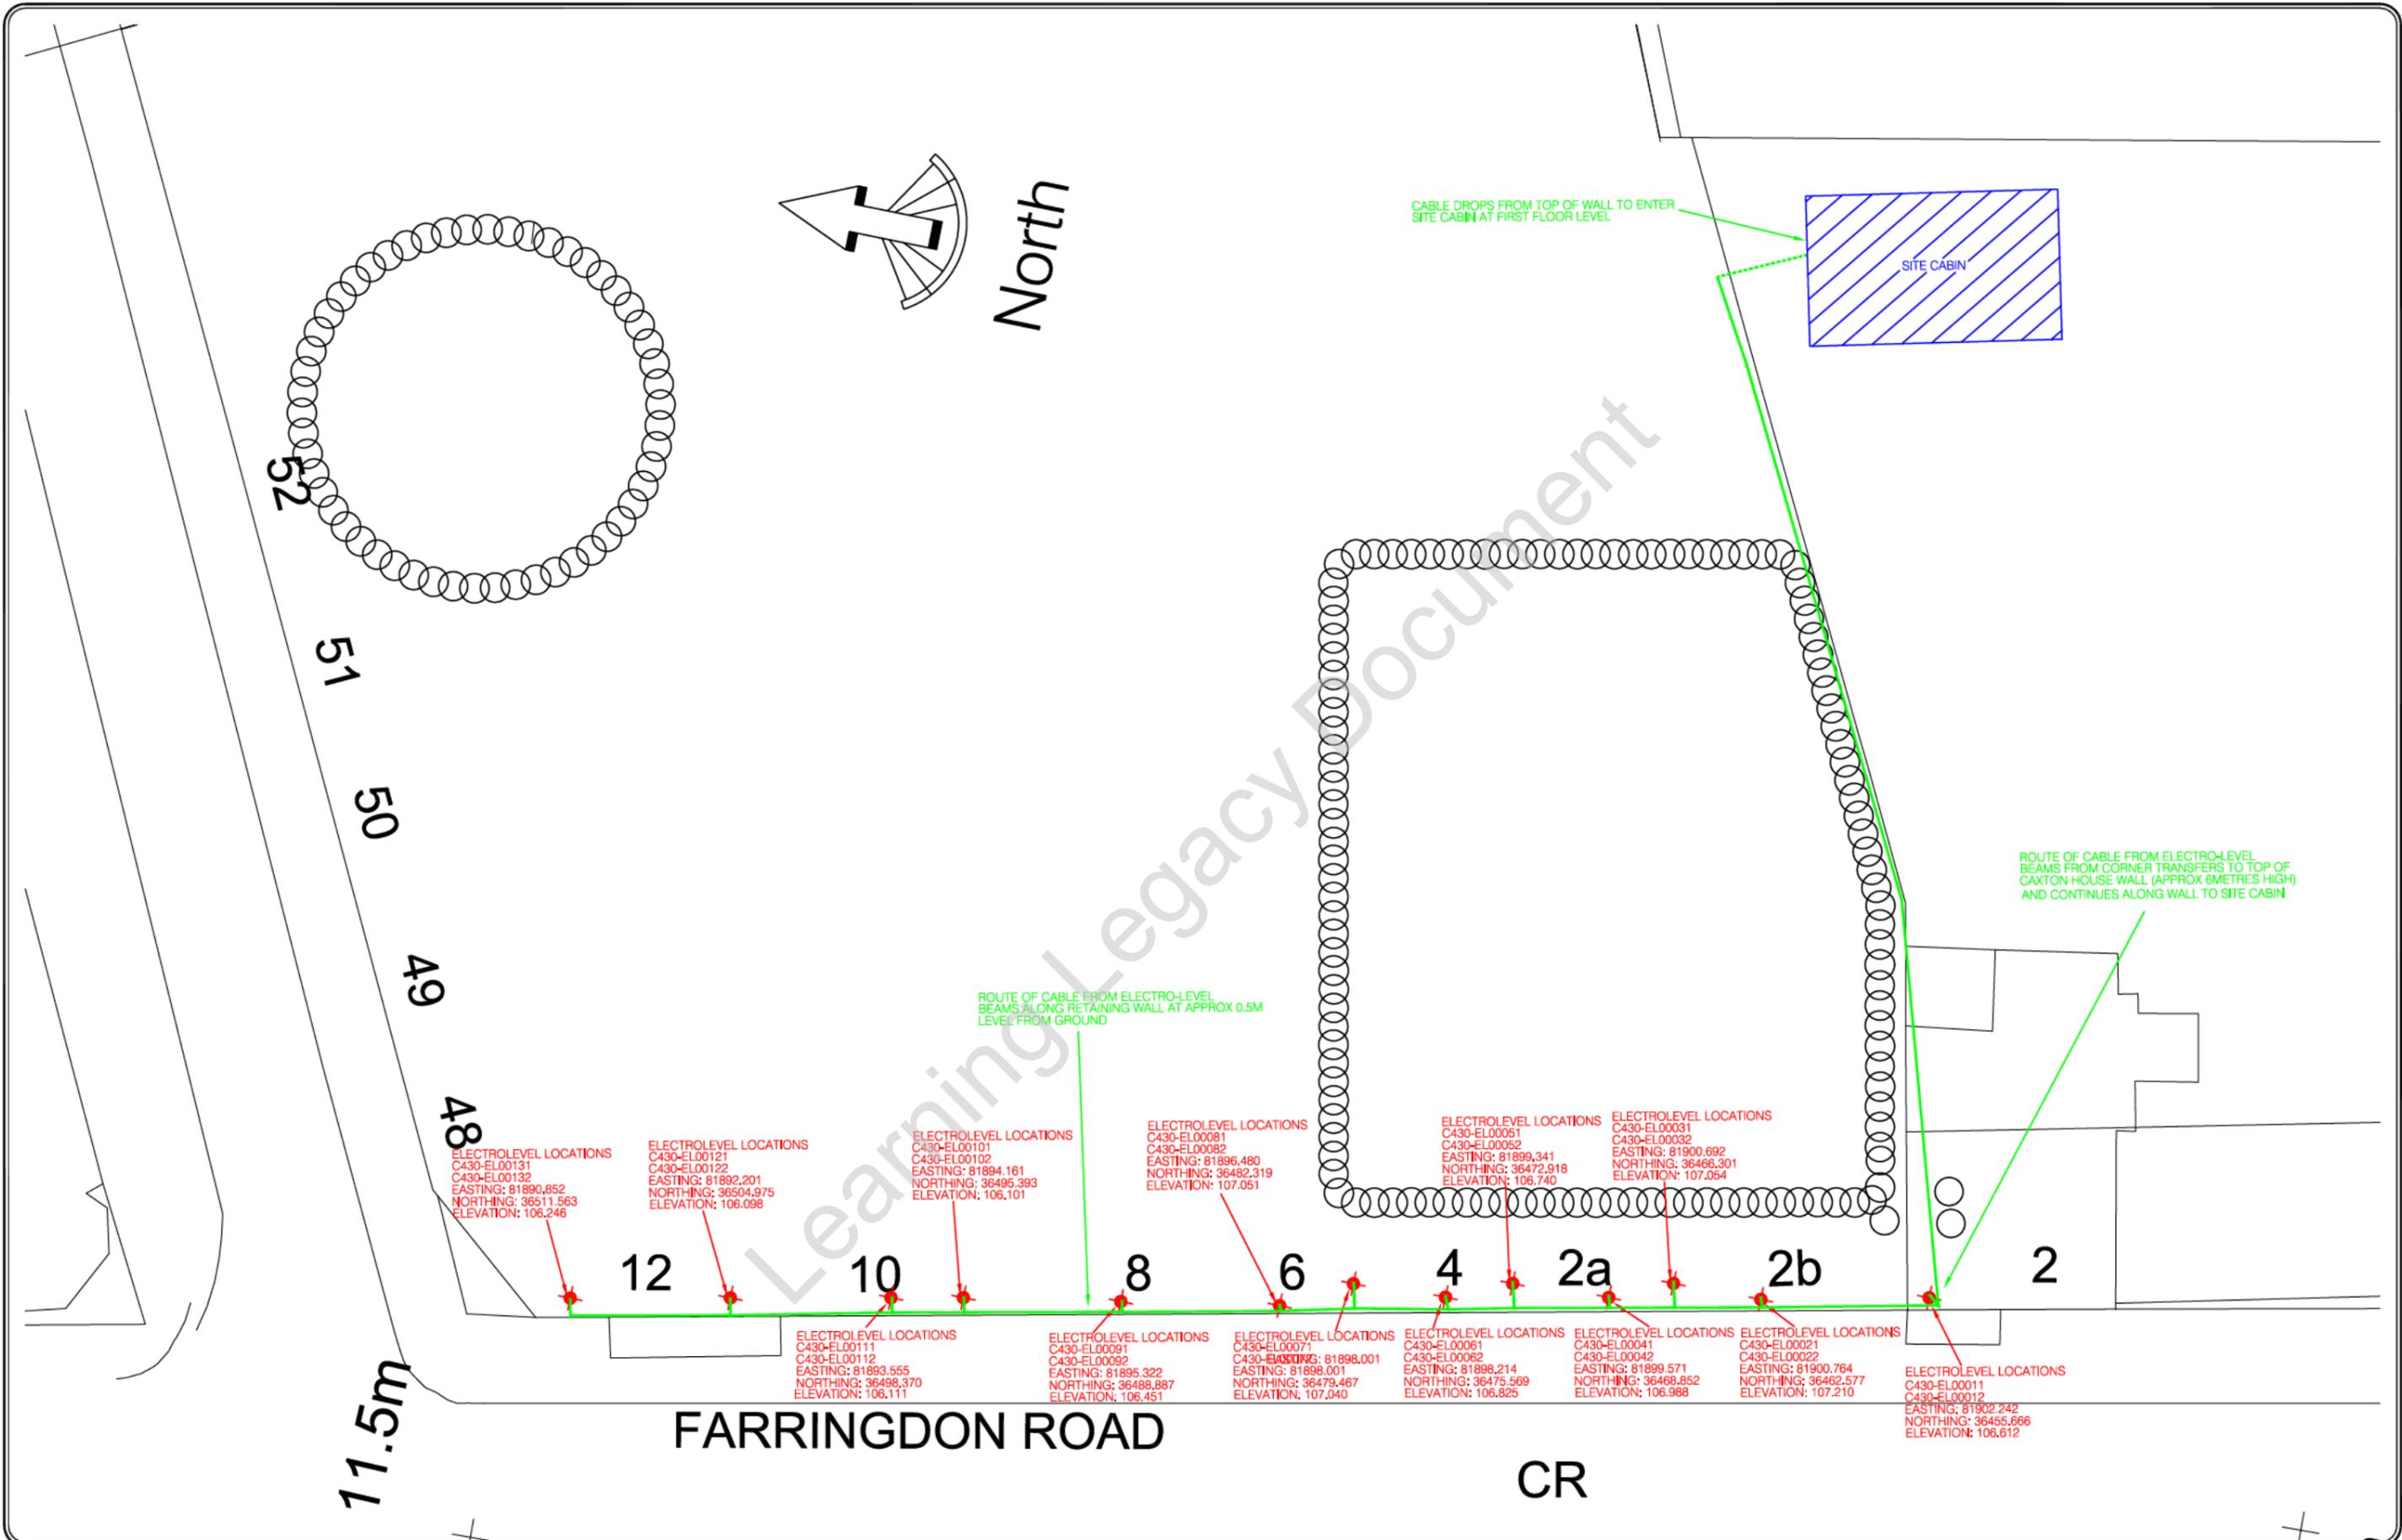
Drawing Number: MSL4100-S-WTH-ELB-1

ROUTE OF CABLE FROM ELECTRO-LEVEL BEAMS ALONG RETAINING WALL AT APPROX 0.5M LEVEL FROM GROUND

CABLE DROPS FROM TOP OF WALL TO ENTER SITE CABIN AT FIRST FLOOR LEVEL

ROUTE OF CABLE FROM ELECTRO-LEVEL BEAMS FROM CORNER TRANSFERS TO TOP OF CAXTON HOUSE WALL (APPROX 6METRES HIGH) AND CONTINUES ALONG WALL TO SITE CABIN

- Electro Level Beam Location Installed Vertically on Brick Retaining Walls
- Cable route of Electrolevel Beams to Site Cabin to Database Computers

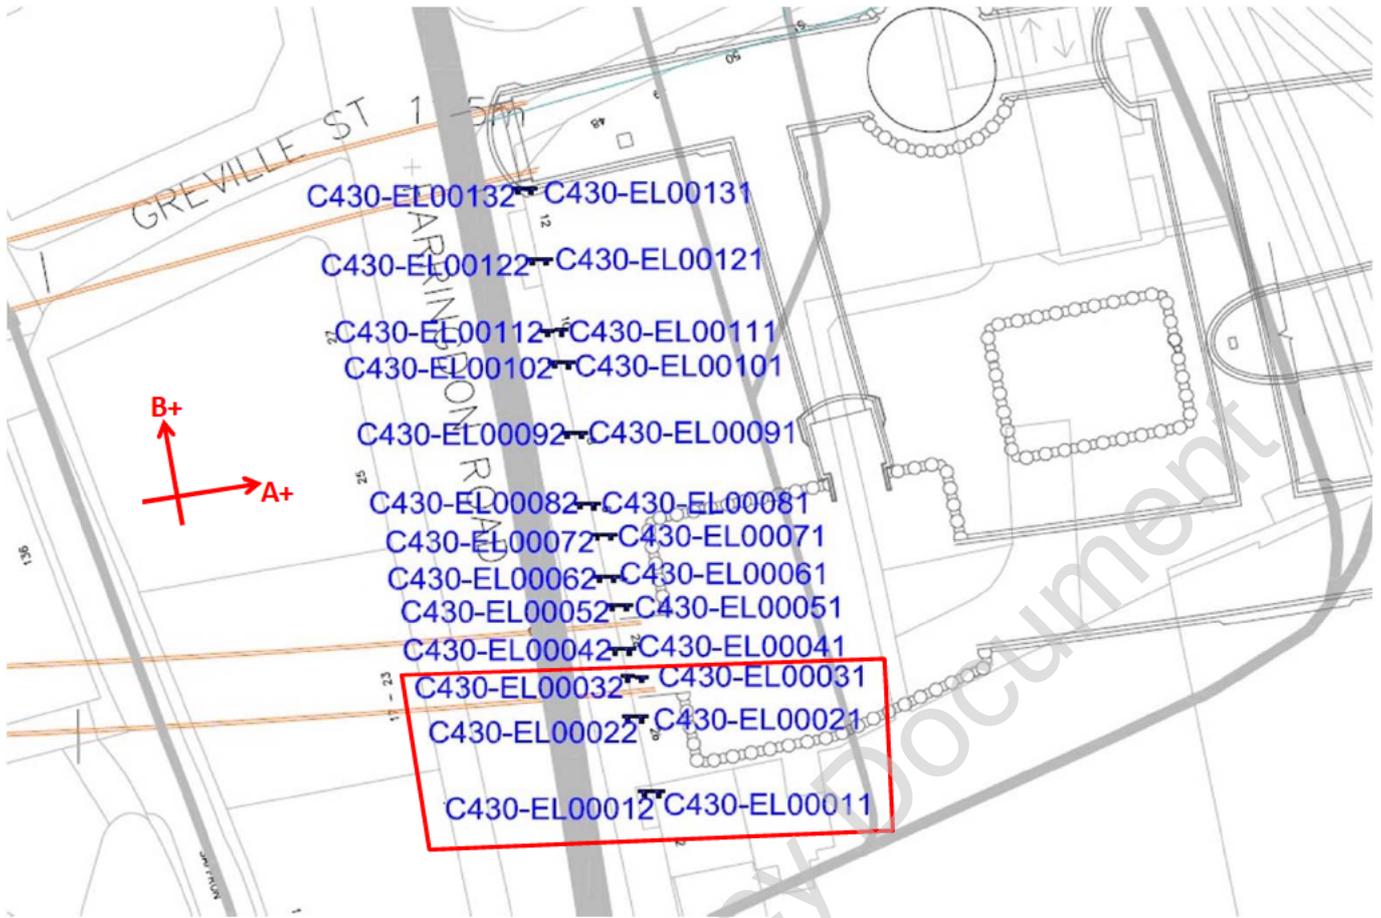
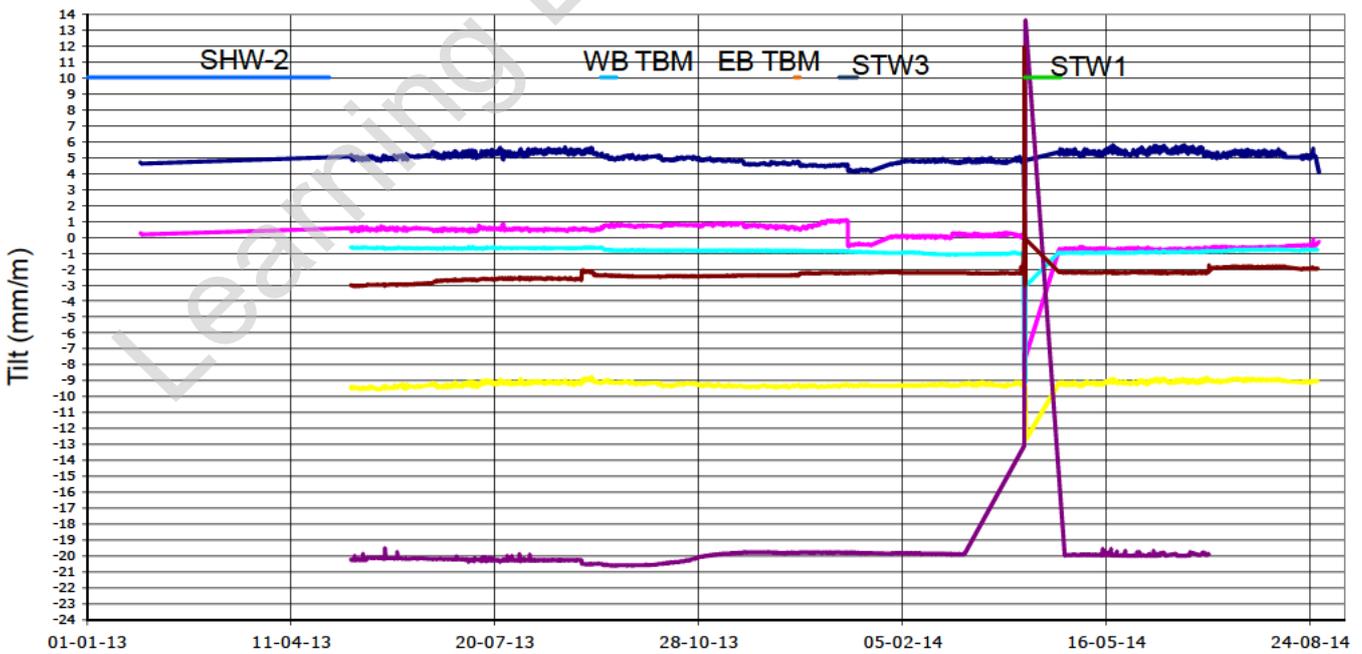
- Less than 1mm/m caused by the WB TBM from 10-09-2013 to 18-09-2013 in A direction.
- Residual movement captured by C430-EL00011 caused 1mm/m of horizontal movement in A direction.
- No movement captured by the EB TBM from 14-12-2013 to 17-12-2013.
- STW3 caused maximum horizontal movement 2mm/m from 05-01-2014 to 14-01-2014 in B direction.
- Less than 1mm captured by the sensors during the STW1 construction from 06-04-2014 to 26-04-2014.
- Maximum horizontal movement -2mm/m in A and B direction.

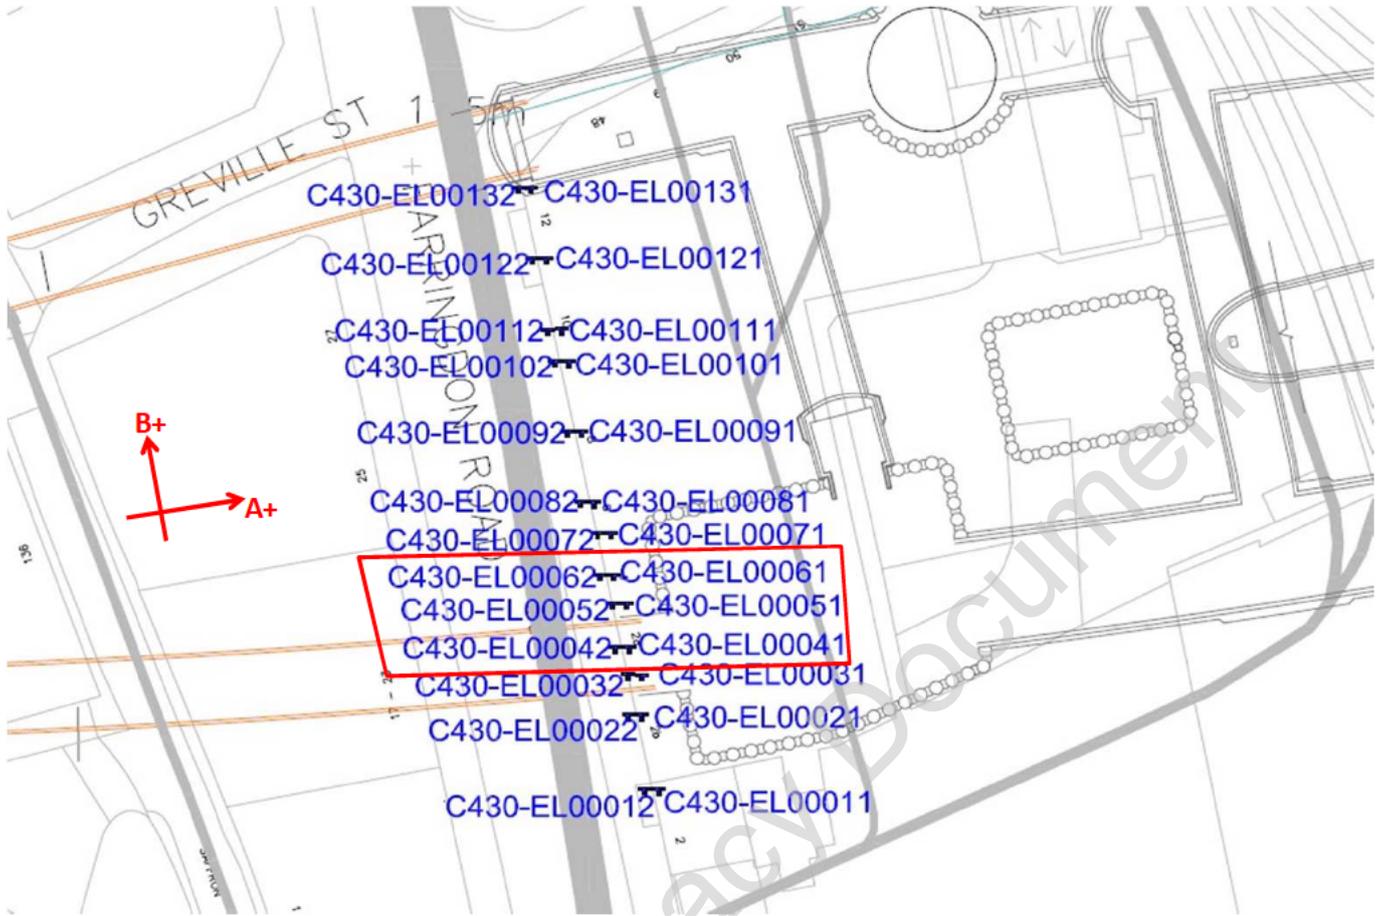
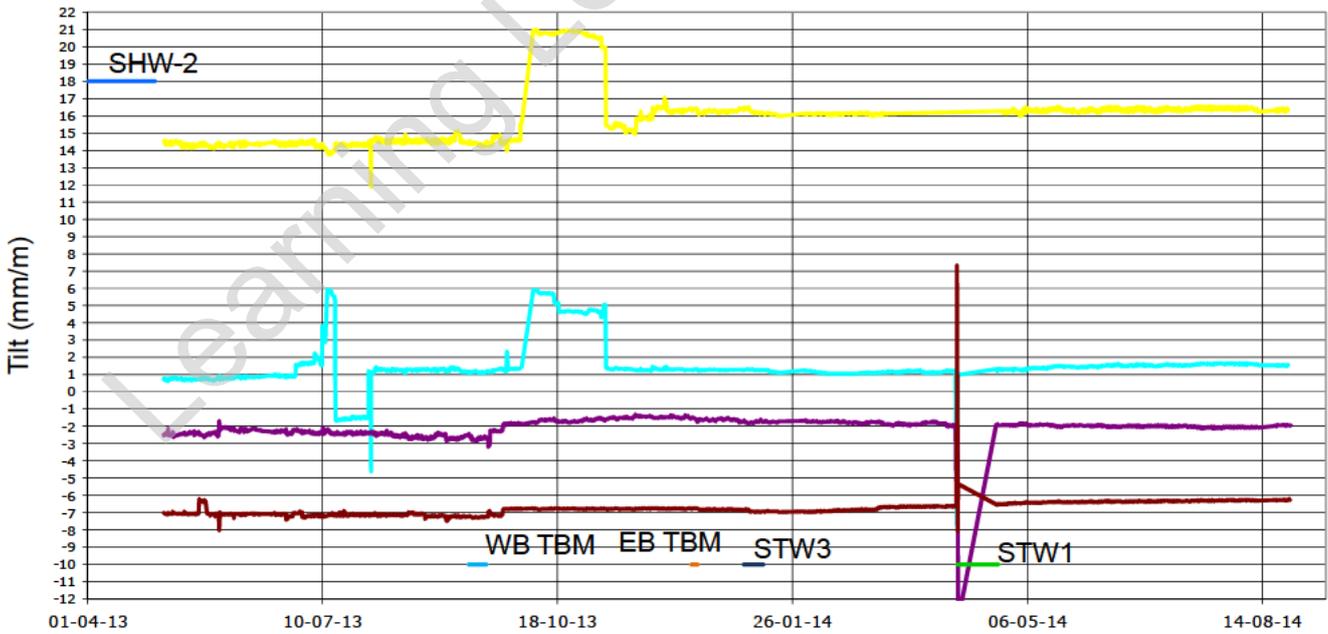
- WB TBM caused maximum +1mm/m in A direction from 10-09-2013 to 18-09-2013.
- No movement during EB TBM.
- No movement during STW3 excavation.
- No movement during STW1 excavation.
- Maximum horizontal movement +1mm/m in A direction.

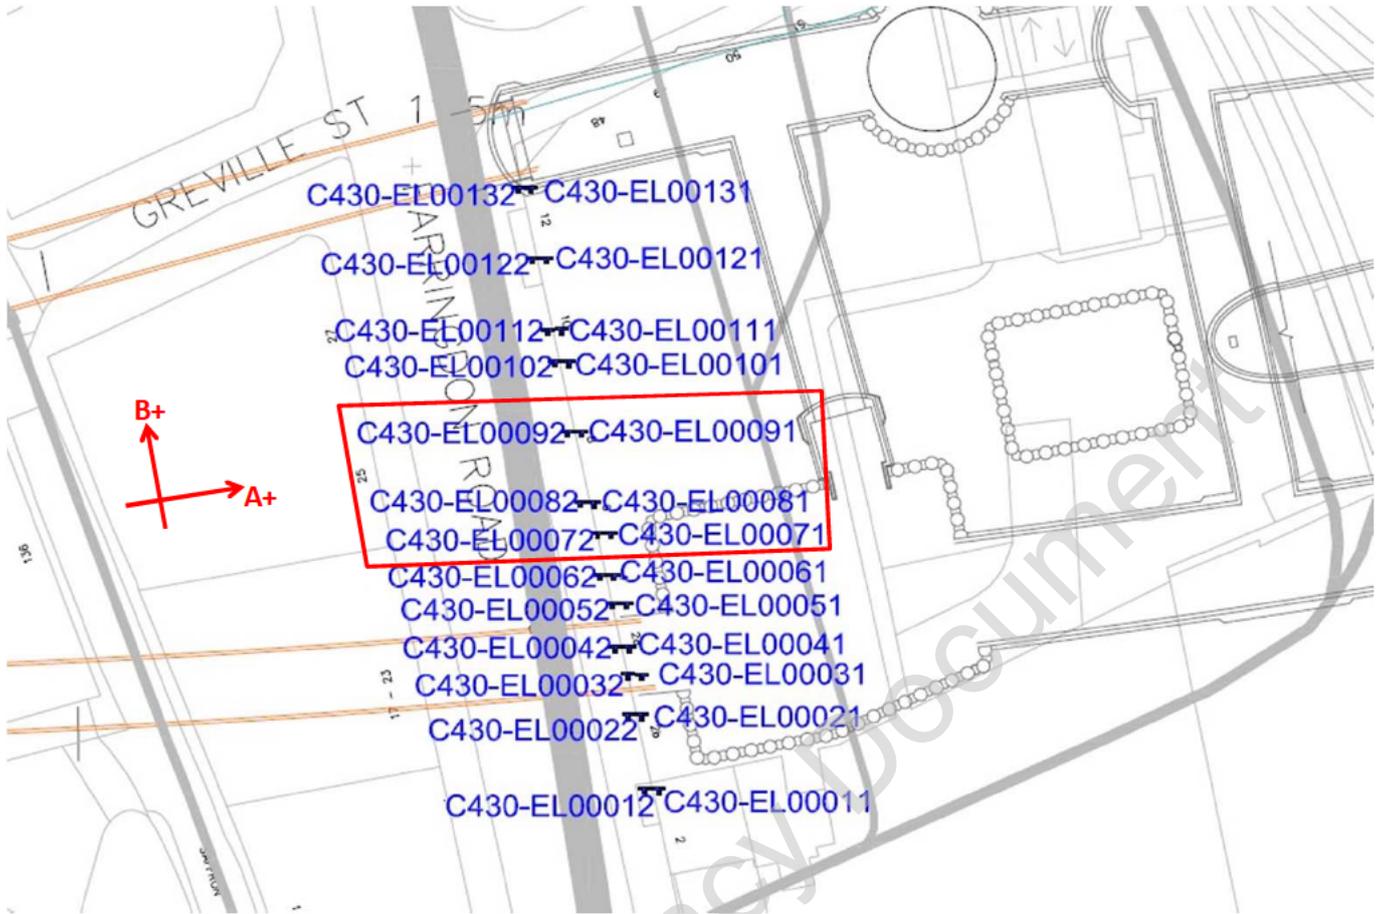
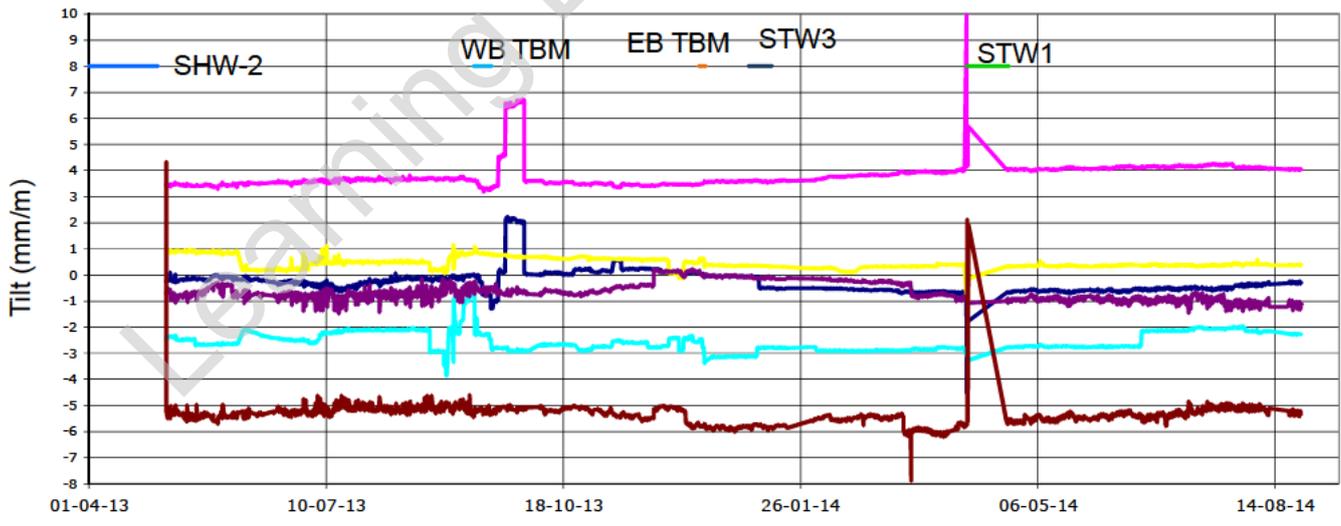
— C430-TU00071-A(mm/m)	— C430-TU00072-B(mm/m)	— C430-TU00081-A(mm/m)
— C430-TU00082-B(mm/m)	— C430-TU00091-A(mm/m)	— C430-TU00092-B(mm/m)

- WB TBM caused maximum -1mm/m in B direction from 10-09-2013 to 18-09-2013.
- EB TBM caused maximum -1mm/m in B direction from 14-12-2013 to 17-12-2013.
- No horizontal displacement during STW3 works.
- No movements during STW1 construction.
- Maximum horizontal displacement -1mm/m in B direction.

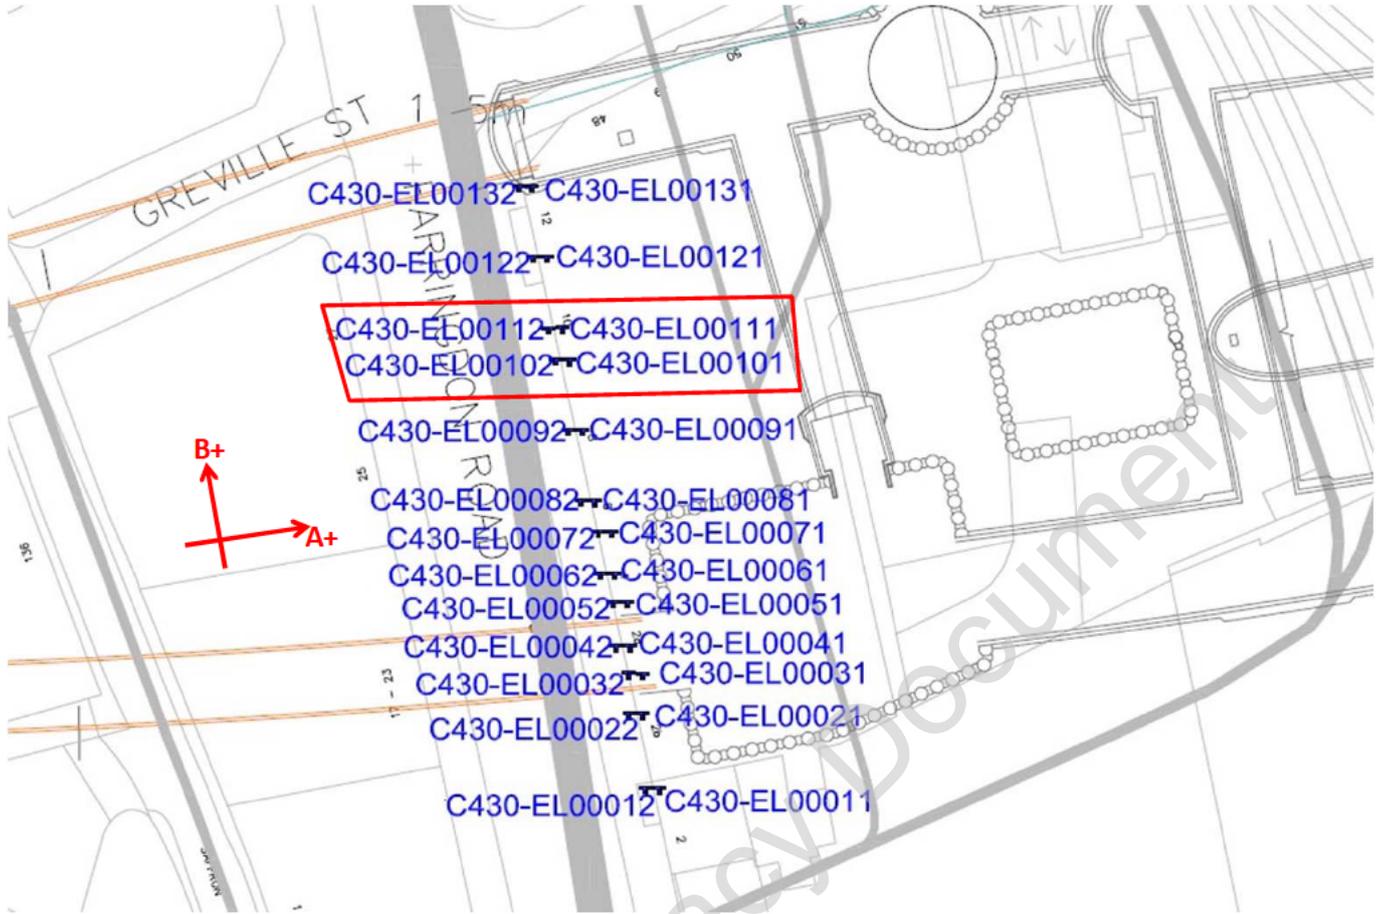
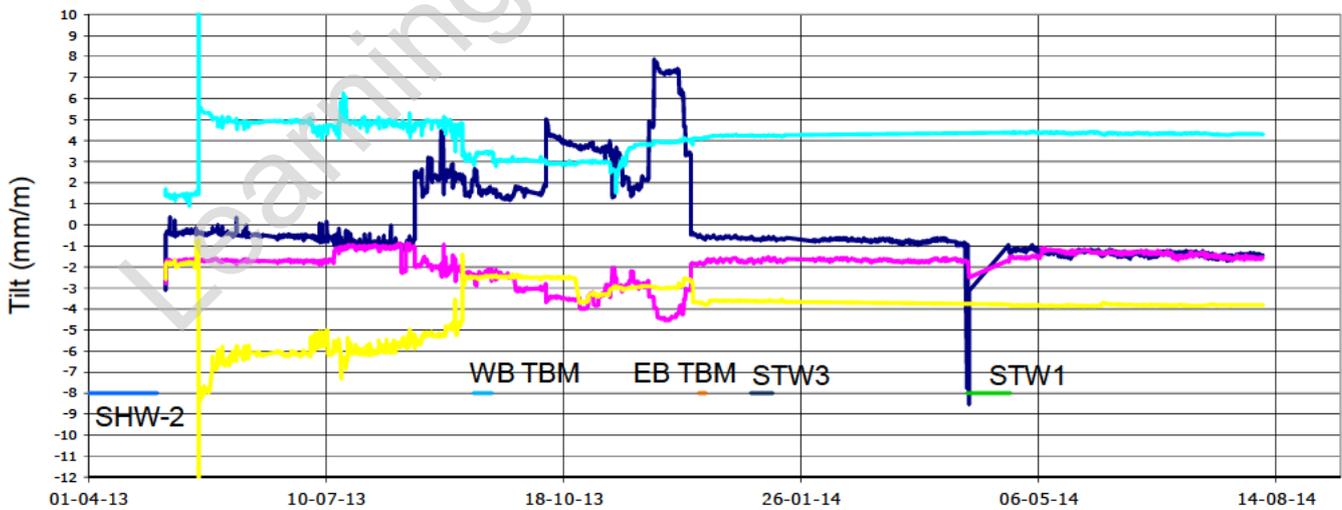
- WB TBM caused maximum 3mm/m in A direction from 10-09-2013 to 18-09-2013.
- EB TBM caused maximum 2mm/m in B direction from 14-12-2013 to 17-12-2013.
- No movement during the STW3 construction.
- No movement during the STW1 construction.
- Maximum horizontal displacement 3mm/m in A direction.

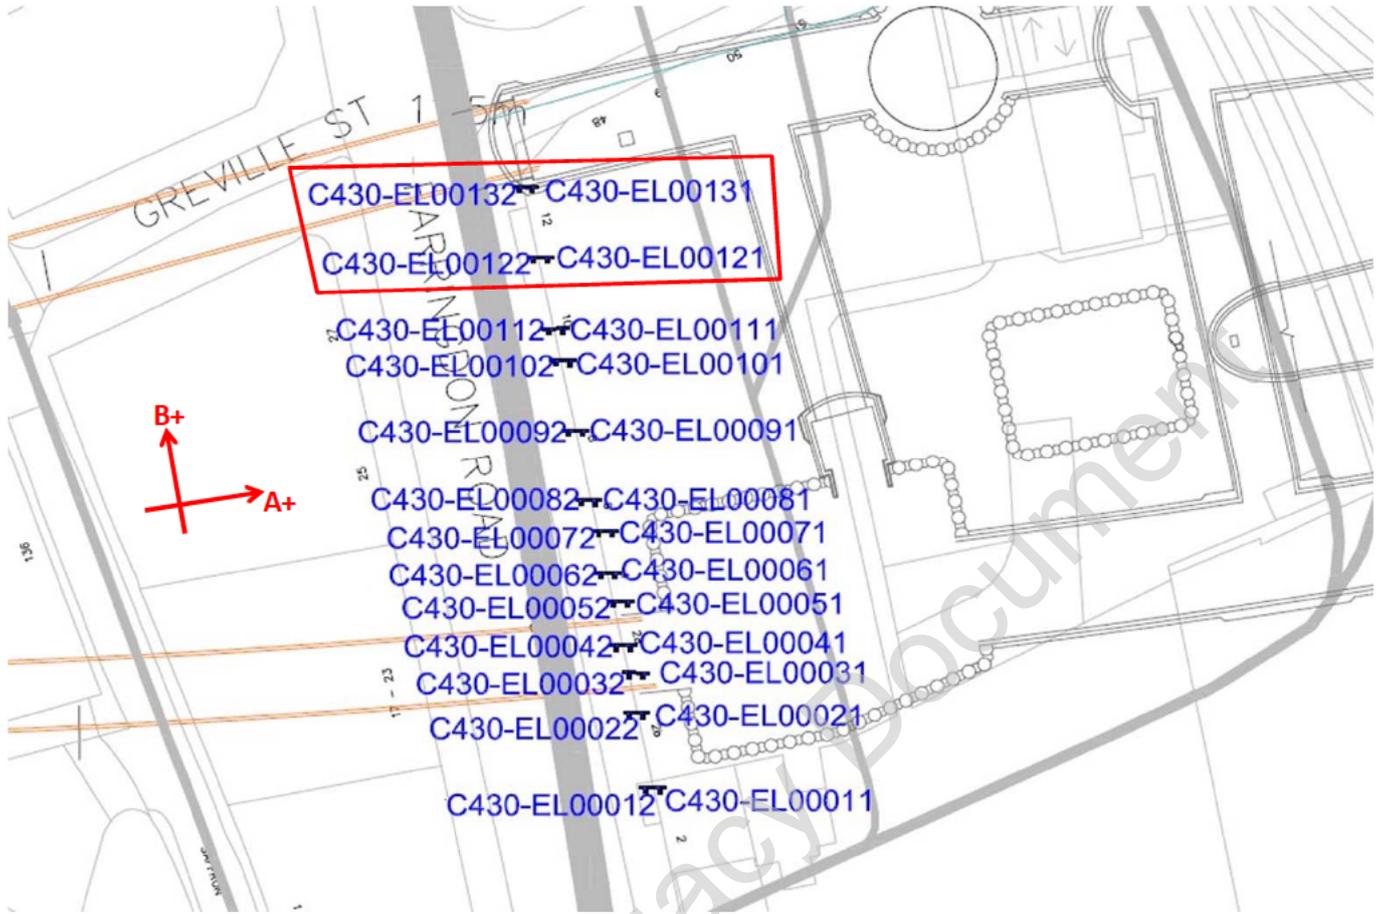
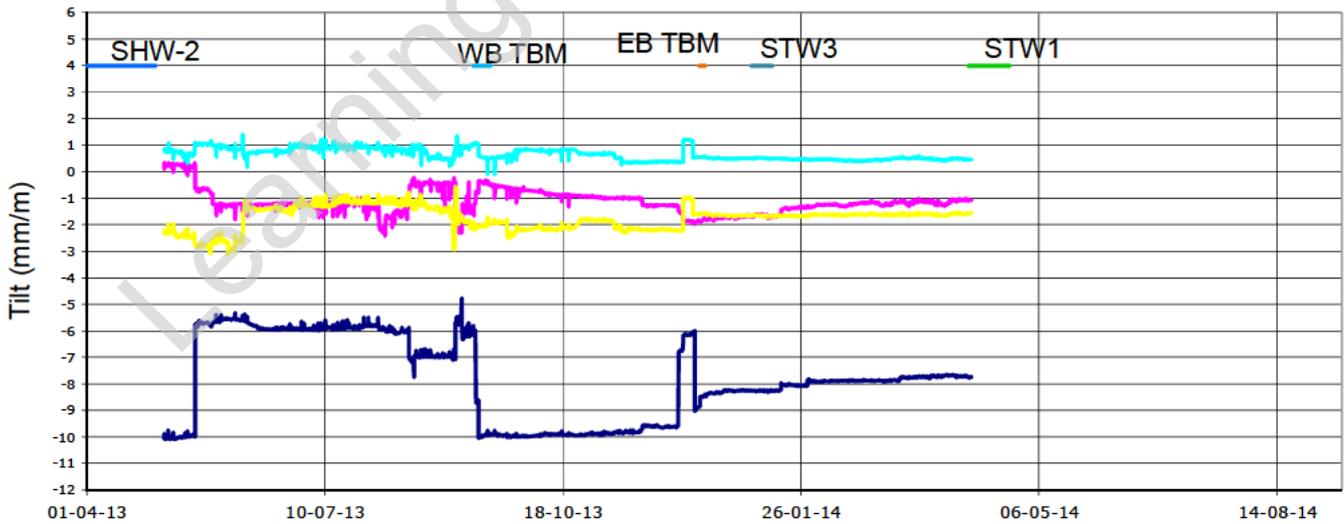
- WB TBM caused maximum 1mm/m in A direction from 10-09-2014 to 18-09-2014.
- No movement caused by EB TBM.
- No horizontal displacement captured during the STW3 construction.
- No movement captured by the tiltmeters during STW works.
- Maximum horizontal displacement 1.5mm/m.
