C510 - Whitechapel and Liverpool Street Station Tunnels

Instrumentation and Monitoring Close Out Report Block 08 Liverpool Street

CRL Document Number: C510-BBM-C2-RGN-C101-50228

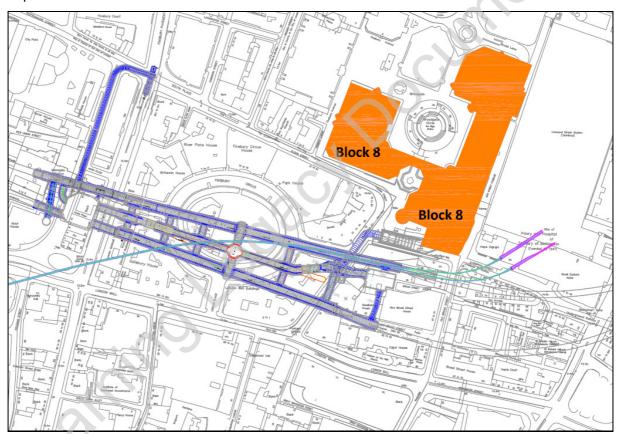
Figure 1- Liverpool St General Location Plan - including Block 08 monitoring area

Figure 1 shows the Liverpool St general location plan, C510 tunnel construction and where Block 08 is situated. Detailed location plans can be found within the installation reports and photomontages as listed in Section 3.2. Each monitoring sensor's location is shown within the assessment plans (Section 5.4).

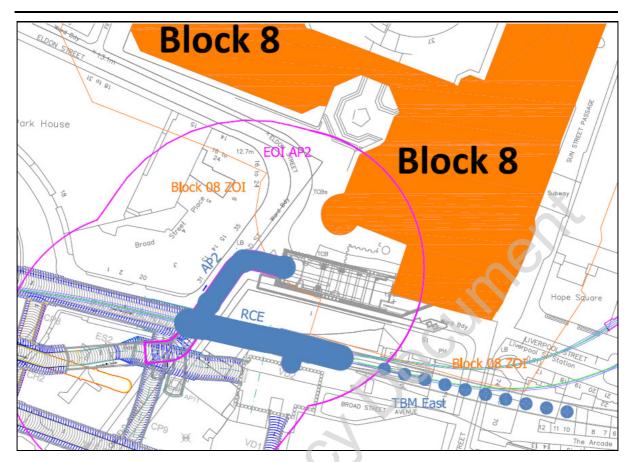
Figure 2 - Block 08 EOI Constructions

To identify the tunnels that had the potential to significantly affect Block 08, a ZOI area was established by giving each monitoring sensor a radius of 2.0 x tunnel diameter. This area was then used to determine all the mining advances that occurred within its boundary, *Figure 2* shows the ZOI boundary (orange outline). As the only construction within the ZOI of Block 08 was AP2, the EOI will be referenced to assist the analysis of construction against monitoring data. *Figure 2* highlights the tunnel constructions (blue colour) within the Block 08 EOI. Tunnel advance start and finish dates will be used in assessment of the monitoring data.

N.B. AP2 EOI is represented in *Figure 2* to display the area of Block 08 affected by AP2 construction.

Figure 2 shows that the only C510 works within the ZOI for Block 08 is the end of AP2. Therefore, to assist the monitoring analysis of Block 08, the EOI will be referenced against settlement. Due to the depth of AP2, the EOI will be referenced at a 50m radius. The construction advances within the EOI that have the potential to affect Block 08 are listed and summarised in *Table 1*.

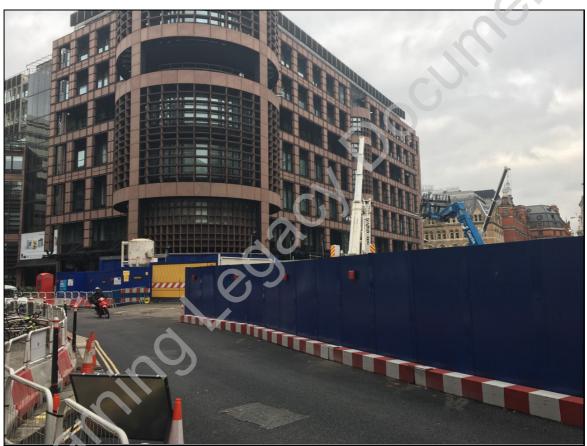
Figure 3 – C502 Site Obstruction

Some road studs have not been measured for extended periods of time due to C502 site hoarding. These sensors are no longer accessible and provide no monitoring data in relation to recent construction. *Figure 3* shows the C502 site hoarding occupying the front of The Octagon Arcade along Eldon St and Liverpool St.

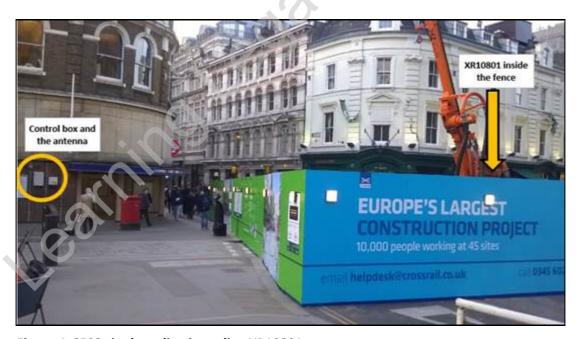
Figure 4- C502 site hoarding impeding XR10801

In November 2015 it was reported that XR10801 was not producing any data. A Soldata technician inspected the area and found that the sensor was no longer accessible and that the line of sight between the extensometer, the control box and antenna was now impeded by C502 site hoarding. The site hoarding made it difficult to access the sensor and therefore servicing and maintenance was intermittent.

It is ostensible that due to flooding and access issues that the XR10801 data is unreliable. The sensor is no longer active and outside the EOI of any current or future C510 construction. It is therefore proposed that decommissioning be agreed.

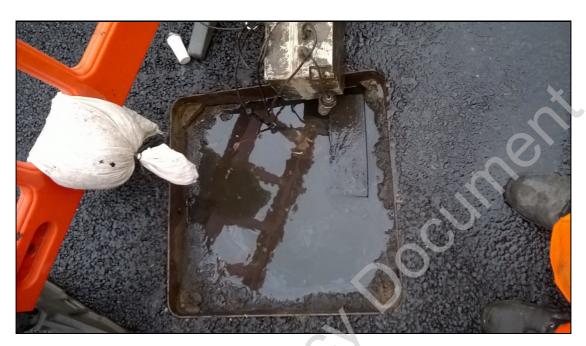
Figure 5- Block 08 C510-XR10801 Flooding - Old Broad St

XR10801 experienced flooding during May 2016 and underwent multiple battery replacements; as a result of the flooding the vibration wire interface (AVW200) was damaged. Soldata were instructed not to source a replacement as the sensor was to be decommissioned in the near future, therefore there is no monitoring data since the 3rd of May 2016.

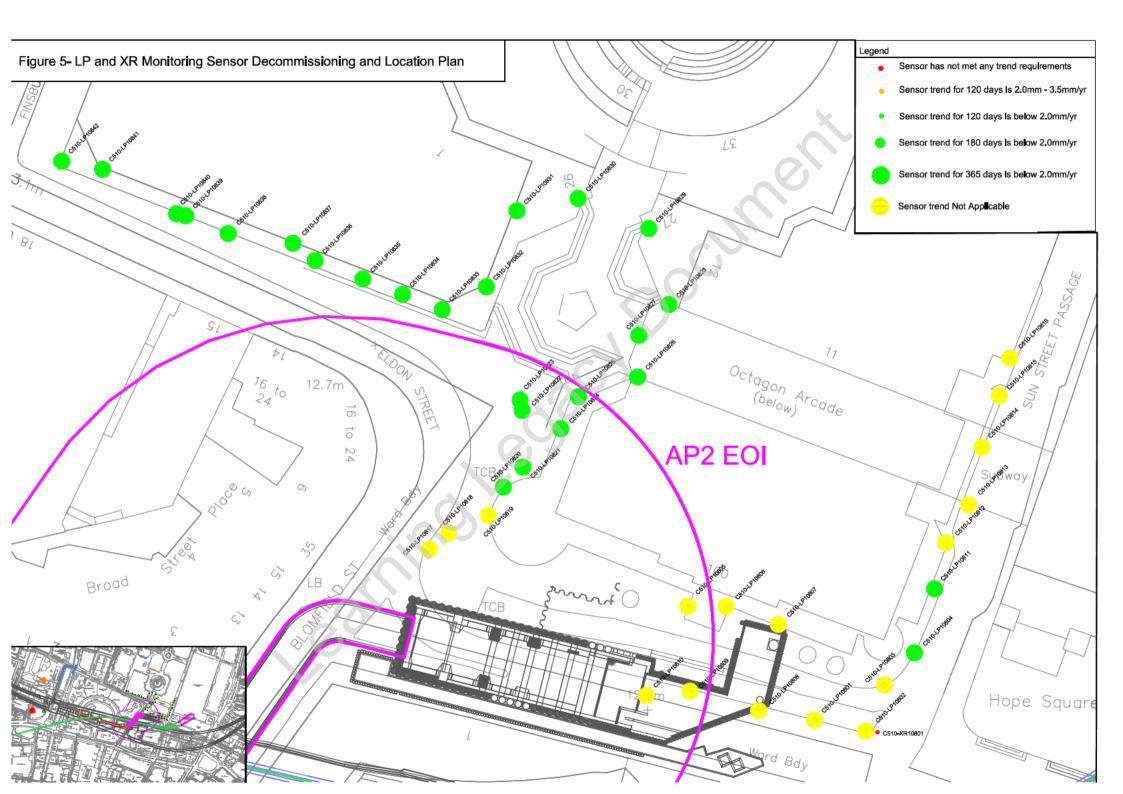
The following plots provide a visual representation of all Block 08 monitoring sensors with a colour circle that defines its settlement status. A green circle represents when a trend is below 2mm/yr and the larger the circle the greater the trend period. When a trend has not been met, a small red circle will represent the monitoring sensor.

Through the monitoring assessment process in Section 5, it is purposed that all Block 08 sensors are to be decommissioned. *Table 2* Decommissioning Tracker lists all Block 08 monitoring sensor's decommissioning status and the supporting evidence.
