C510 – Whitechapel and Liverpool Street Station Tunnels

Instrumentation and Monitoring Close Out Report Block 01 Liverpool Street

CRL Document Number: C510-BBM-C2-RGN-C101-50238

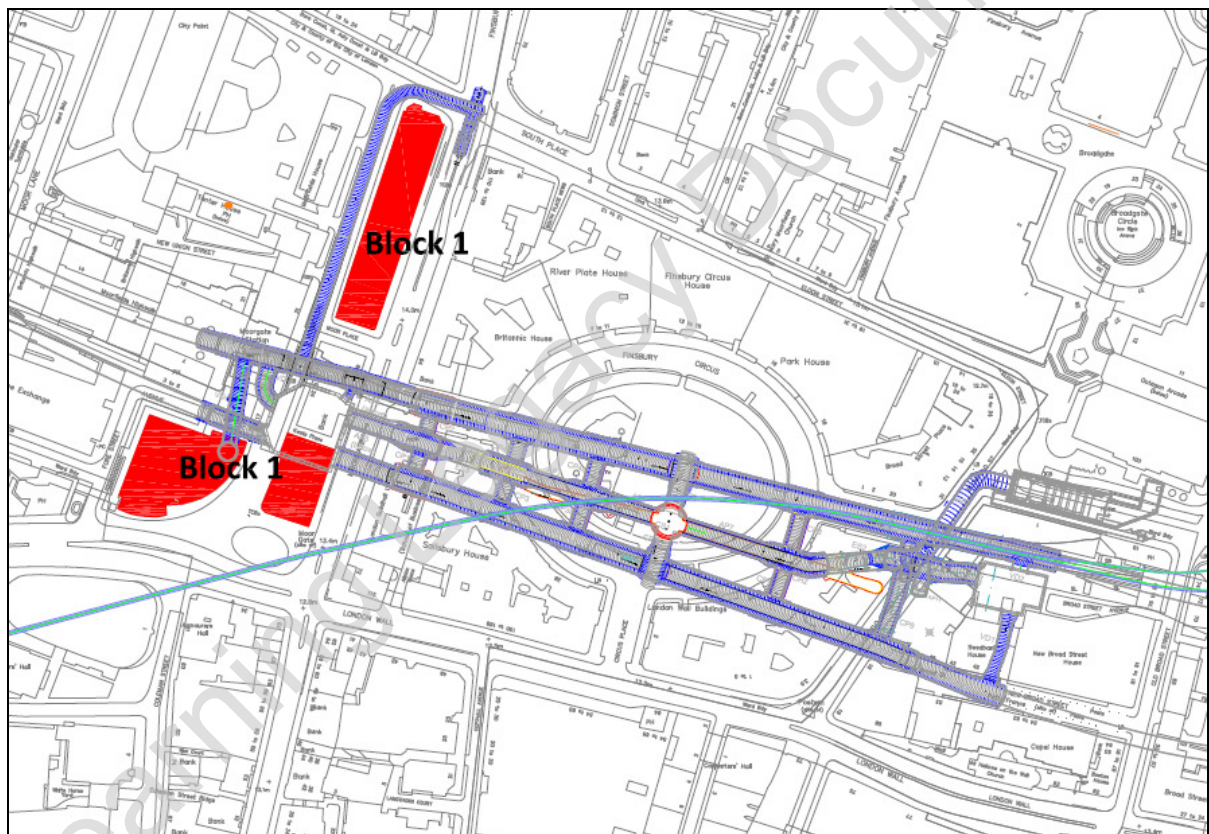
Figure 1- Liverpool St General Location Plan - including Block 01 monitoring area

Figure 1 shows the Liverpool St general location plan, C510 tunnel construction and where Block 01 is situated. Detailed location plans can be found within the installation reports and photomontages as listed in Section 3.2. Each monitoring sensor's location is shown within the assessment plans (Section 5.4).

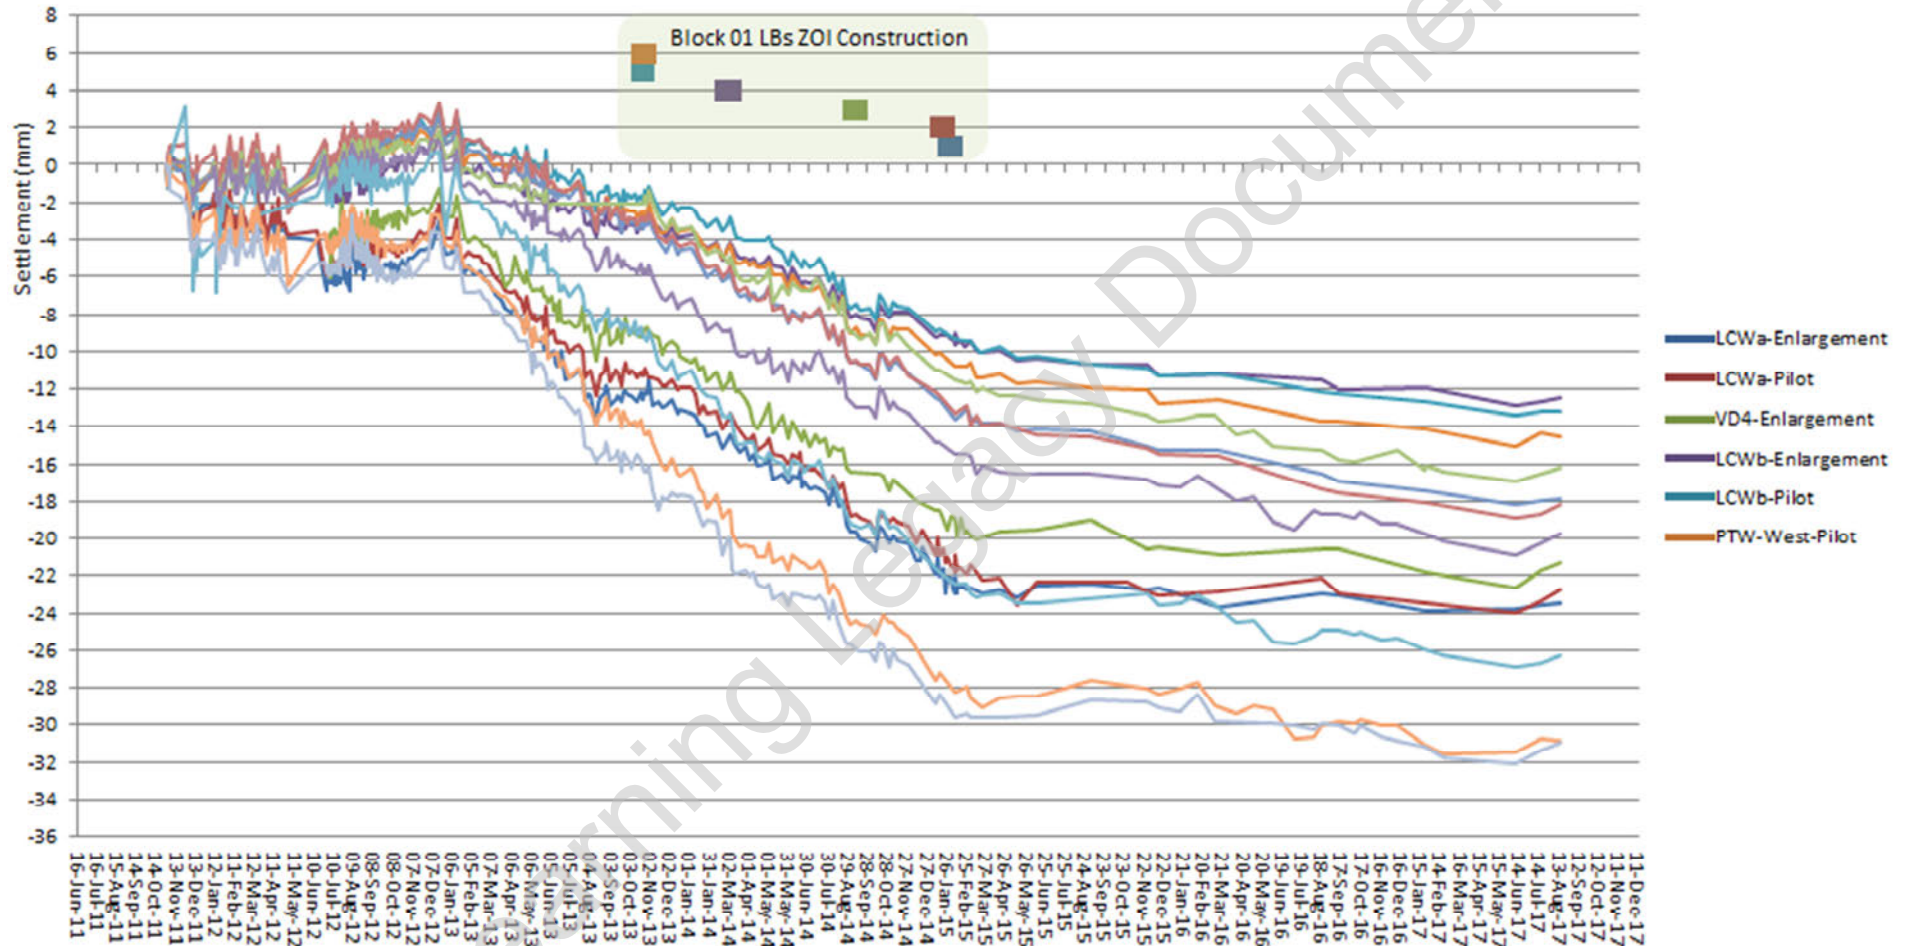
Graph 1- All Block 01 BREs (LB) Manual Monitoring History in Relation to Construction

To assess the movement of Block 01 monitoring sensors; each monitoring sensor data type is displayed in a line graph, with a gantt chart (bar) representing the construction identified in Section 4:

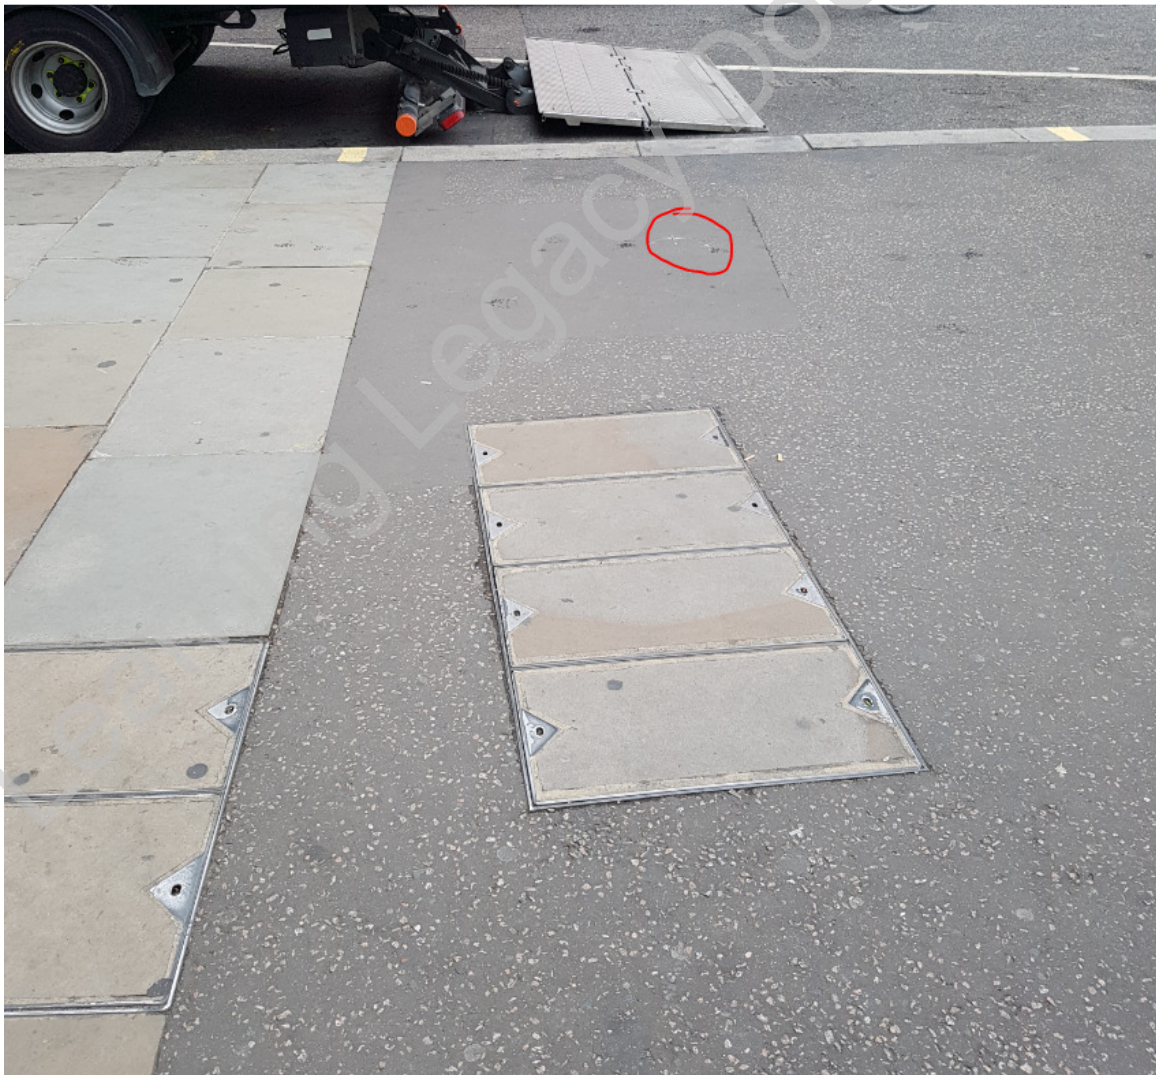
Figure 3- LP12129 Location on Pavement

LP12129 has not met any trend requirements; however, the surrounding studs have all met the allowable trend for a minimum of 180/365 days. It can be seen in *Figure 3* below that the circled pin is located on a section of pavement that was resealed more recently than the surrounding pavement. It is likely that some utility works were undertaken in this vicinity and in turn, may have led to greater settlement than the adjacent area (e.g. due to poor compaction). As such, the settlement trend may not be a true reflection of the absolute ground movement caused by Crossrail works in the area.

It should also be noted that the head of the road stud does not clearly protrude above the pavement around it; therefore, monitoring results may have been affected if the measuring staff was not exclusively resting on the stud.

Based on the adjacent road studs' settlement trends, it is proposed to consider LP12129 as unreliable with regards to trends caused by tunnelling construction and to decommission the sensor.

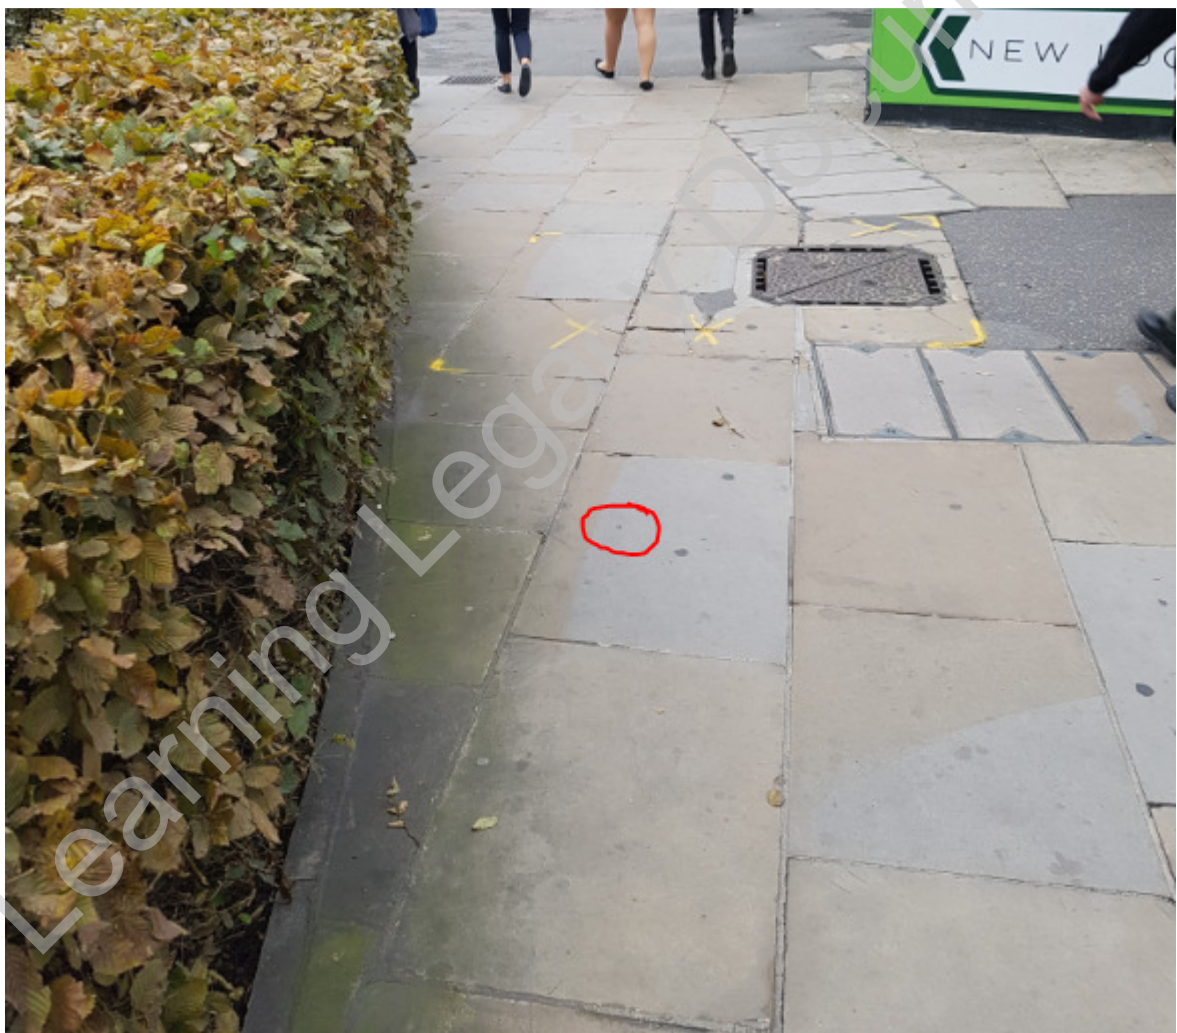
Figure 4- LP12135 Location on Pavement

LP12135 has not met any trend requirements; however, the surrounding studs have all met the allowable trend for a minimum of 365 days. Upon investigation of the road stud, it was noted that it was located near a garden hedge which may affect the ground by seasonal changes. It can also be seen in *Figure 4* below that the stud also is very close to a manhole and reticulated stormwater system. This may also be subject to local superficial movement and not a reflection of deeper seated movement caused by tunnelling construction. Furthermore, the damage to the pavement stones nearby suggests that a heavy object/impact caused some localised movement.

Based on the adjacent road studs' settlement trends, it is proposed to consider LP12135 as unreliable with regards to trends caused by tunnelling construction and to decommission the sensor.

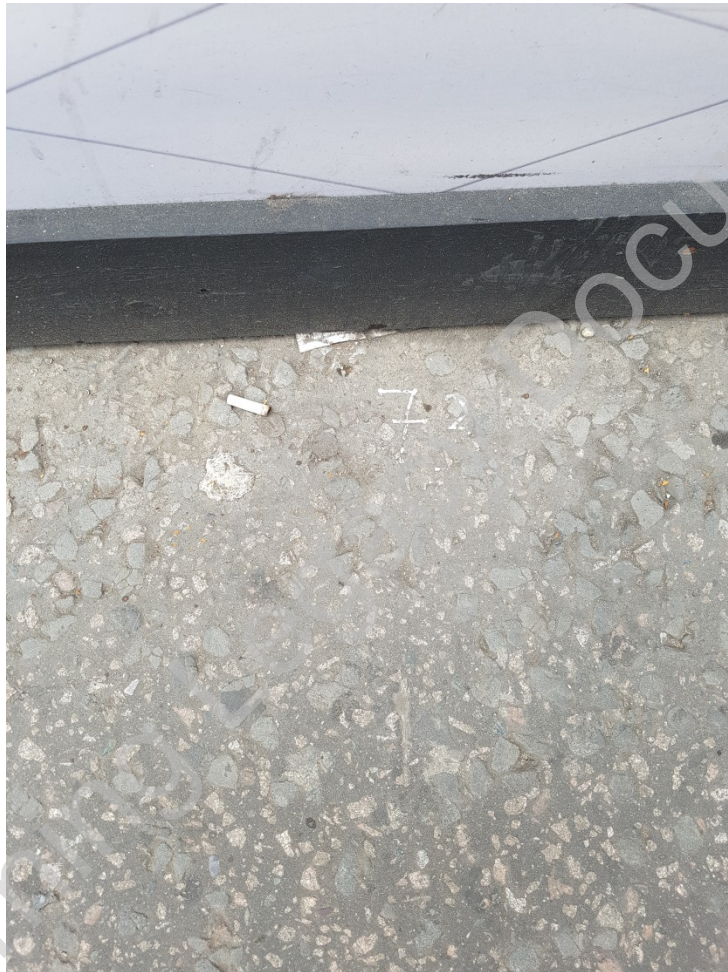
Figure 5- LP12173B Location on Pavement

LP12173B settlement trend is 2.2-2.9mm/year; however, the surrounding studs have met the allowable trend for a minimum of 180 days. It can be seen in *Figure 5* that the stud is located at the base of a temporary hoarding. The road stud is located directly under the hoarding and is no longer accessible for monitoring.

Based on the adjacent road studs' settlement trends, it is proposed to consider LP12173B as unreliable with regards to trends caused by tunnelling construction and to decommission the sensor.
