C510 – Whitechapel and Liverpool Street Station Tunnels

Instrumentation and Monitoring Close Out Report Block 04 Liverpool Street

CRL Document Number: C510-BBM-C2-RGN-C101-50243

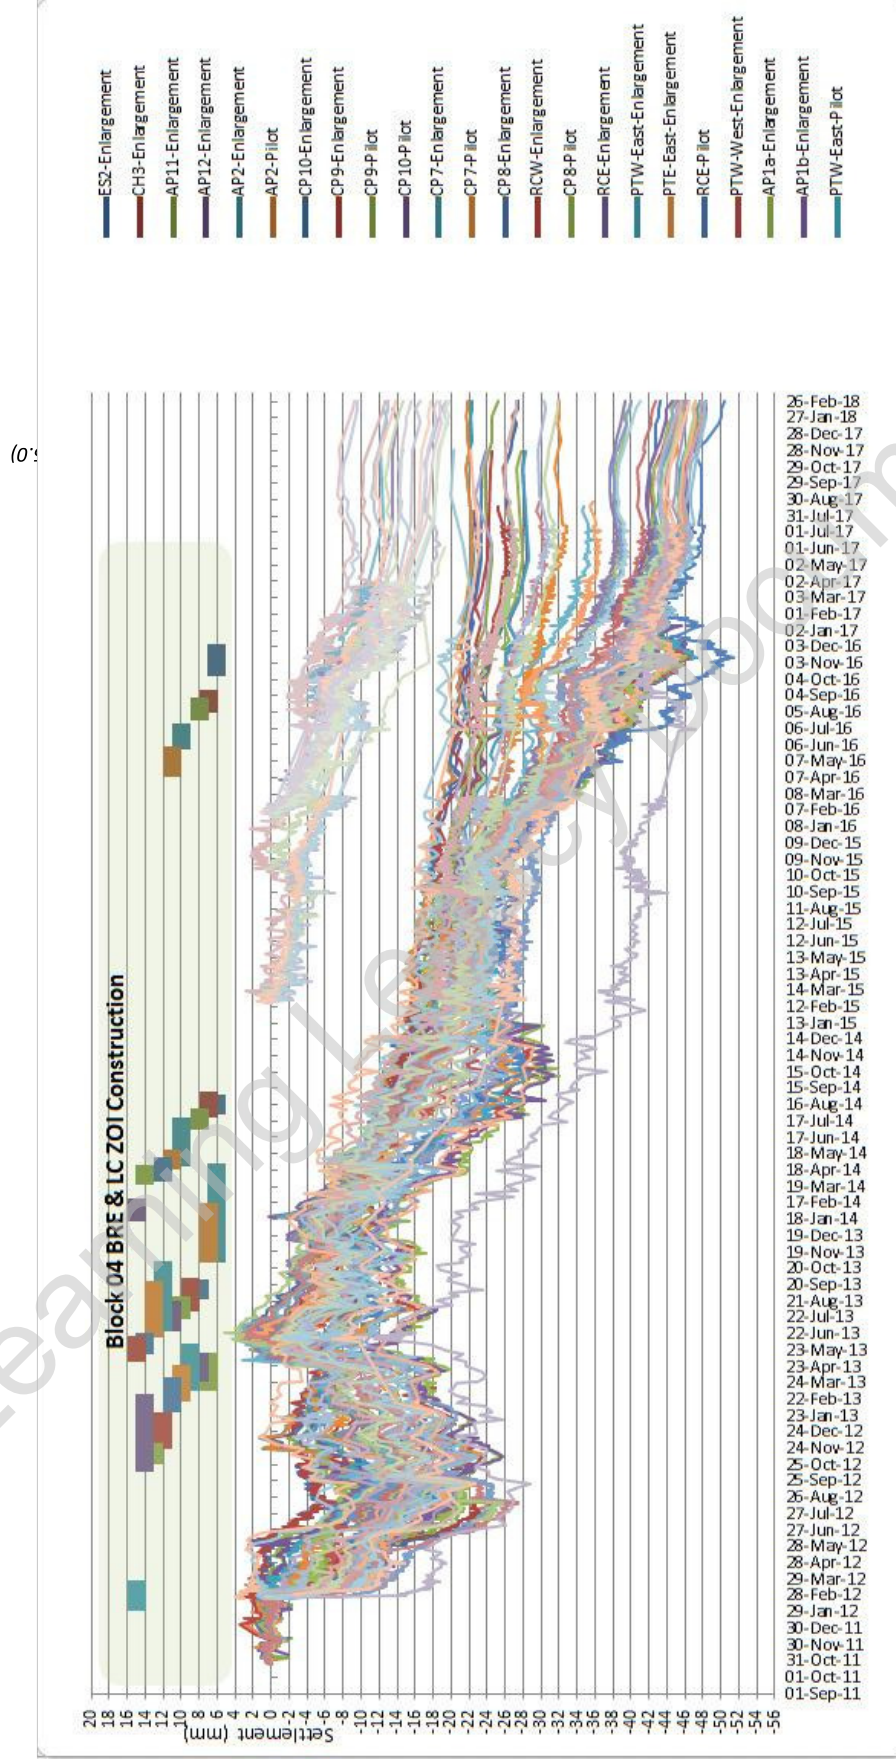
Graph 1 - Block 04 Building (BRE & LC) Manual Monitoring History in Relation to Construction

To assess the movement of Block 04 monitoring sensors; each monitoring sensor data type is displayed in a line graph, with a Gantt chart (bar) representing the construction identified in Section 4:

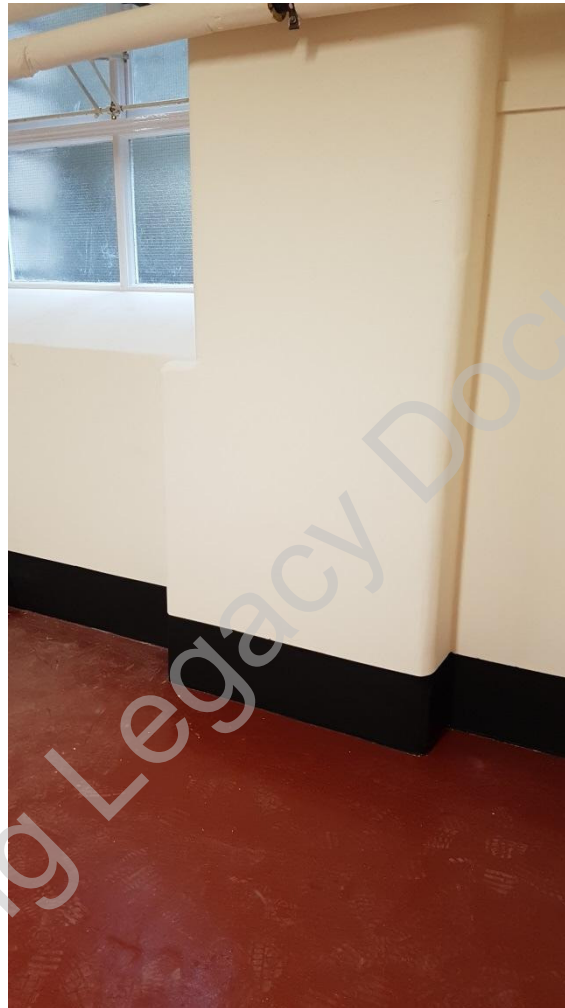
Figure 3. London Wall Basement -

- LB10457 – The BRE was removed during works at London Wall Basement. Latest data 28/11/2017

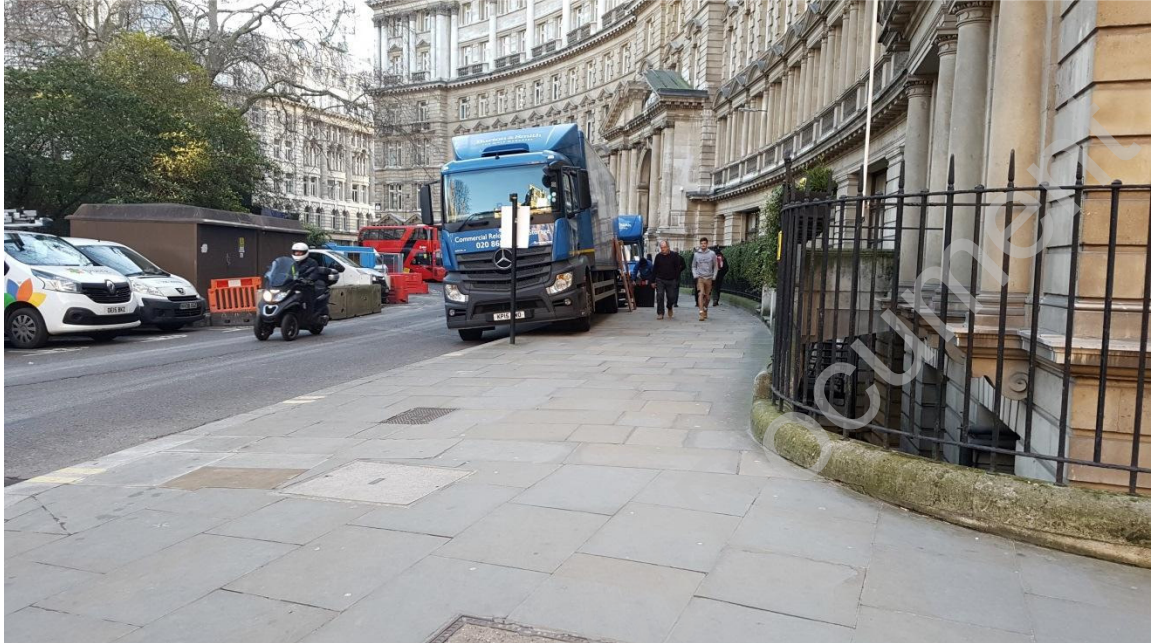
- LP12403–Data of roadstud LP12403 probably affected by HGV parked over the studs on the pavement. Trends of points LP12404-07 might also be affected.

Figure 4. Finsbury Circus pavement, 23-25 London Wall - HGV parked over the studs

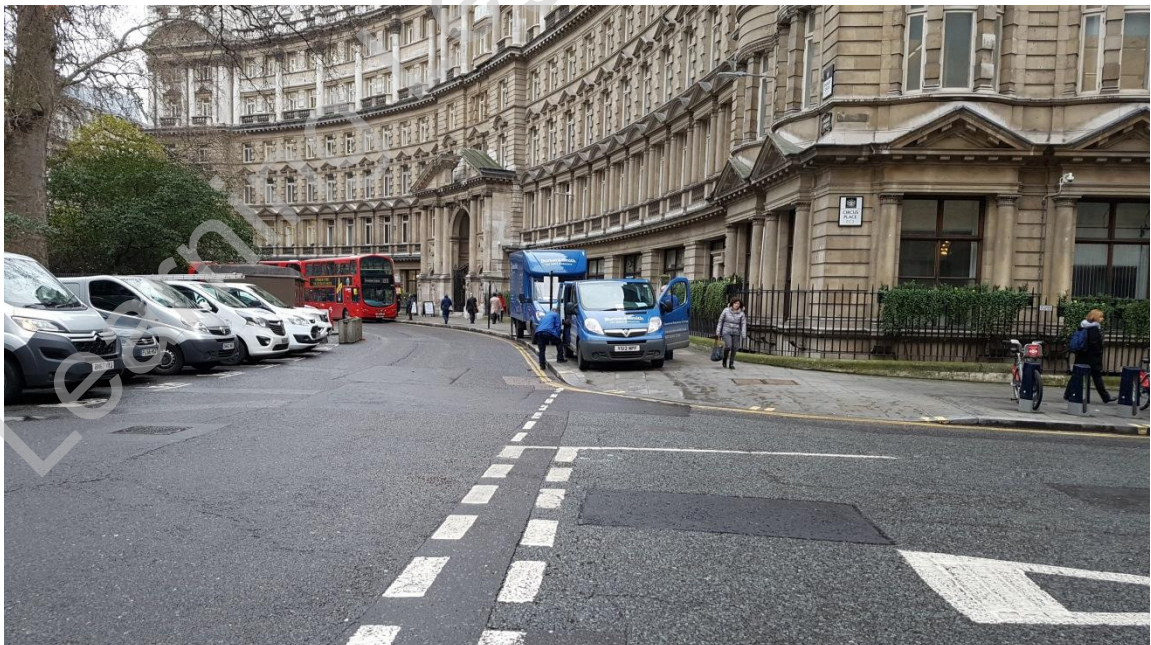
Figure 5. Finsbury Circus pavement, 23-25 London Wall - HGV parked over the studs

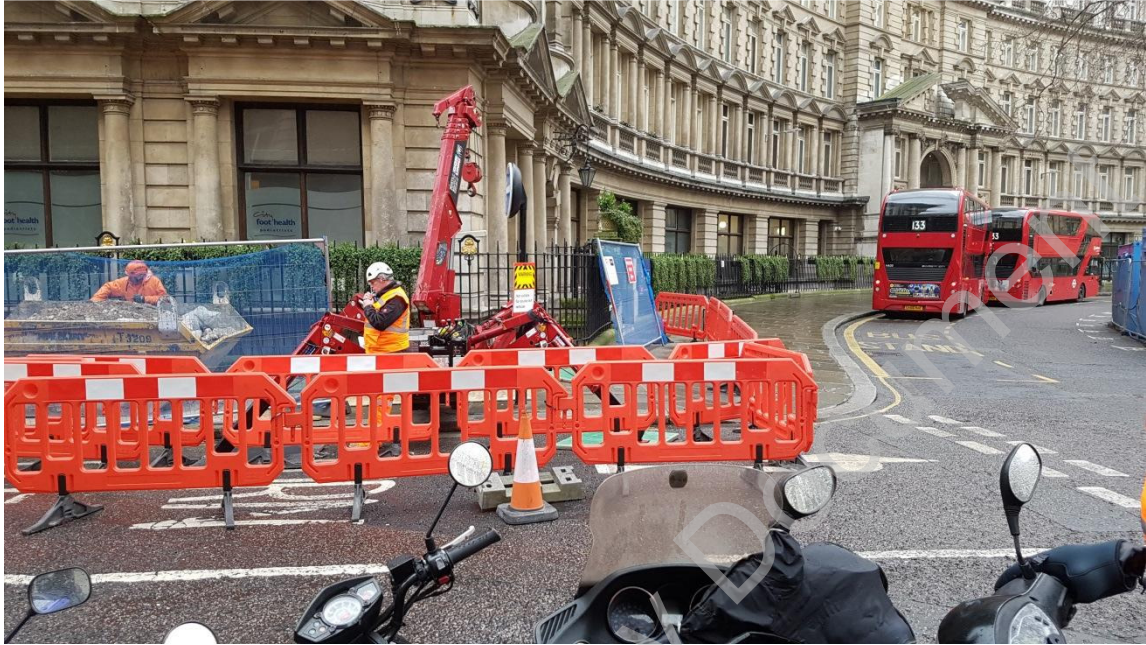
LP12418: Data of roadstud LP12418 affected by settlement that was caused by London Wall basement works due to HGV moving and parking over studs (Figure 6)

Figure 6. London Wall basement works

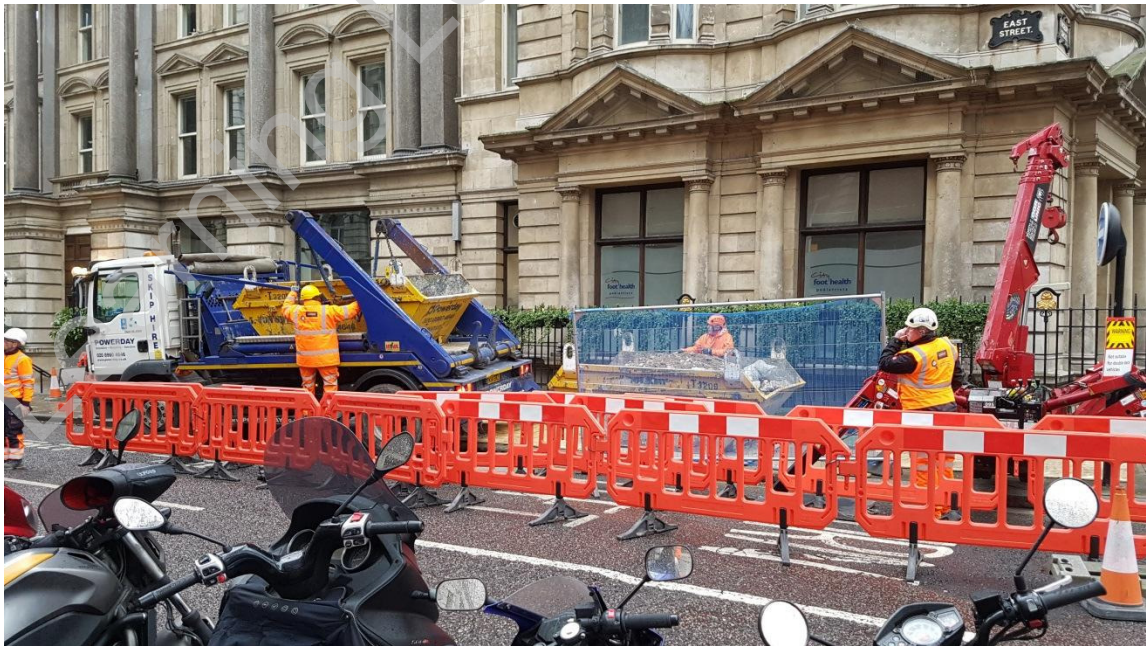
LP12419-25: Trend affected by settlement that was caused by London Wall basement works (Figure 7)

Figure 7. London Wall basement works

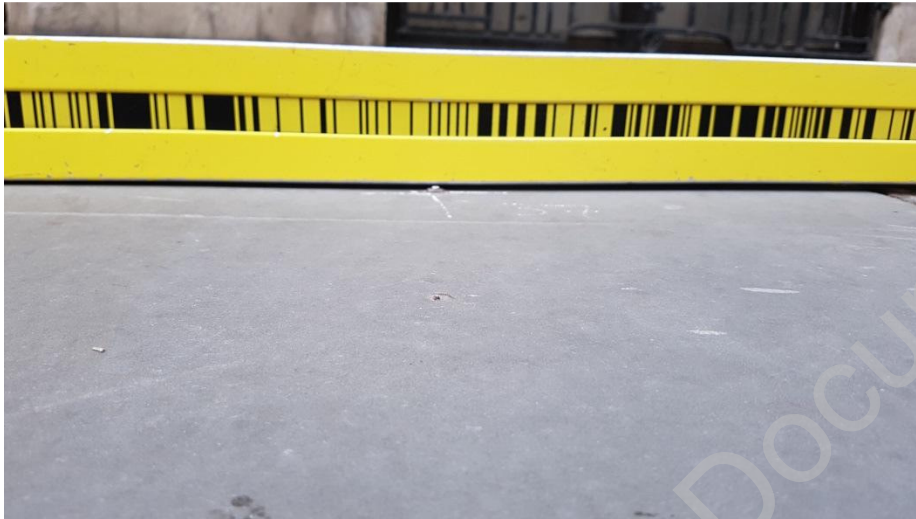
LP12436-37: Trend affected by settlement that was caused by recent utility works that affected LP12438-39. (Figure 8-9)

Figure 8. LP12437 Uneven slabs

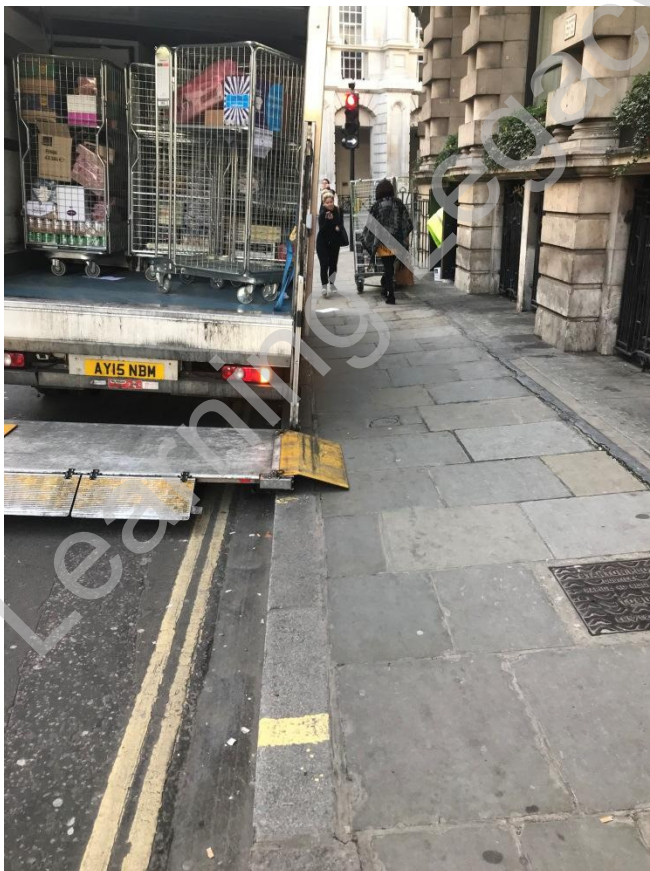
LP12438-39: Utility works lifted slabs and studs were destroyed since 13/06/2017 (Figure 9)

Figure 9. Utility works lifted slabs and studs LP12438-39 were destroyed since 13/06/2017. Works also affected trends of LP12436-37.

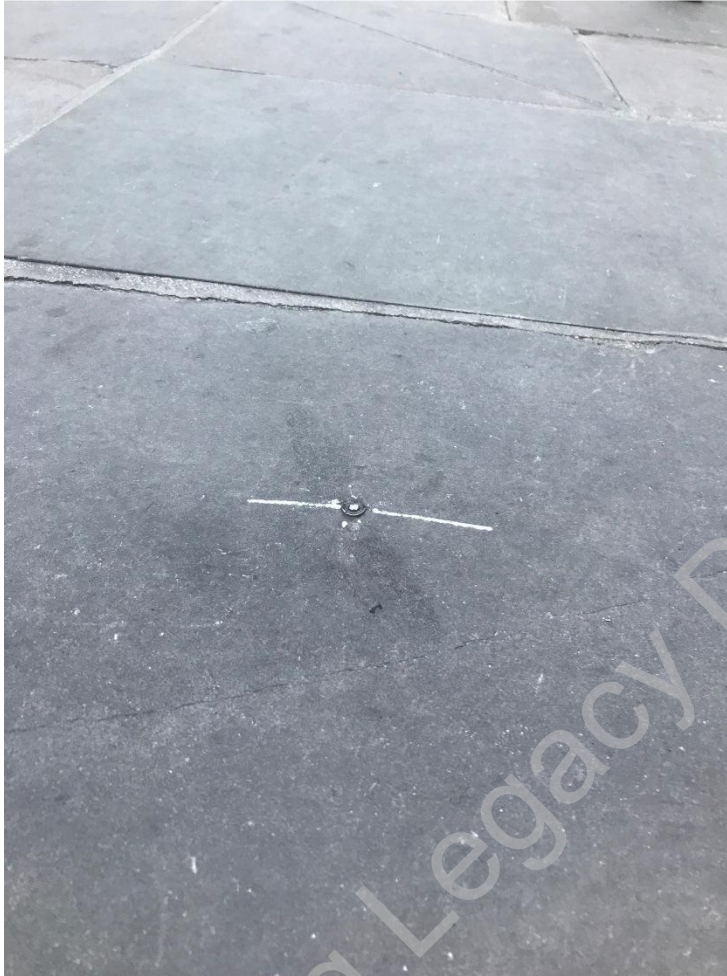
- LP12455: Stud is damaged.

Figure 10. LP12455 Stud is damaged

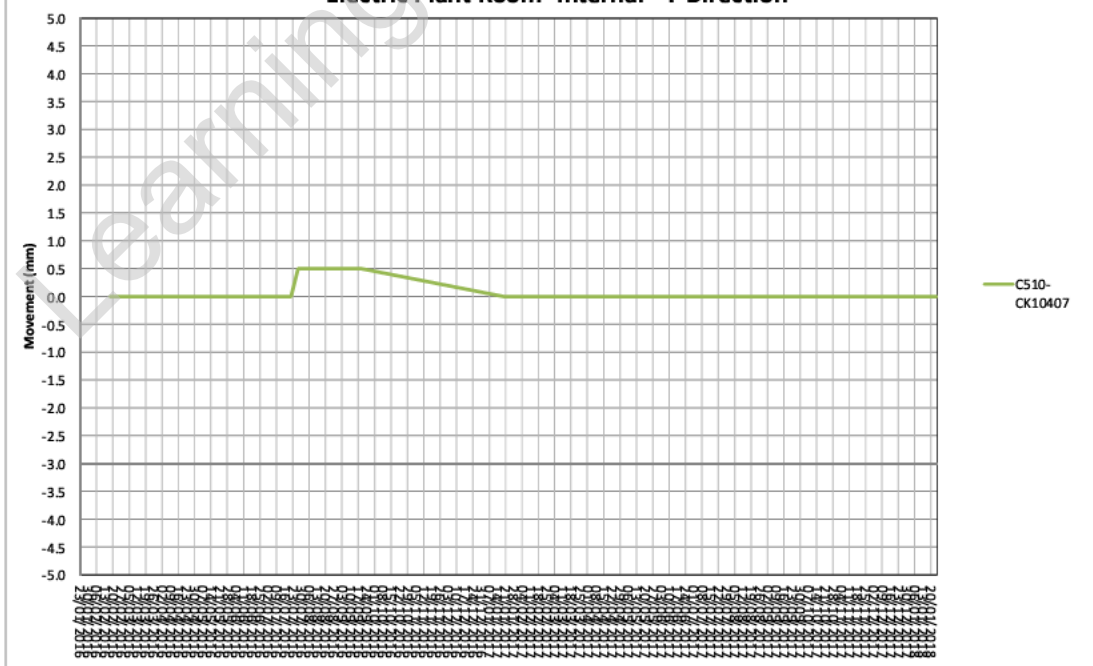
Electric Plant Room- Internal - Y Direction

Electric Plant Room					
Previous Name	UCIMS Name	Initial Crack Width (mm)	Baseline Date	Baseline Value	
				X	Y
CK510LWBEPRI	C510-CK10407	3.00	10/02/2015	0.00	0.00

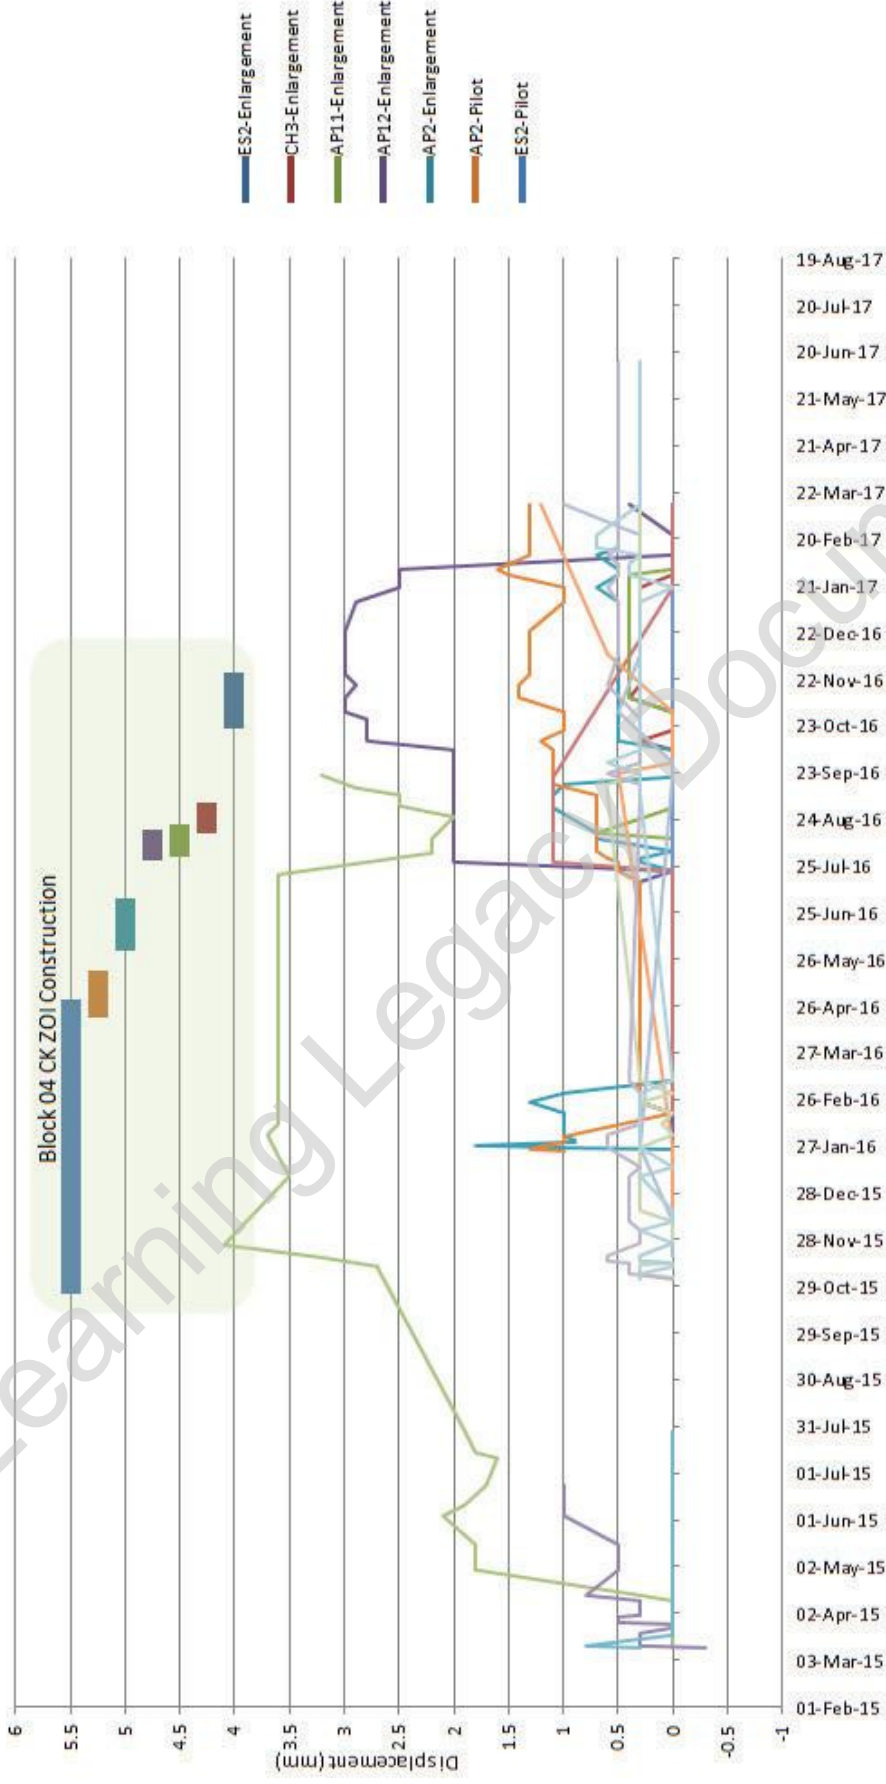
Graph 8 – All Block 04 Crack Monitors (CK) Manual Monitoring History in Relation to Construction

Note: Calculated crack monitor values (Z) provided are the hypotenuse of the measured X and Y movement, i.e. $Z^2 = (X^2 + Y^2)$

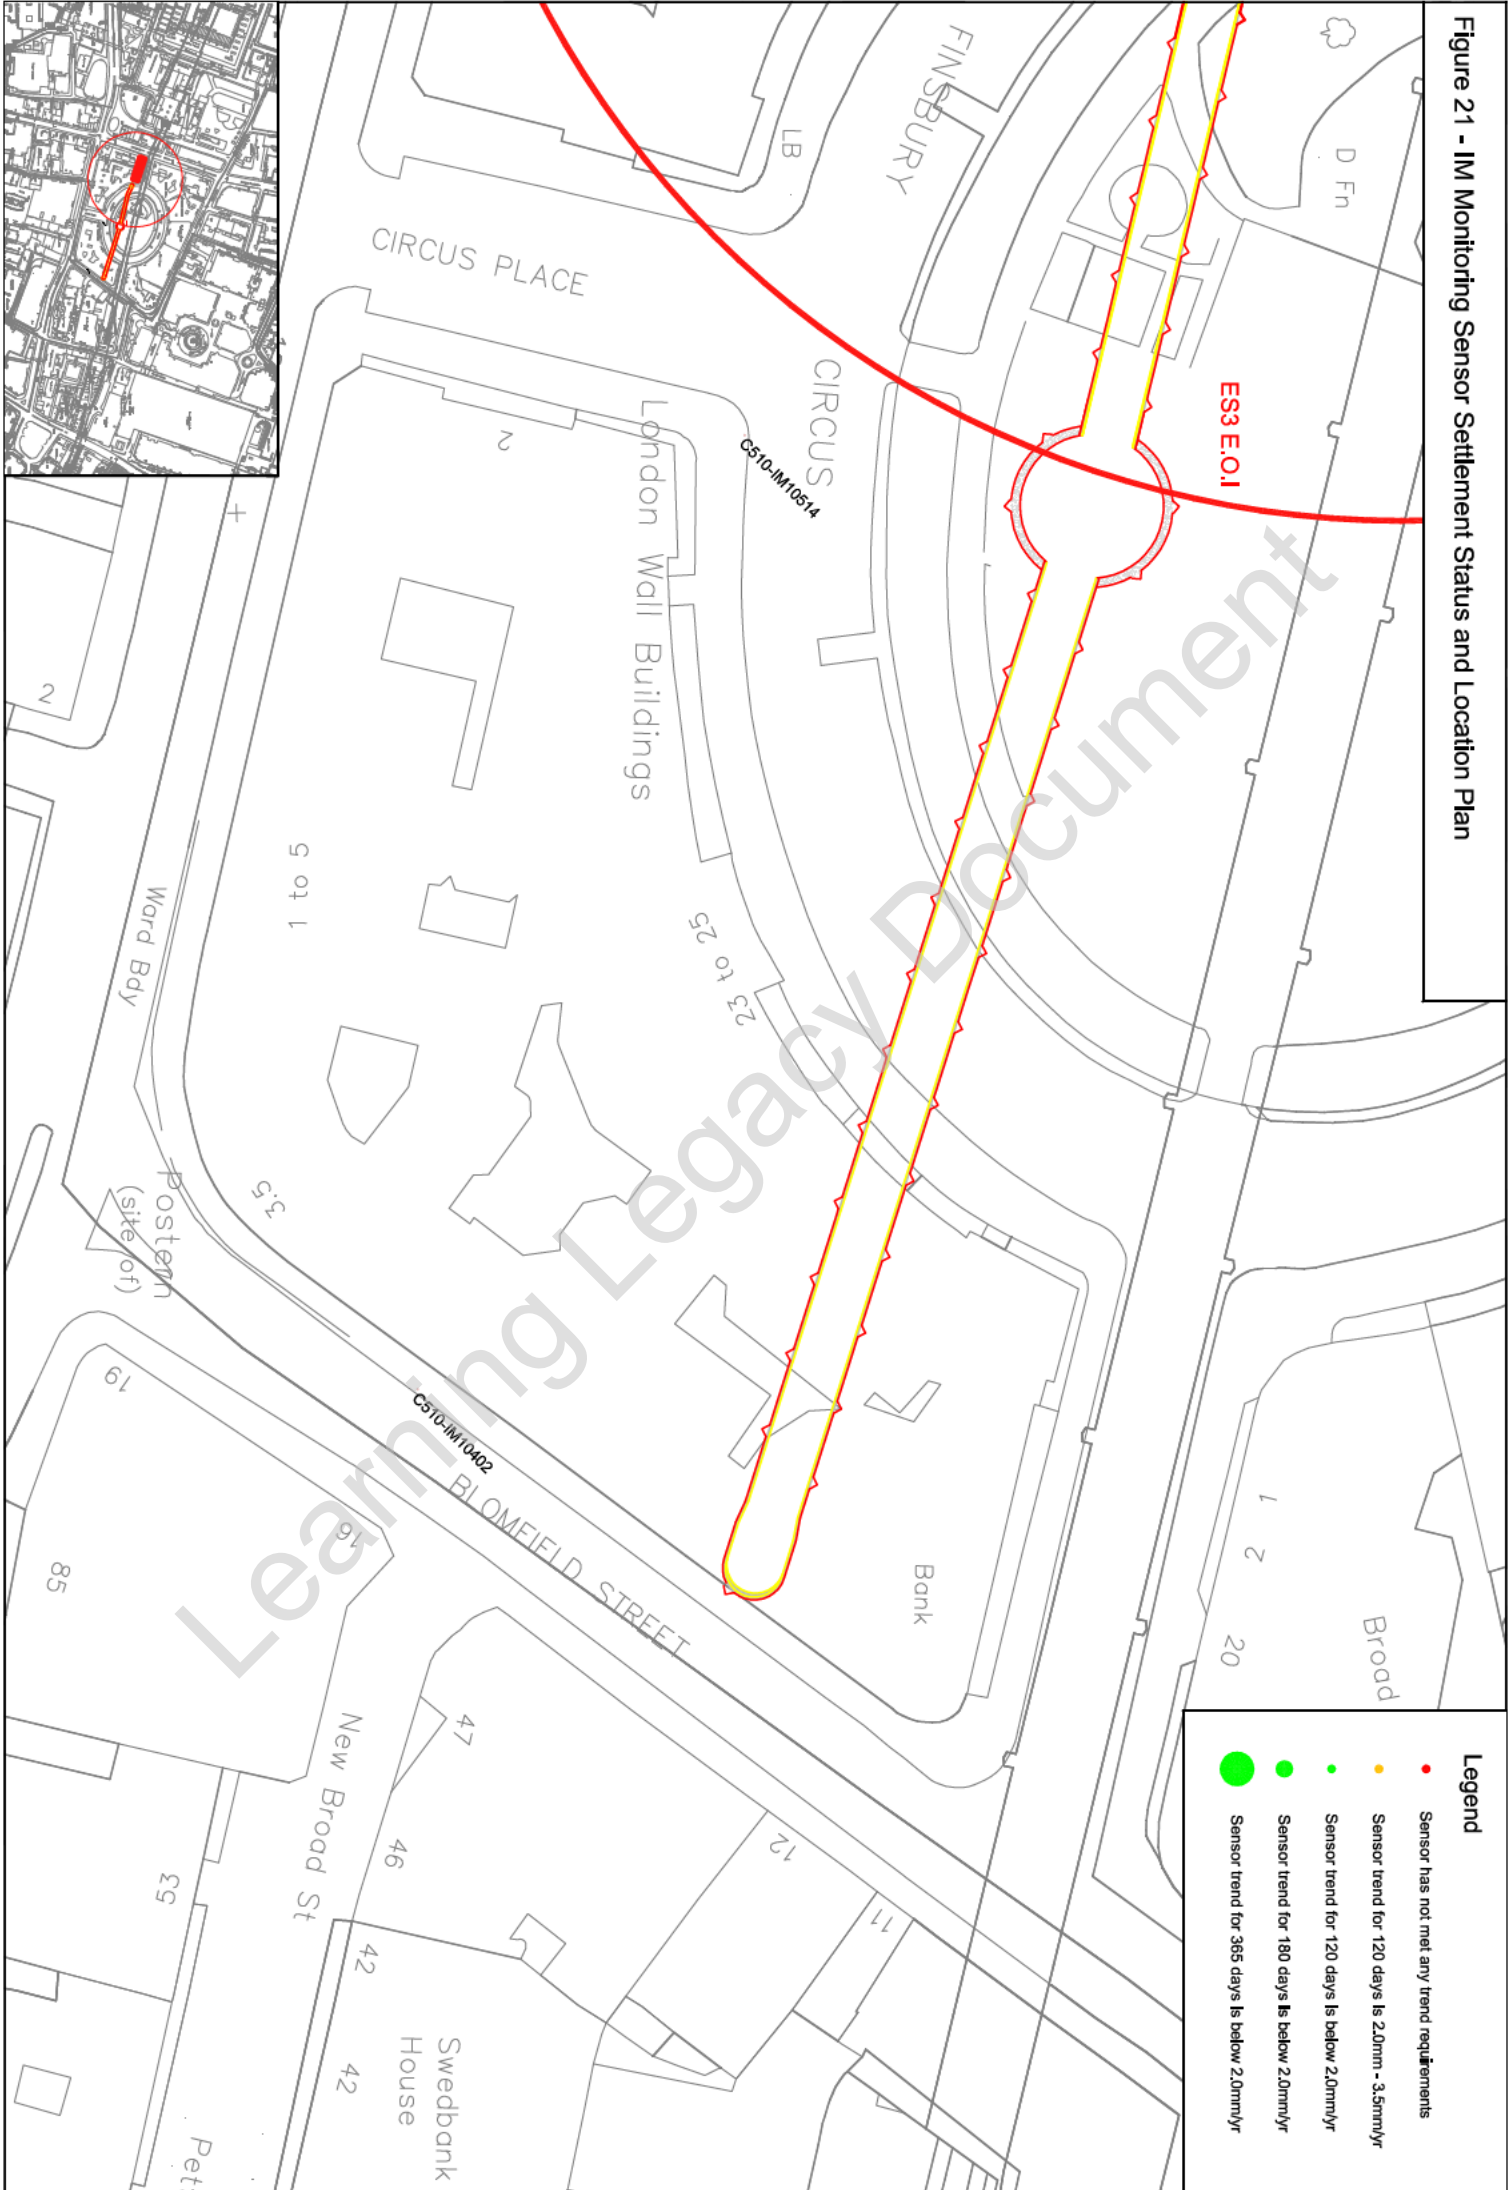
Figure 21 - IM Monitoring Sensor Settlement Status and Location Plan

- Sensor has not met any trend requirements
- Sensor trend for 120 days is 2.0mm - 3.5mm/yr
- Sensor trend for 120 days is below 2.0mm/yr
- Sensor trend for 180 days is below 2.0mm/yr
- Sensor trend for 365 days is below 2.0mm/yr

- Road studs, BREs and invar scales that have not met the <2mm/year specification, as identified in Section 2;
- All crackmeters until adjacent monitoring sensors meet the <2mm/year specification;
