C510 – Whitechapel and Liverpool Street Station Tunnels

Instrumentation and Monitoring Close Out Report Block 02 Liverpool Street

CRL Document Number: C510-BBM-C2-RGN-C101-50246

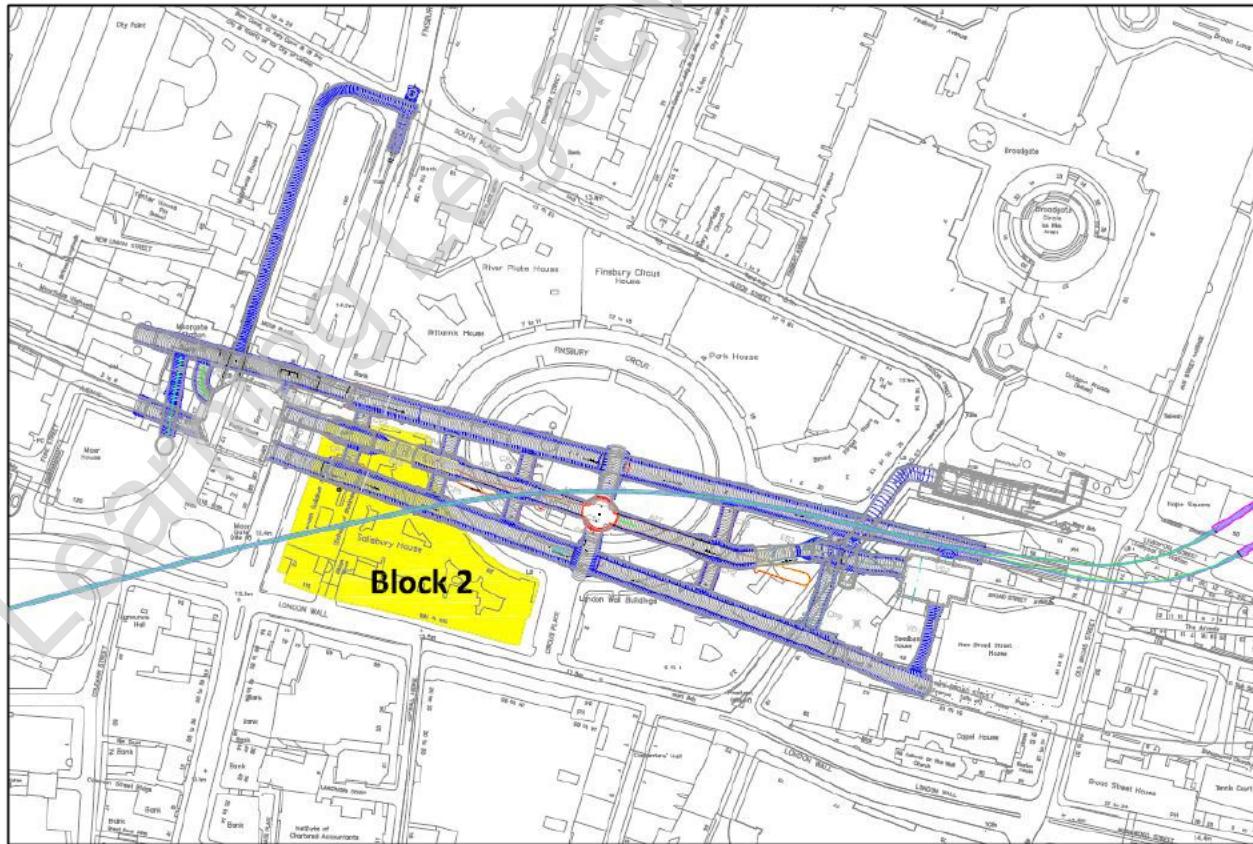
Figure 1 - Liverpool St General Location Plan - including Block 02 monitoring area

Figure 1 shows the Liverpool St general location plan, C510 tunnel construction and where Block 02 is situated. Detailed location plans can be found within the installation reports and photomontages as listed in Section 3.2. Each monitoring sensor's location is shown within the assessment plans (Section 5.4).

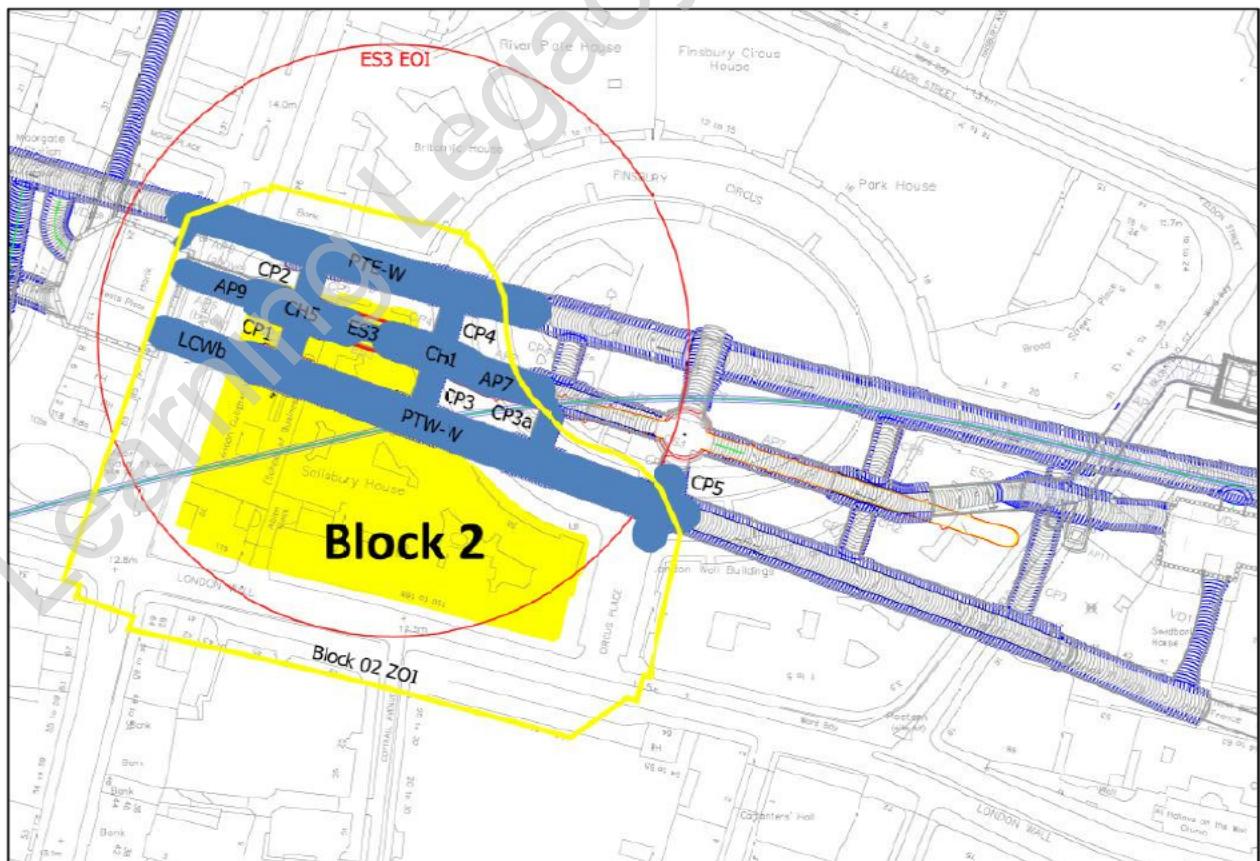
Figure 2 - Block 02 ZOI Constructors

To identify the tunnels that had the potential to significantly affect Block 02, a ZOI was established by giving each monitoring sensor a radius of 2.0 x tunnel diameter. This area was then used to determine all the mining advances that occurred within its boundary. Figure 2 shows the ZOI boundary (yellow outline), ES3 EOI, and the tunnel constructions. Tunnel advance start and finish dates will be used in the assessment of the monitoring data.

Figure 2 shows the Block 02 ZOI and the tunnel advances that occurred within its boundary. The construction advances within the ZOI that have the potential to affect Block 02 are listed and summarised in Table 1. Further evidence for construction dates can be seen in Table 2, which lists the latest tunnel advance for each point.

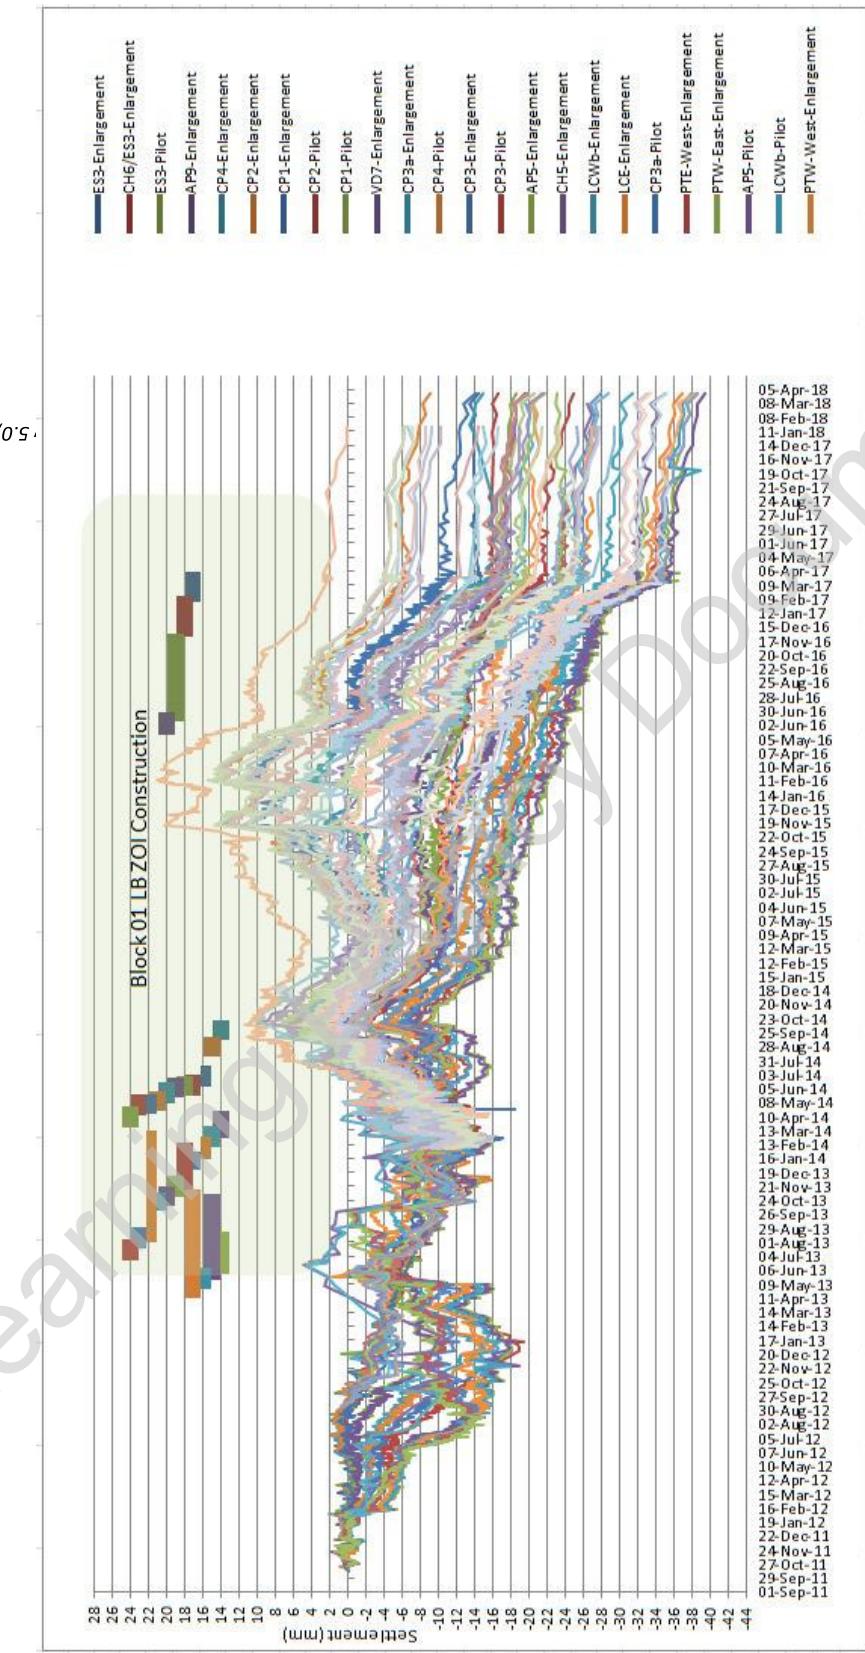
Graph 1 - Block 02 Building (BRE & LC) Manual Monitoring History in Relation to Construction

To assess the movement of Block 02 monitoring sensors; each monitoring sensor data type is displayed in a line graph, with a Gantt chart (bar) representing the construction identified in Section 4:

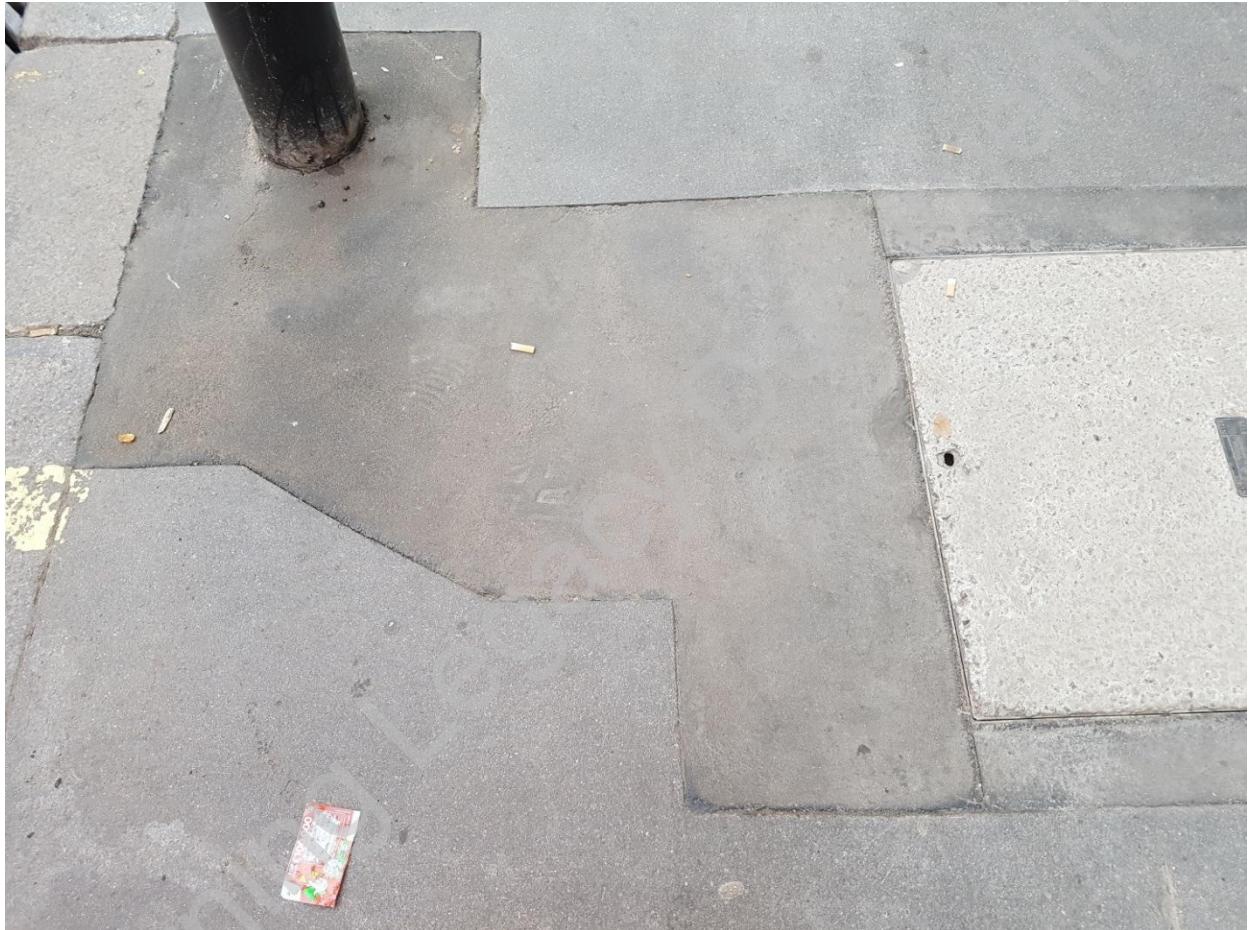
Figure 3. LP12234

- LP12234 - The road stud that was located in the area shown in the picture below (Figure 3) has been damaged and removed.

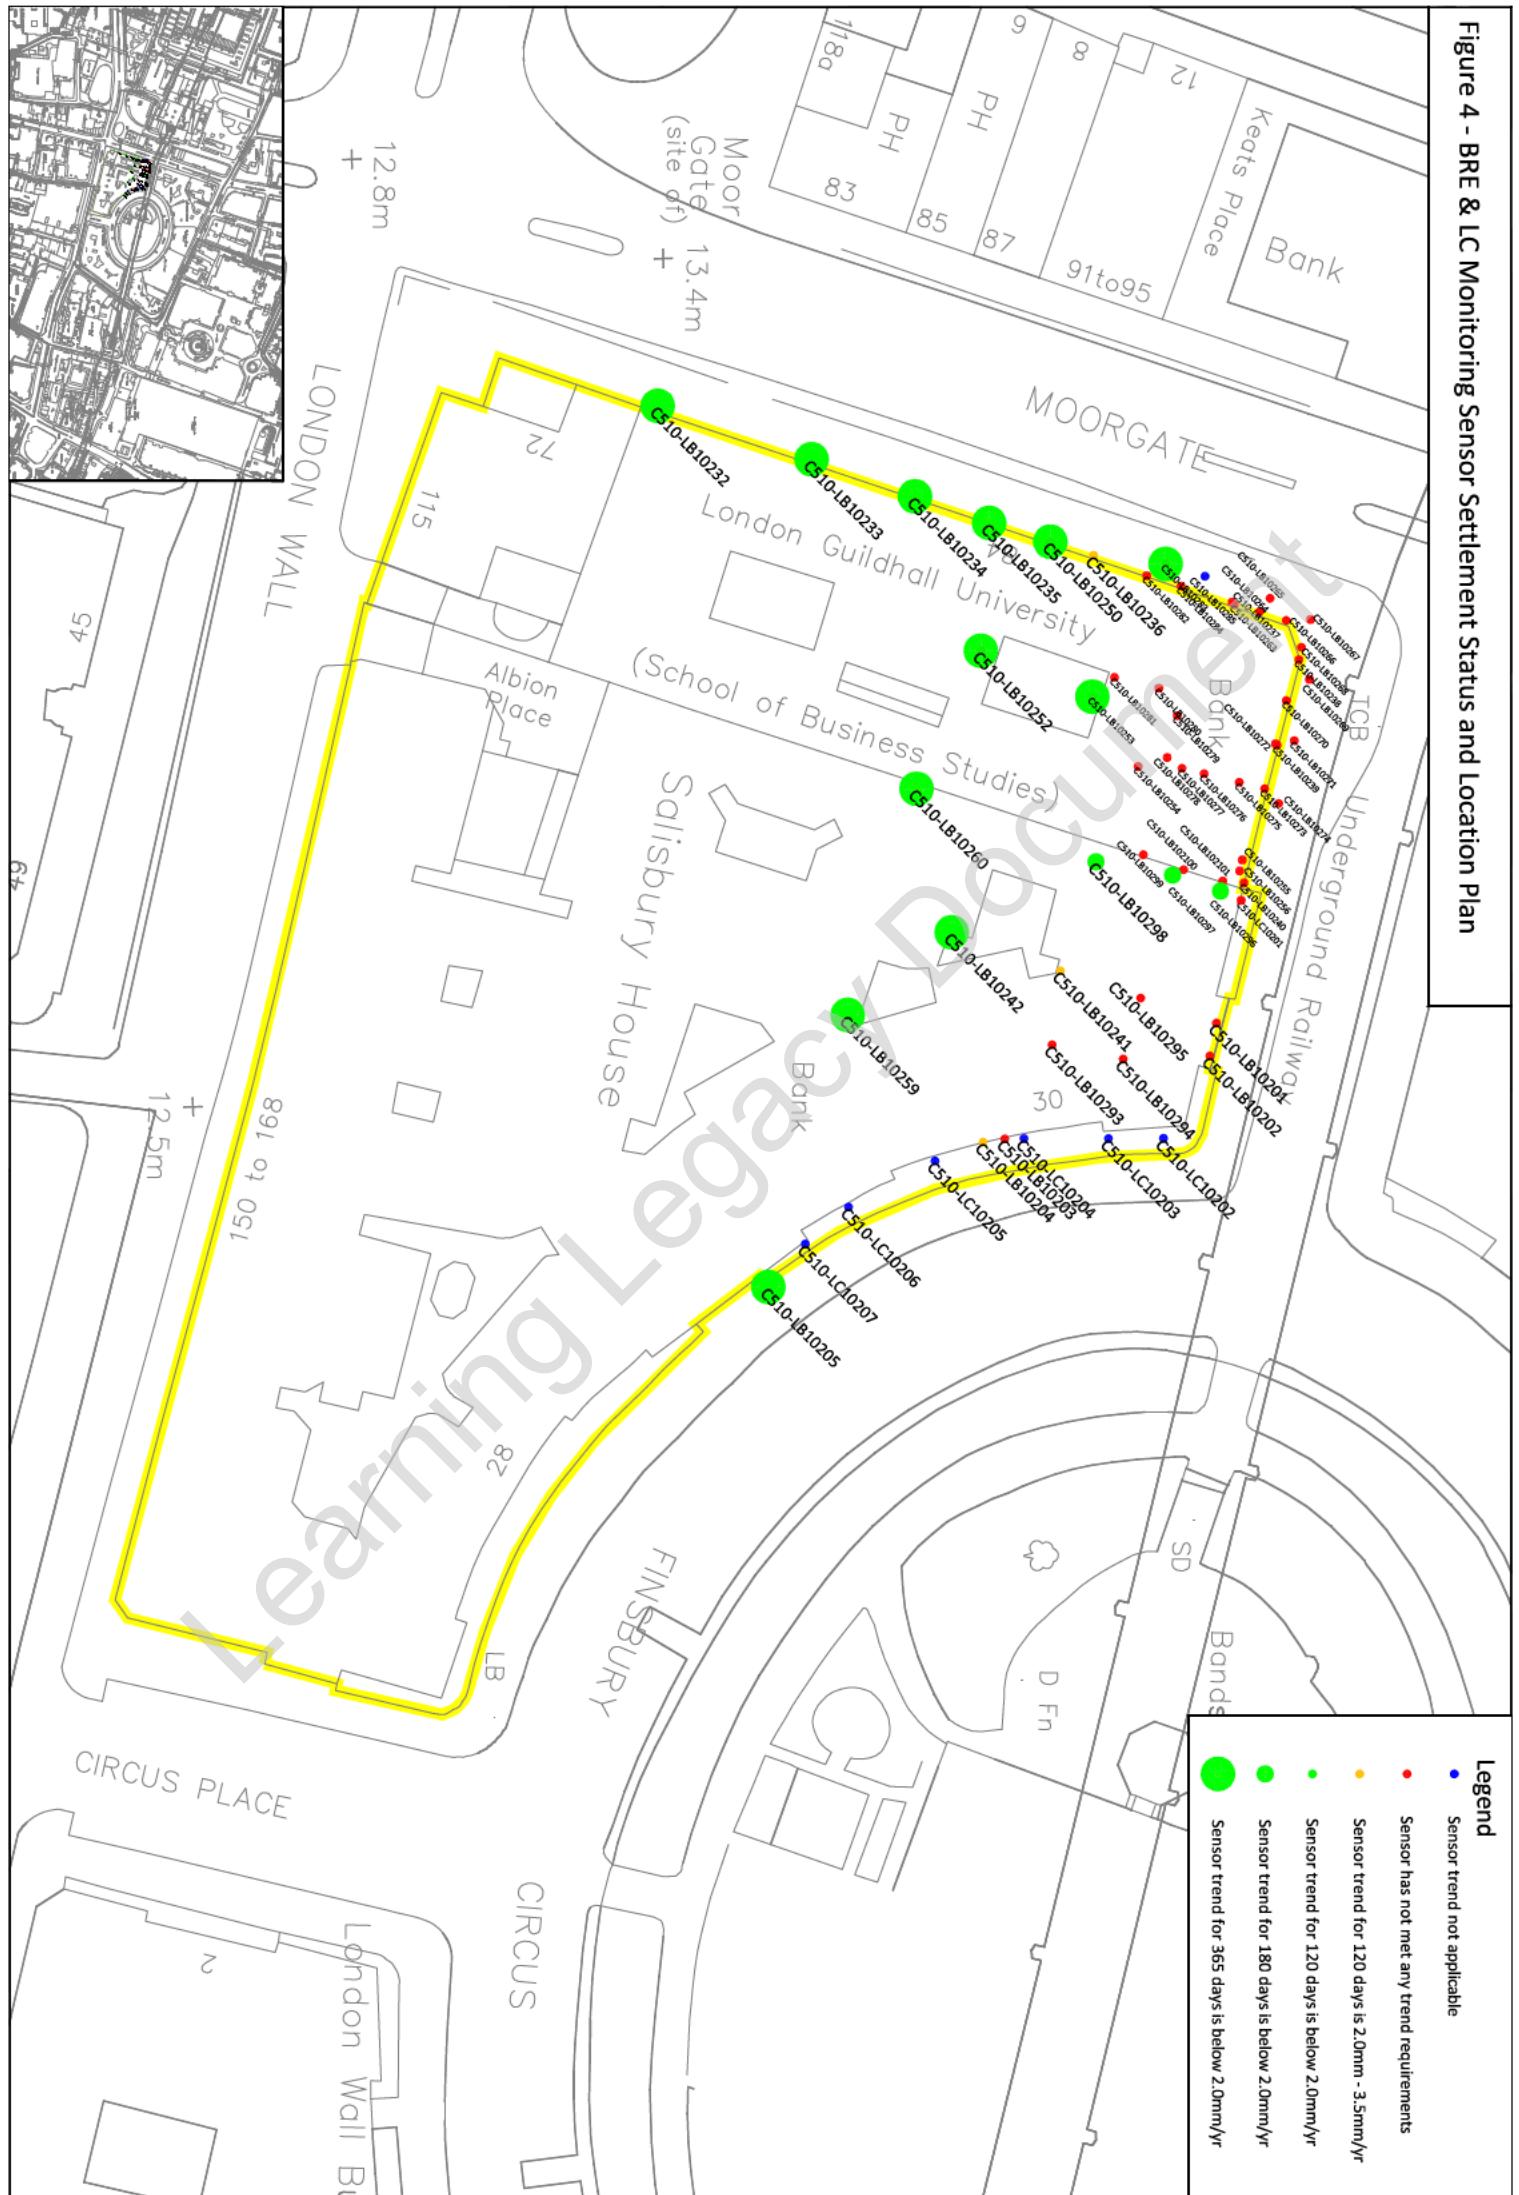
- Figure 4 - BRE & LC Monitoring Sensor Settlement Status and Location Plan
- Figure 5 - LP Monitoring Sensor Settlement Status and Location Plan
- Figure 6 - RP Monitoring Sensor Settlement Status and Location Plan

- Road studs, BREs and invar scales that have not met the <2mm/year specification, as identified in Section 2;
- All crackmeters until adjacent monitoring sensors meet the <2mm/year specification;

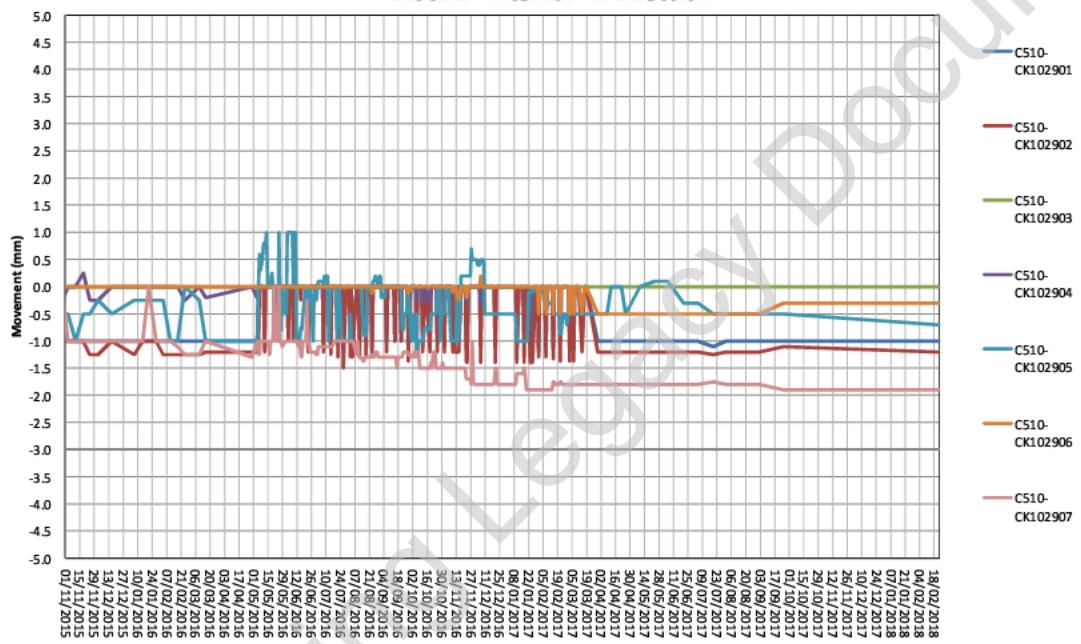
Block 2 - Internal - X Direction

Crack Width (mm)	Date Installed	Baseline Value x	Baseline Value y
C510-CK102901	2.0	28/05/2014	0.0	0.0
C510-CK102902	1.8	28/05/2014	0.0	0.0
C510-CK102903	0.0	28/05/2014	0.0	0.0
C510-CK102904	1.0	28/05/2014	0.0	0.0
C510-CK102905	0.5	28/05/2014	0.0	0.0
C510-CK102906	1.0	28/05/2014	0.0	0.0
C510-CK102907	0.5	28/05/2014	0.0	0.0

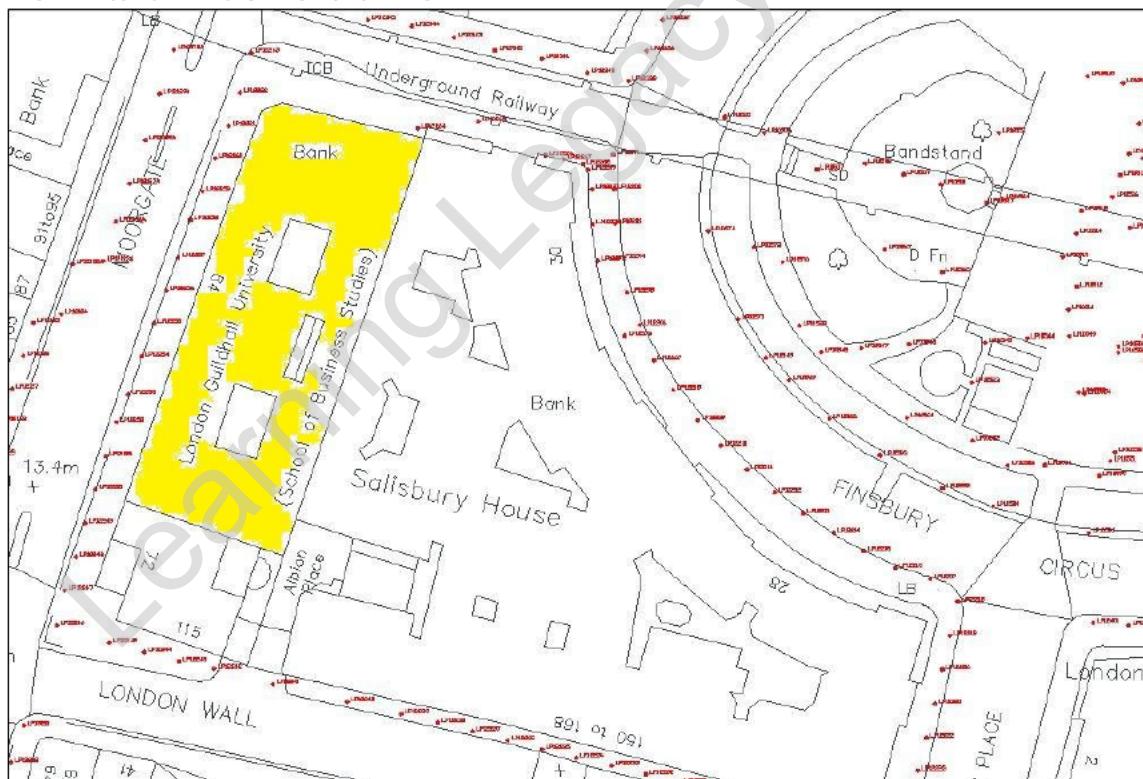
GENERAL LOCATION PLAN FOR UNIVERSITY CRACKMETERS

25/05/2016 CK102507 The crack-meter is damaged due to the wall movement and needs to be re-installed.
 27/07/2016 - CK102301-2 No access to crack meters.
 27/09/2016 - No access to C510-CK102202 & CK102203 due to class in progress.
 27/09/2016 - CK102308 showing movement, but likely due to crack meter being disturbed.
 11/10/2016 - CK102508-16 and CK102202-03 Couldn't get in a class going on
 25/10/2016 - CK102202-03 Couldn't get in a class going on
 12/12/2016-
 2017-01-17 502, 402 broken 104, 112 not visable due to lighting
 07/04/2017 - CK102305 has been knocked.
 2017-07-17 CK102104,05,14 Removed
