C435 Farringdon Main Station

Monitoring Close Out Report – Inground Monitoring Section A

CRL Document Number: C435-BFK-C2-RGN-M123-51049

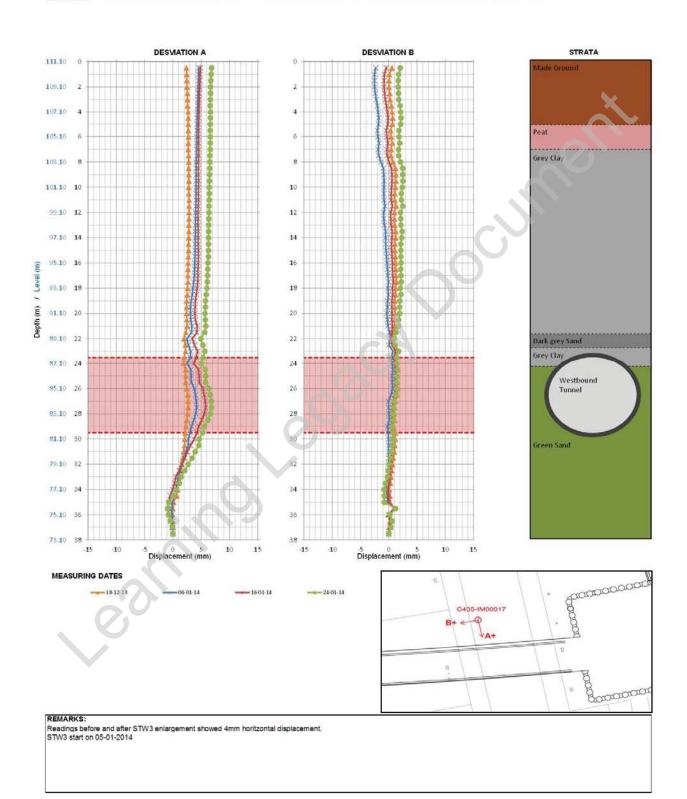
DEVICE: Inclinometer C435-IM00017 - READINGS BEFORE AND AFTER STW3 ENLARGEMENT

The monitor data for the inclinometer located directly north of the WB TBM tunnel (C435-IM00017) is presented in Appendix B. The passage of the WB TBM tunnel is shown to have caused a maximum horizontal displacement of 9mm in the same level than tunnel, as expected. There is a reading taken on 15-10-13 that show maximum -15mm in B direction is a bad reading. During the enlargement of STW3 this inclinometer shows 4mm horizontal displacement, less than expected.
