C435 Farringdon Main Station

Monitoring Close-Out Report: Internal Monitoring: Sockets and Crackmeters

CRL Document Number: C435-BFK-C2-RGN-M123-51653

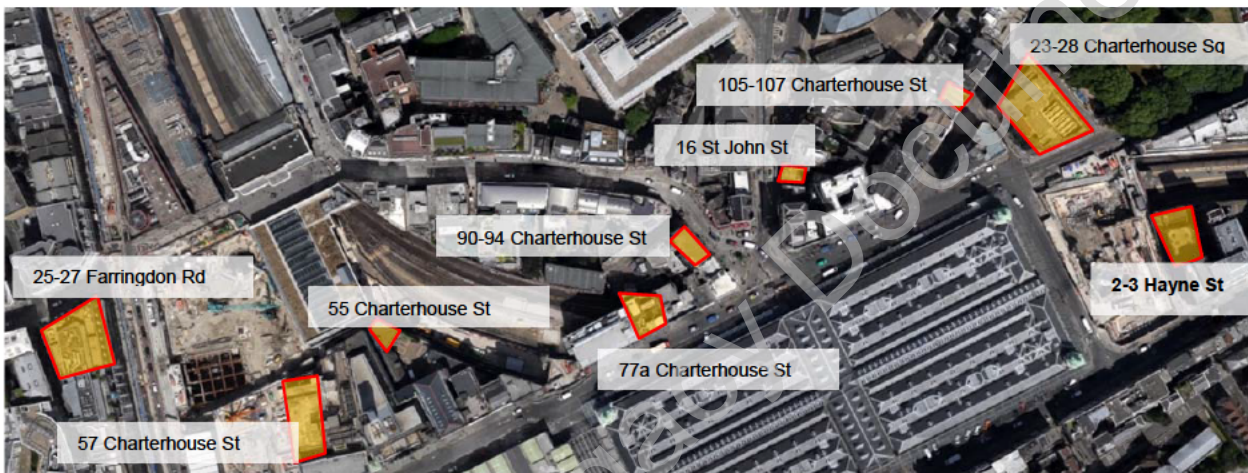
Figure 1 – Plan showing the Location of the sockets and crackmeters.

Sockets and crackmeters are located on the plan below highlighted in yellow.
