C435 Farringdon Main Station

Monitoring Close-Out Report: Section K

CRL Document Number: C435-BFK-C2-RGN-M123-51659

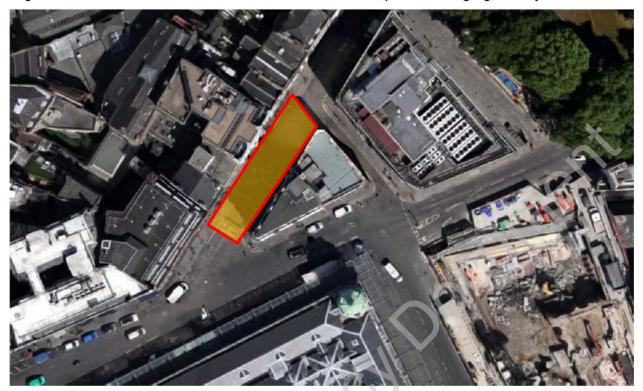
Figure 1 – Plan showing the Location for the device on Section K

In ground devices associated with Section K are located on the plan below highlighted in yellow.

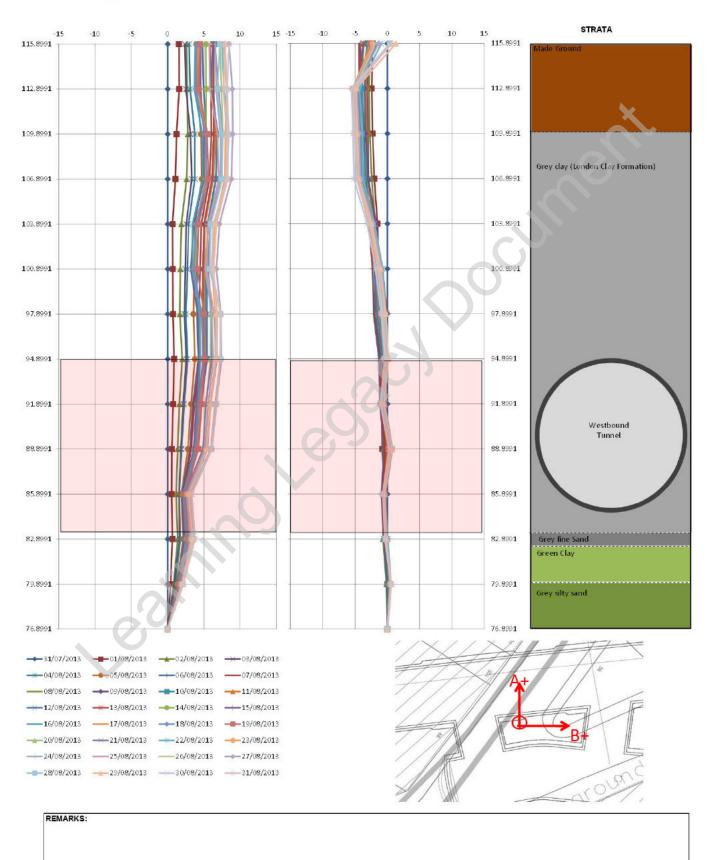
Inclinometer C435-IE00013

- Compensation grouting from Moorgate Shaft 2 caused 8mm lateral displacement in A direction and 6mm in B- direction from 31-07-2013 to 31-08-2013.
- EB TBM caused maximum 10mm lateral displacement in A direction, towards the tunnel and 4mm in B- direction from 01-01-2014 to 01-02-2014.

- PTE enlargement caused 14mm lateral displacement in A direction toward the tunnel and 5-6mm in B+ direction from October 2014 to November 2014.
- CP6 construction caused 16mm lateral displacement in A direction toward PTE tunnel and 8mm in B- direction between 01-11-2014 to 23-11-2014.

- CH2 (combination of pilot and enlargement) construction works caused 14-15mm lateral displacement in A- direction and 14-15mm in B- direction from 08-01-2015 to 09-04-2015.

- CP7 caused 4-5mm lateral displacement in A direction toward the PTE tunnel and 5-6mm in B direction toward CP7 tunnel from 01-02-2015 to 28-02-2015.
- Maximum horizontal movement in A direction, 25mm

- Maximum horizontal displacement in B direction, -25mm
