**C263 LATE EAST**  
**Non-listed Built Heritage Recording Report**  
**Plumstead Portal, Worksites West and East**

**Document Number: C263-MLA-X-RGN-CRG07-50025**

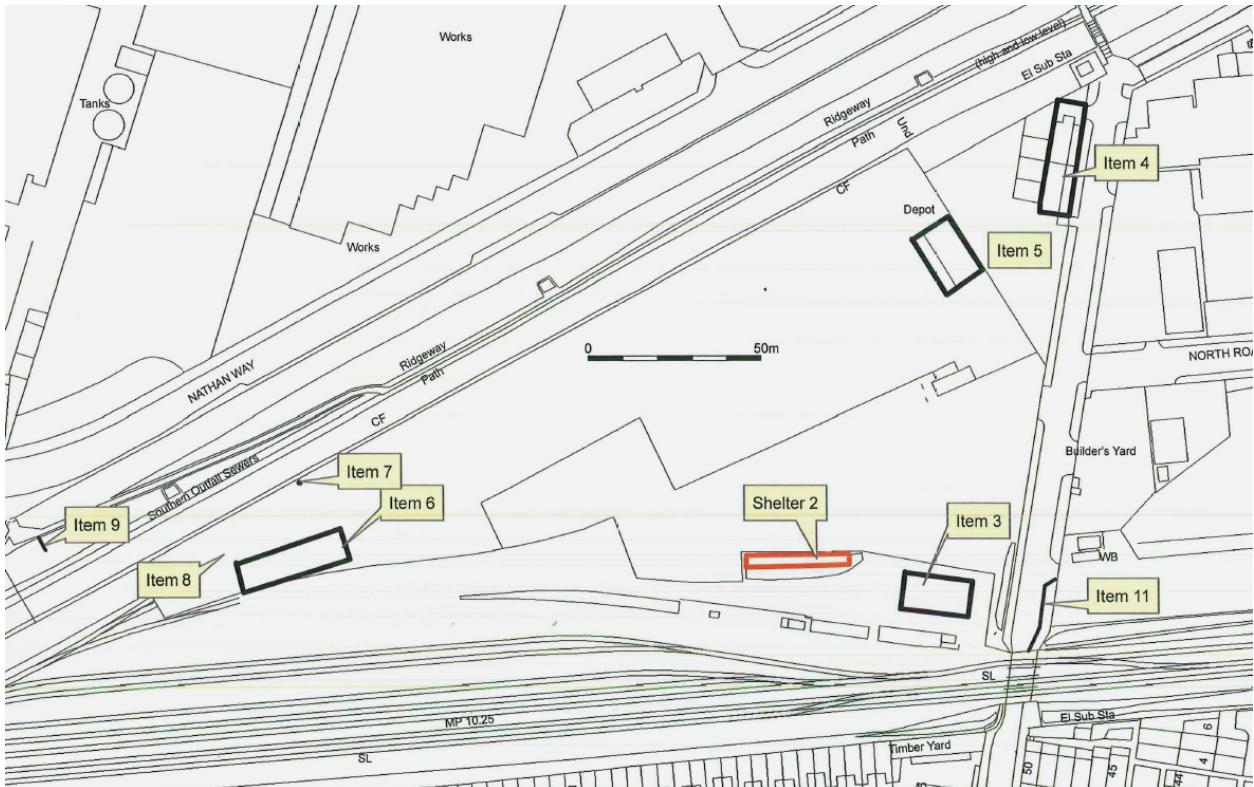
Fig 2 The location of NLBH features within and outside the site boundary of Worksite West.

Shelter 2 lay within the Worksite West area and was recorded to the west of the former electricity power station adjacent to the railway tracks (its location is shown in Fig 2). Externally the shelter appeared to be a linear mound lying west to east, approximately 30m in length, covered with foliage. This was cut back from around the entrance at the eastern end of the feature (Photo 27) and annotated and measured sketches were made of the structure both internally and externally. A second opening was also discovered approximately 20m to the west of the entrance (Photo 29) which is likely to have formed an emergency exit or escape hatch to the shelter. However a definitive link was not established between the escape hatch and the observed underground shelter area. It may be that the link between the two has been obscured by collapsed soil or that the underground network originally extended westwards, beyond the accessible and observed area.

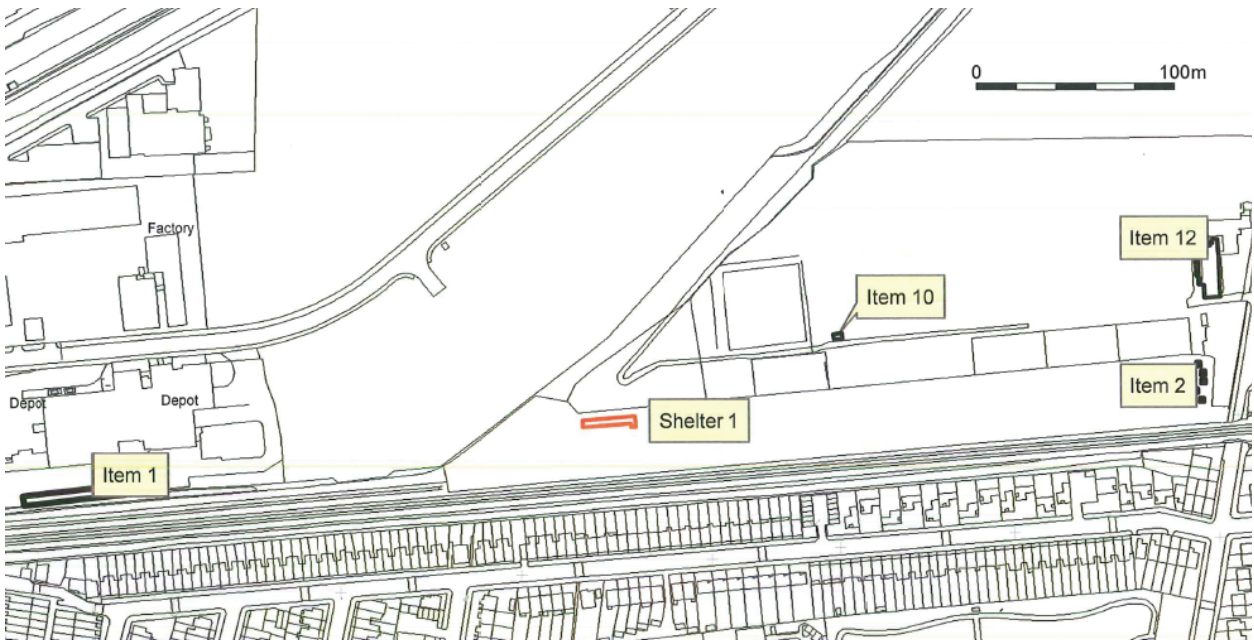
Fig 3 The location of NLBH features within and outside the Worksite East site boundary

Shelter 1 was recorded within the Worksite East area in sufficient detail to constitute an appropriate level 2 record (its location is shown in Fig 3). Photographs were taken and the feature was drawn to scale in plan and section, whilst its relationship to other possible elements of the subterranean complex, the air vent and escape shaft were also photographed and located in plan (Fig 5). The escape shaft led via a metal step ladder down to a brick arched tunnel, running westwards (Photo 25). If this connected to the main body of the shelter, which seems likely, it would have to have been via a 90° angle, turning to the north. This is the arrangement that has been illustrated in the conjectural plan of Shelter 1 (Fig 5), which also includes the circular air vent at the western end. This was in a collapsed state and was formed from large curved concrete blocks (0.33mX0.22mX0.51m), with little or no bonding material, forming a circular shaft 0.95m in diameter.

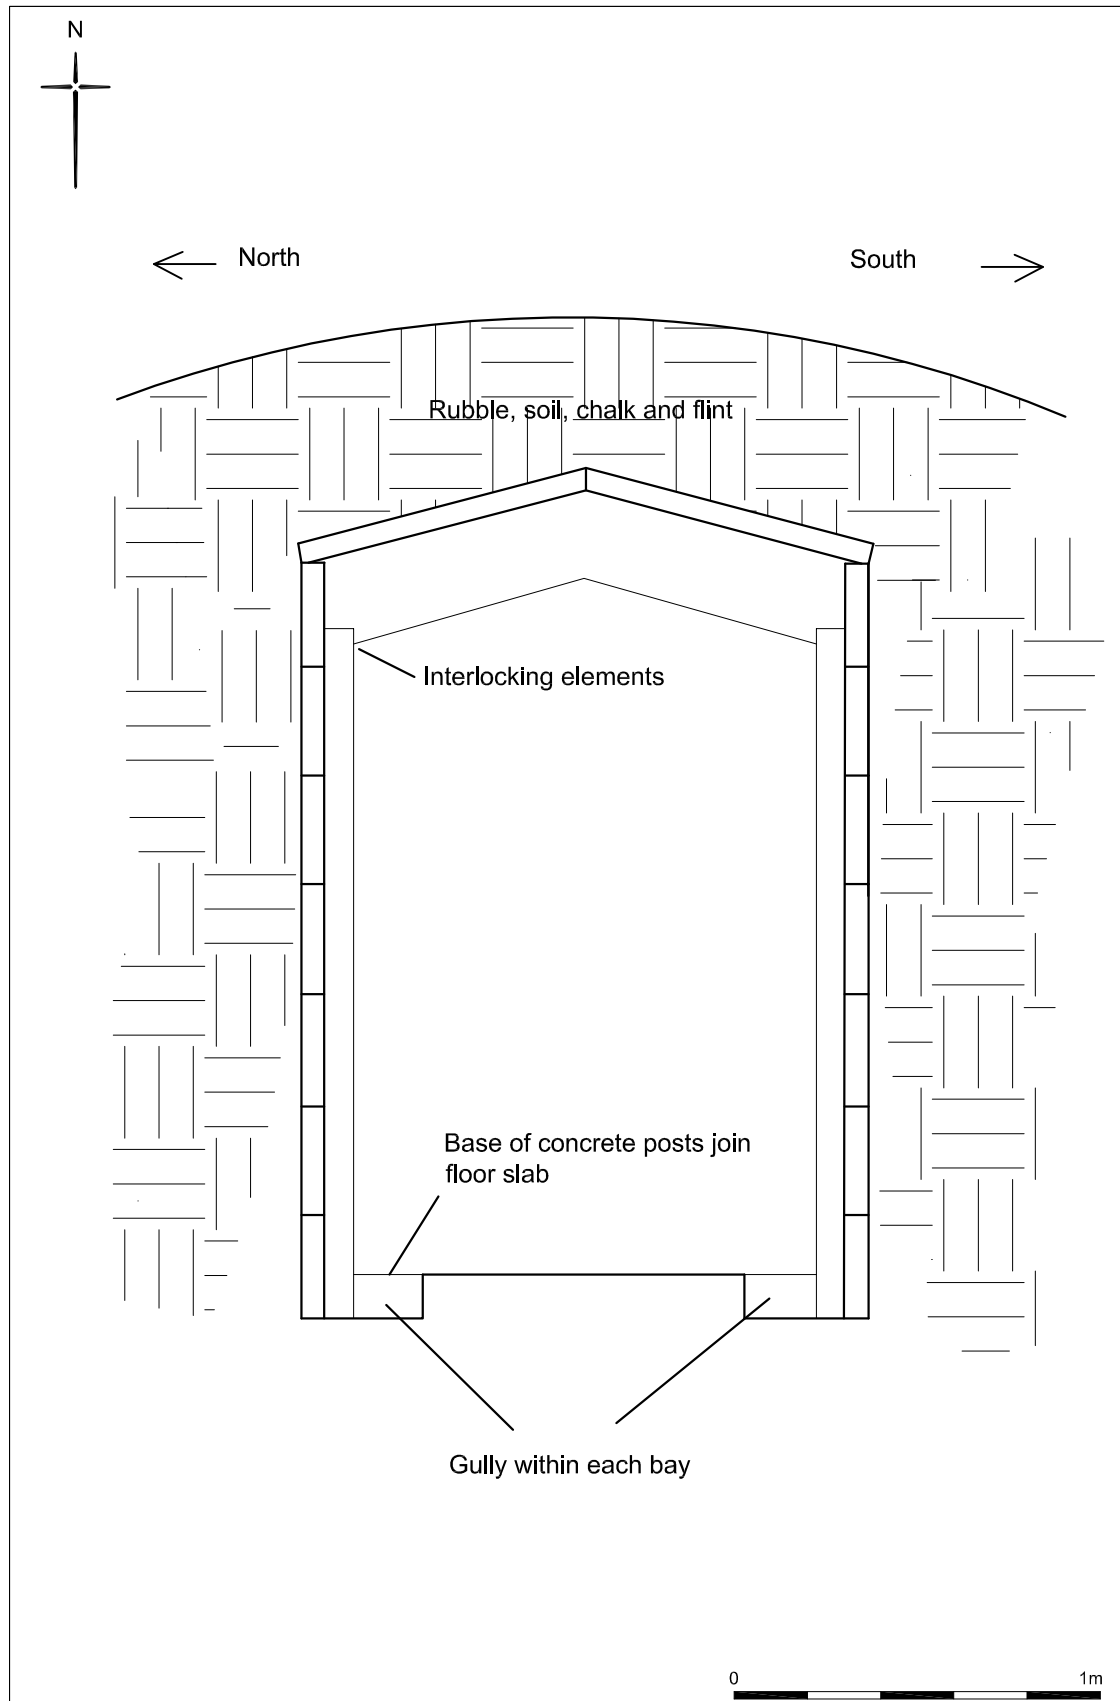
Fig 6 Section through shelter 2

The full height of the interior of shelter 2 was visible (Photo 28) allowing a cross section of the structure to be drawn (Fig 6). The floor was formed from a concrete slab with a lower level at the north and south edges, forming a gully either side of the centre of the concrete floor. However these gullies were not continuous along the length of the shelter but limited to each bay, being separated from each other at each concrete post.

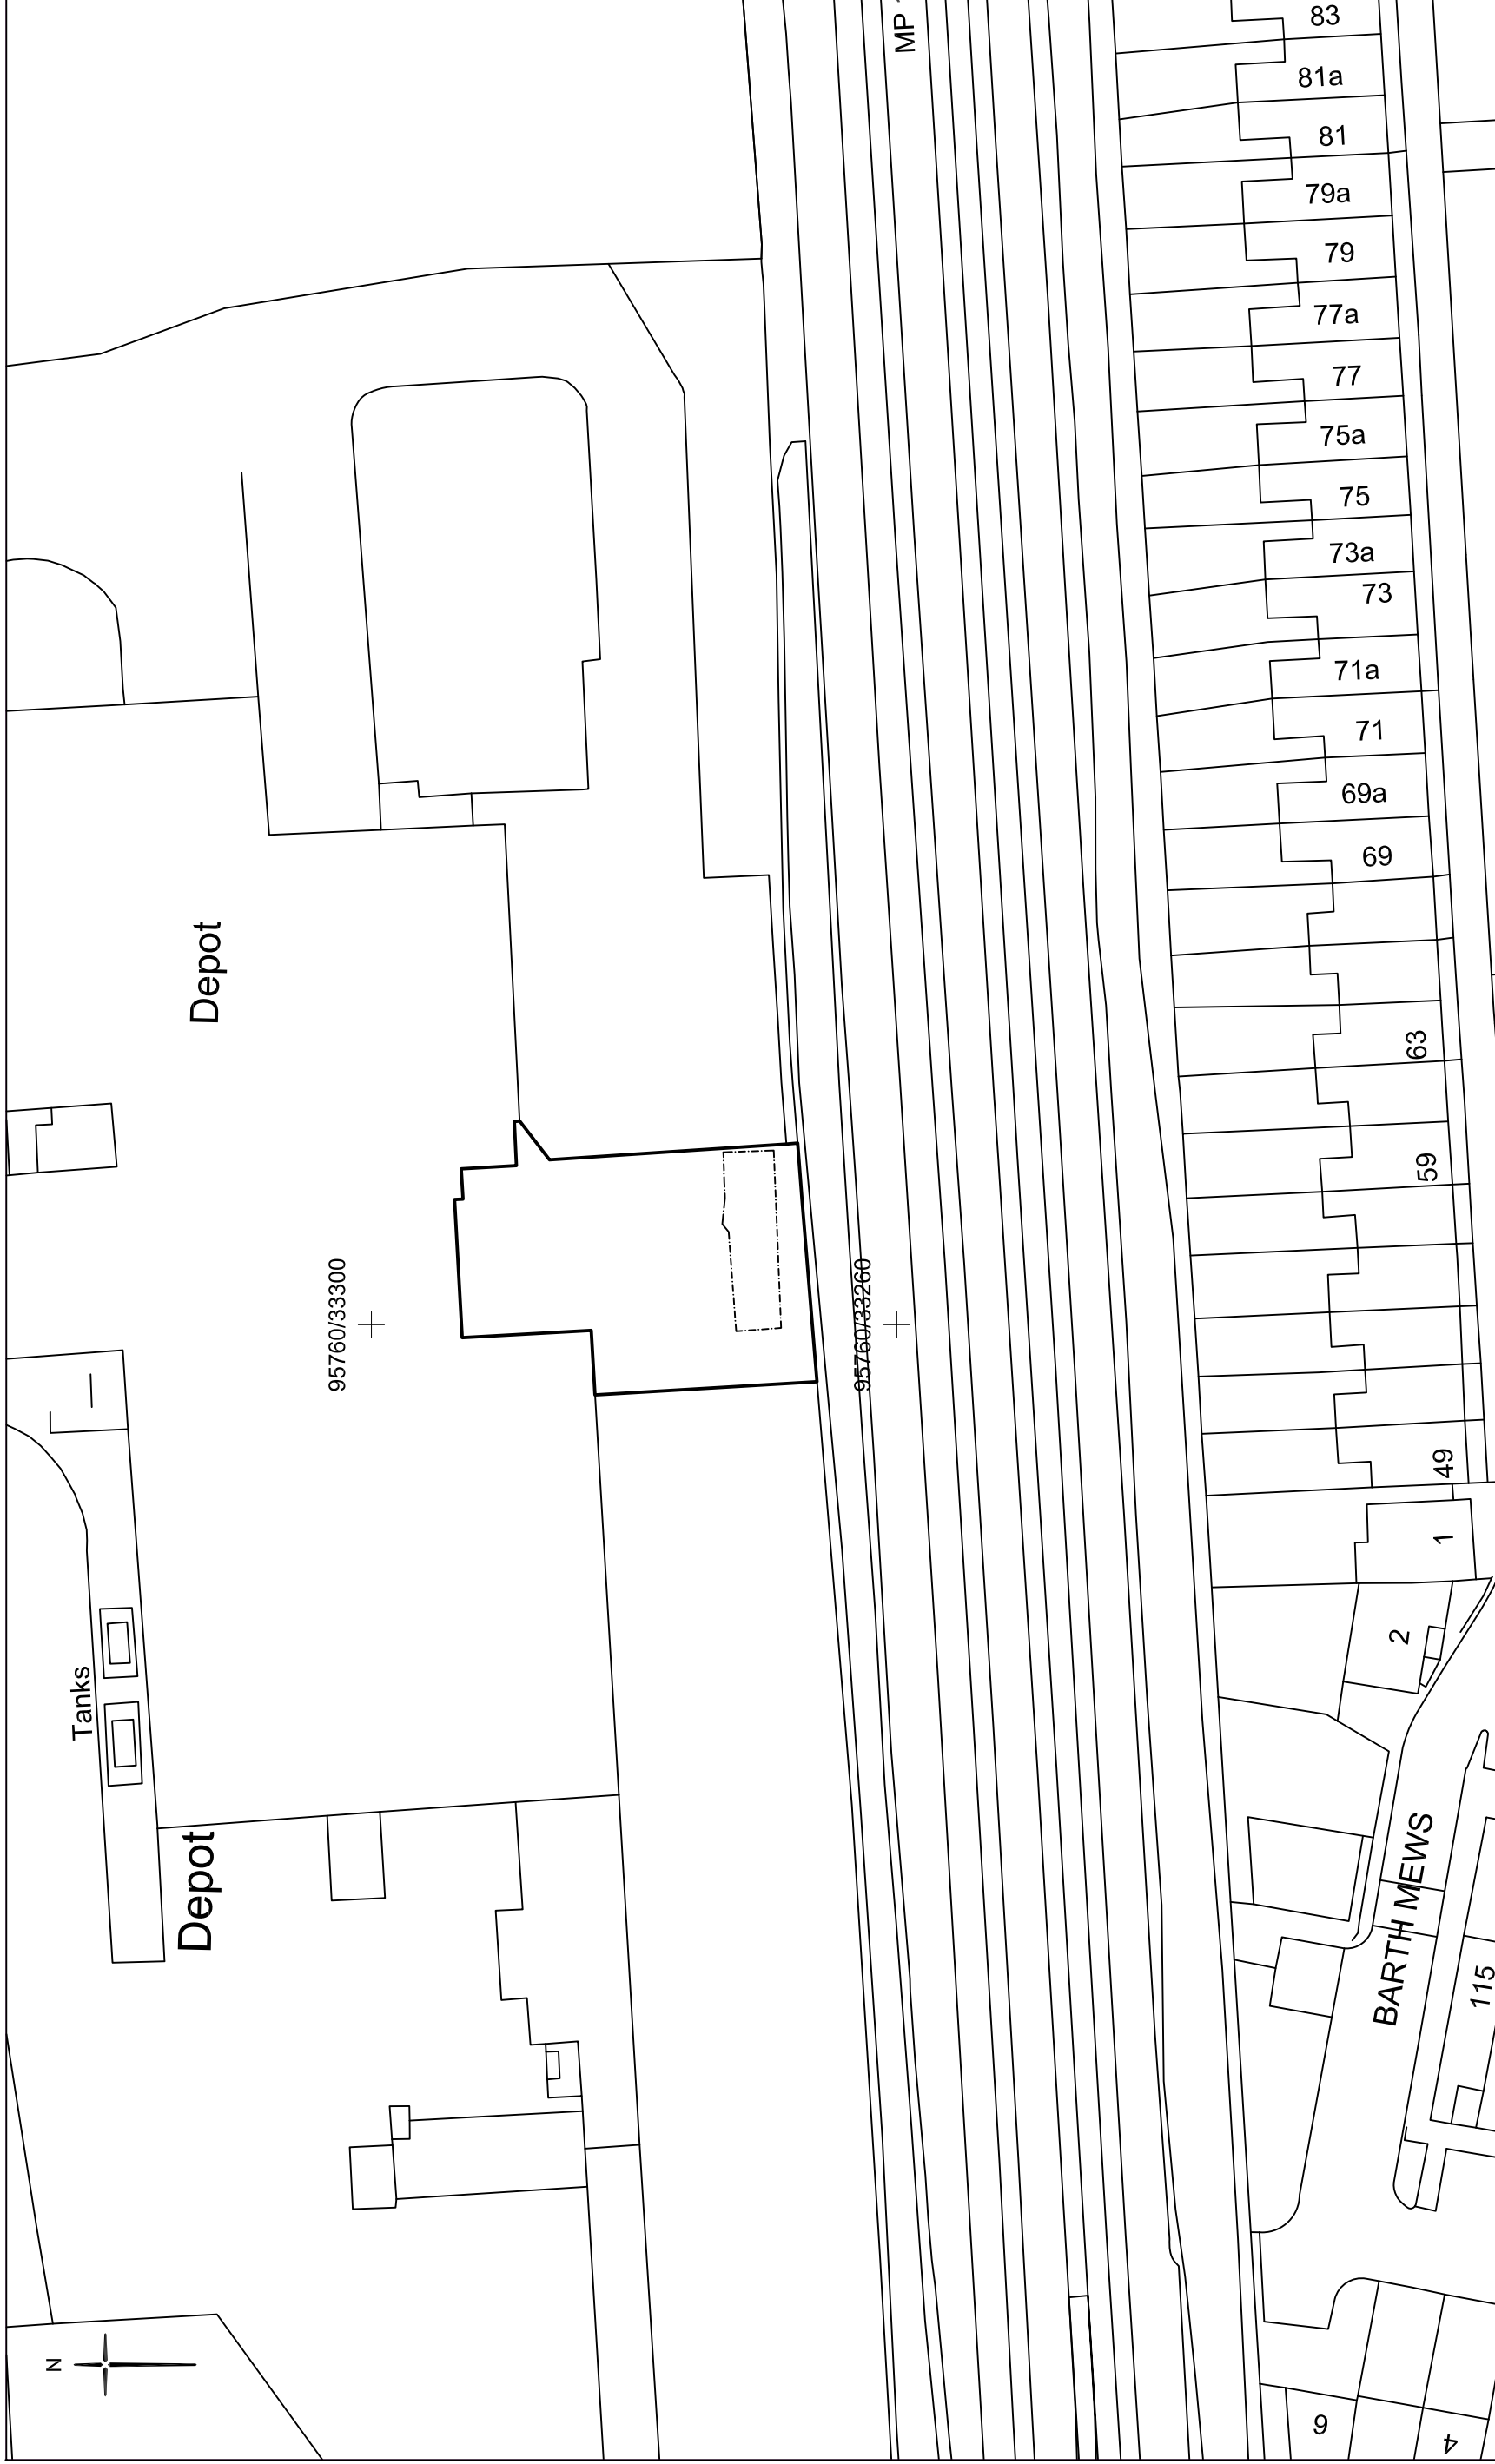
Fig 7 The location of the sub-surface recorded features within worksite east

Within worksite east and to the south of the Grade II Listed former Council Depot building (LB UID 487648), the ground works undertaken in preparation of the Plumstead Portal revealed a substantial brick structure, the former base of a chimney, with an equally substantial concrete structure to the west (see Photo 32). Both structures continued north beyond the limit of excavation. At their highest they lay 0.10m below the present ground surface. The excavation was located approximately 11.m to the south of the central corner of the Depot building where its southern wall returns northwards, (see Fig 7).
