# C435 Farringdon Main Station

## Monitoring Close-Out Report:

### In-ground Monitoring Section B and Internal Monitoring installed on 66 Cowcross St.

**CRL Document Number: C435-BFK-C2-RGN-M123-51605**

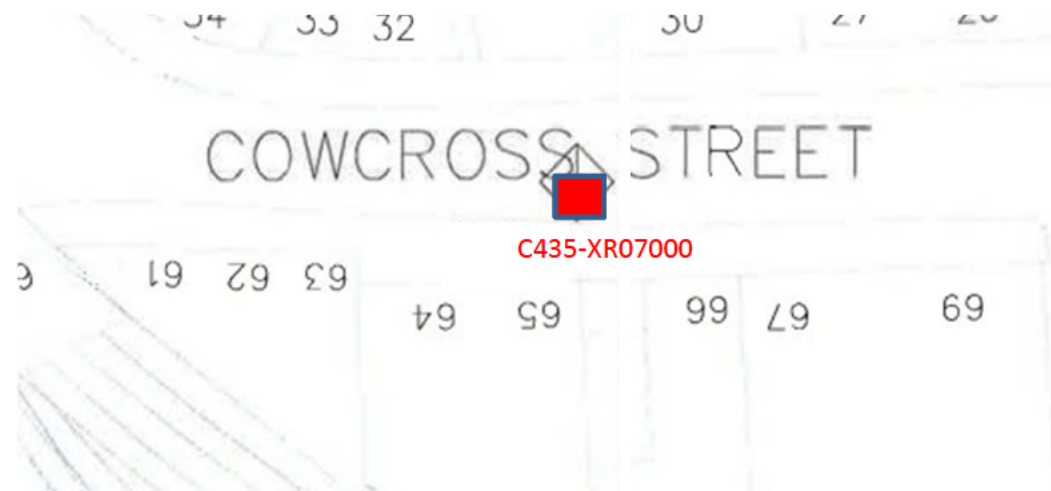
REMARKS: The first reading 14m and 9m are mistakes rebase line required. Three readings taken between 25-09-2014 and 14-11-2014 show bad readings. Some grouting episode was carried out on this period.

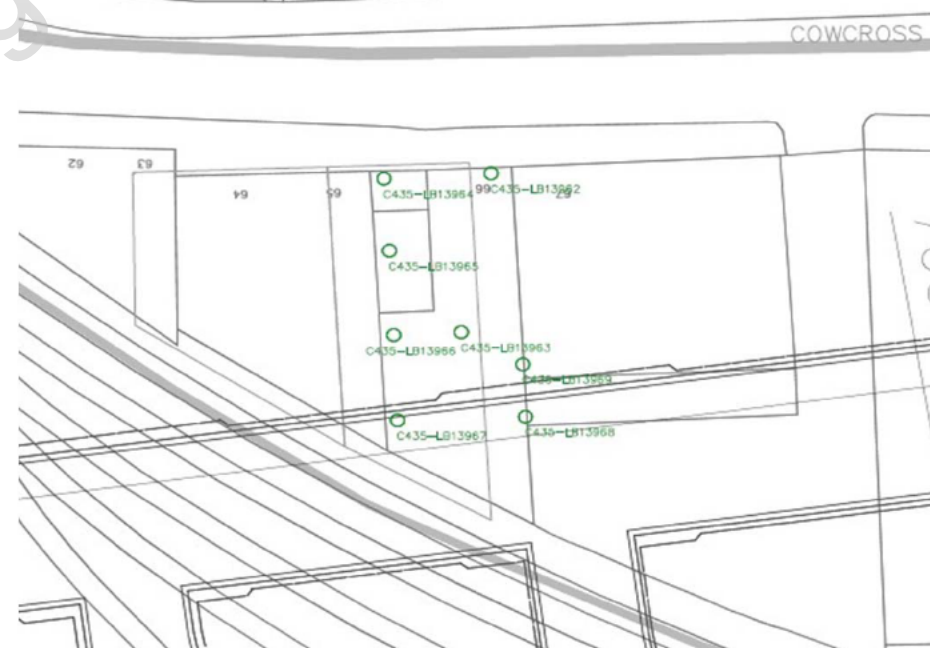
**REMARKS:**No access to the reference point between December 2014 and April 2015. This point was covered by boxes.
