C435 Farringdon Main Station

Monitoring Close-Out Report: Extensometers XR04000, XR05000, XR08000, XR09000 and XR25000.

CRL Document Number: C435-BFK-C2-RGN-M123-51671

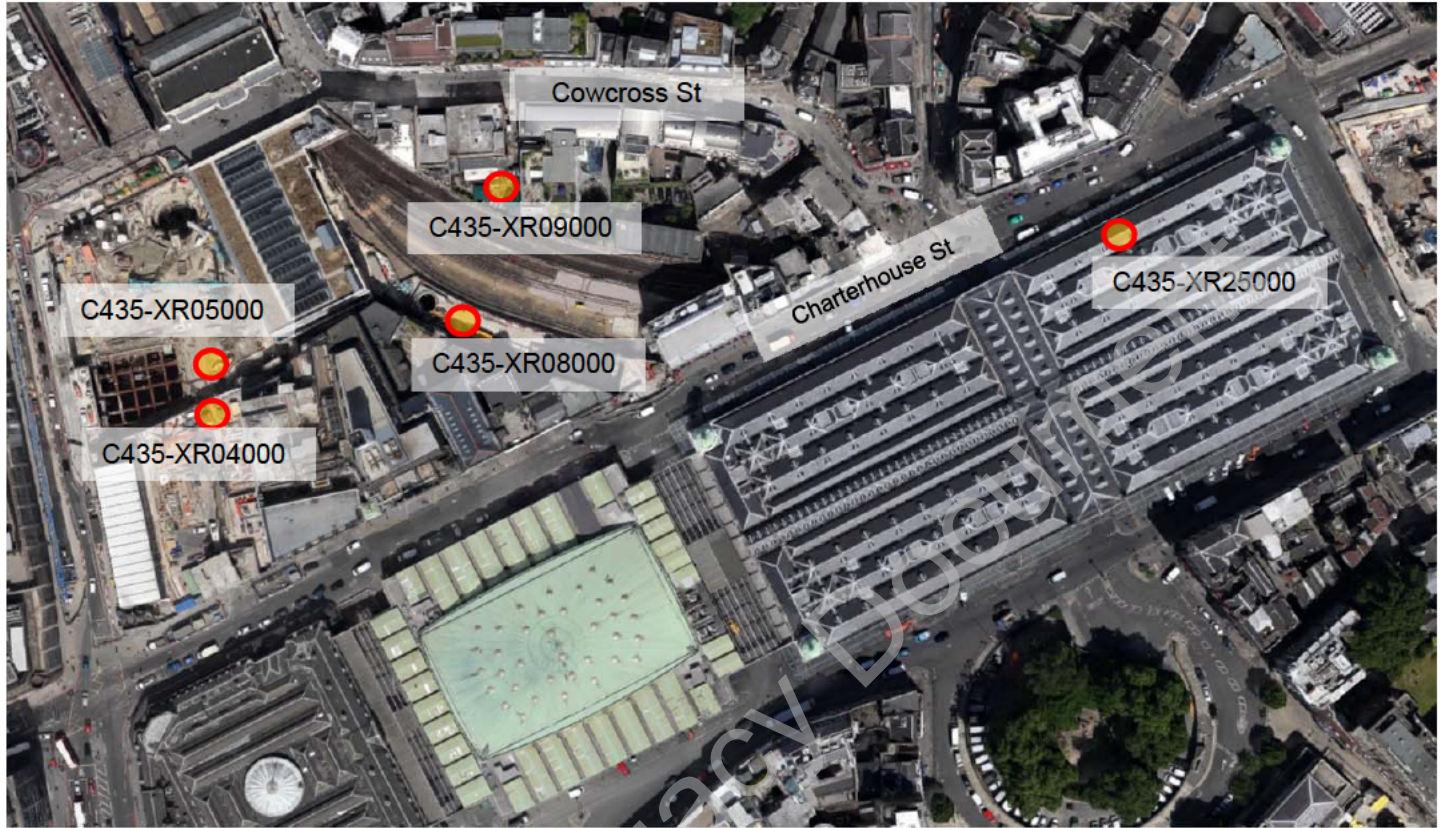
Figure 1 – Plan showing the Location for the Extensometers.

In ground device is located on the plan below highlighted in yellow.
