Damage assessment and monitoring for buildings on the Elizabeth line

Synopsis

The Elizabeth line, due to open in December 2018, crosses London from west to east. The Crossrail project to construct the Elizabeth line has seen 21km of twin-bored tunnels constructed under central London, with eight new stations built on this section.

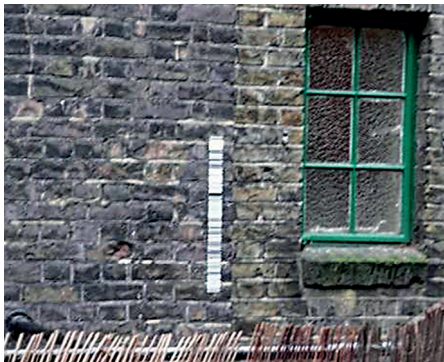
a) Invar scale on building facade – used for precise manual levelling

Techniques used included manual monitoring using studs and Invar calibrated scales (Fig. 9a); automated monitoring of prisms (Fig. 9b); hydrostatic levelling cells (Fig. 9c) and tiltmeters; and, at a later stage, satellite technology to look at ground movements in specific areas. This is an area where there are continuing developments and some changes might be anticipated for subsequent projects.

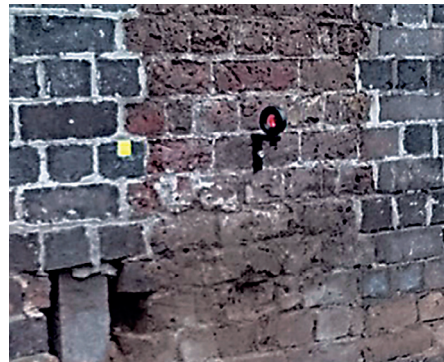
b) Prism on building facade – part of automated monitoring installation using Automated Total Stations

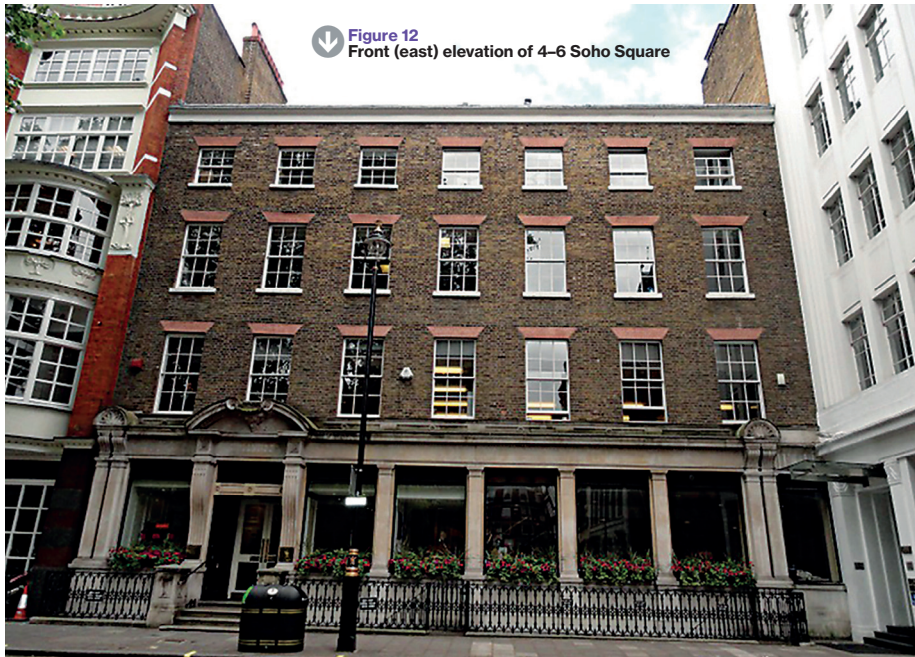
Figure 12
Front (east) elevation of 4-6 Soho Square

The original building fronting Soho Square (Figure 12) is linked to 6 Dean Street on the west side. It was originally constructed as a warehouse c.1801-04 for John Trotter, 'store-keeper general' for army supplies during the Napoleonic wars. The warehouses were altered in 1816, when Trotter converted them into a 'bazaar'. The shop front and ground-floor level were reconstructed c.1890. At that time, there was an open area between the rear of 4-6 Soho Square and the rear of 6 Dean Street. This phase of the building is of loadbearing brickwork with timber floors. It is four storeys at the front on Soho Square and three storeys at the rear on Dean Street; a vaulted brick basement with a concrete slab occupies the entire site.
