◀ HEALTH & SAFETY ALERT ▶

Misuse Failure on Forklift Lifting Attachment/Bridle

Conquip has identified a potential misuse failure mode with their FA809 fork attachment following an incident on Crossrail

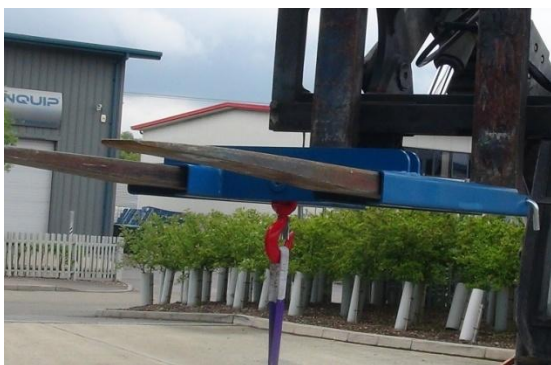
Forks and FA809 fork attachment orientated horizontally.

Hook lifting ring hangs vertically

The FA809 is intended for use on horizontal forks for only vertical lifting over short distances. If the attachment is inclined from ground orientation or manoeuvrability of the forklift type there is potential for the hook lifting ring to touch (and become restrained by when 'under load') the mounting frame. This is known to cause undue lateral stress on the lifting ring that may cause it to fail. **To avoid this potential failure the FA809 must be only used for vertical lifting on horizontal forks.**

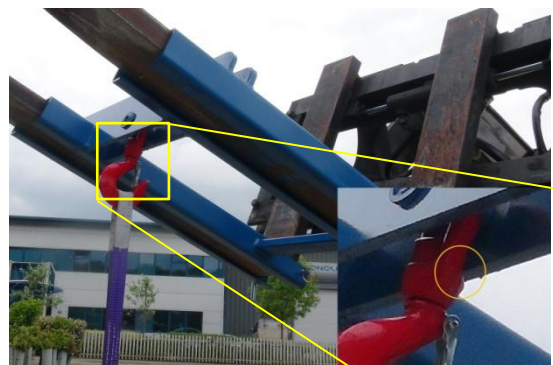
Forks and FA809 fork attachment in raised mode.

Hook lifting ring restrained against the attachment frame

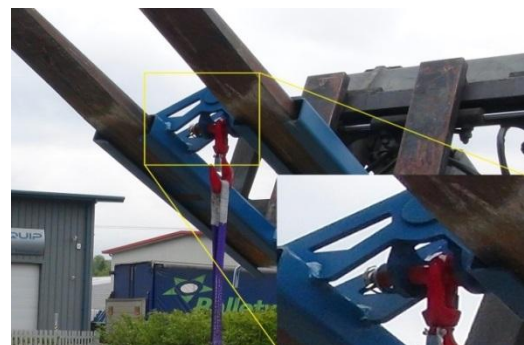
NEW FA810 with universal joint

Conquip have introduced the FA810 that supersedes the FA809.

The FA810 has an improved mounting to compensate for any elevation of the forks from horizontal that eradicates failure potential of the hook lifting ring.
