C131 - PADDINGTON INTEGRATED PROJECT

HISTORIC BUILDING RECORDING – PIP TRIANGLE SITE

Document Number: C131-MMD-T1-RAN-B071-00002

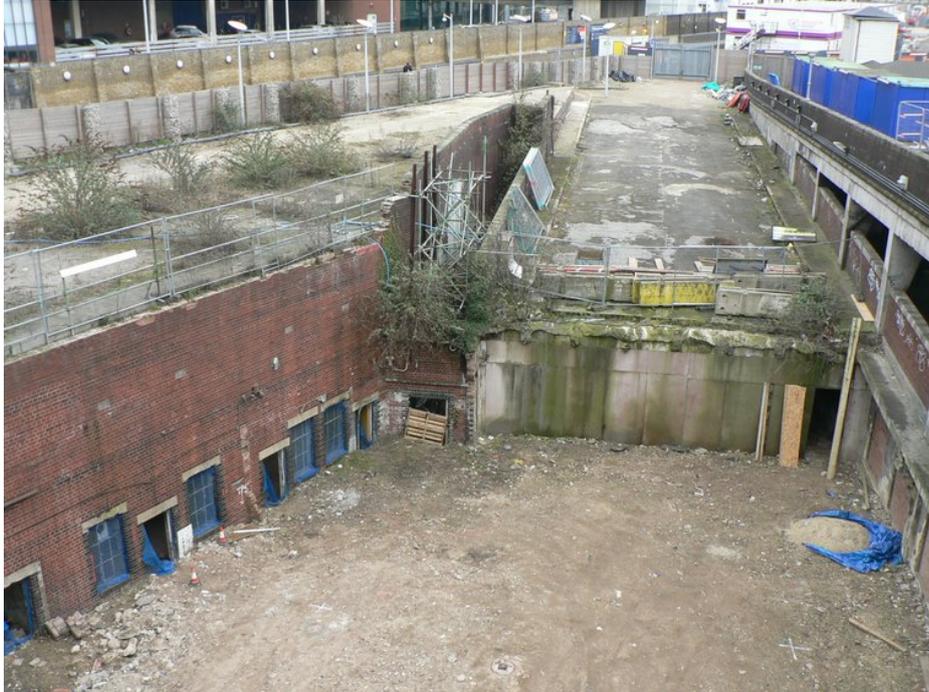
Plate 1 - View towards Goods Ramp (right) and truncated vaults (left) from Bishop's Bridge Road

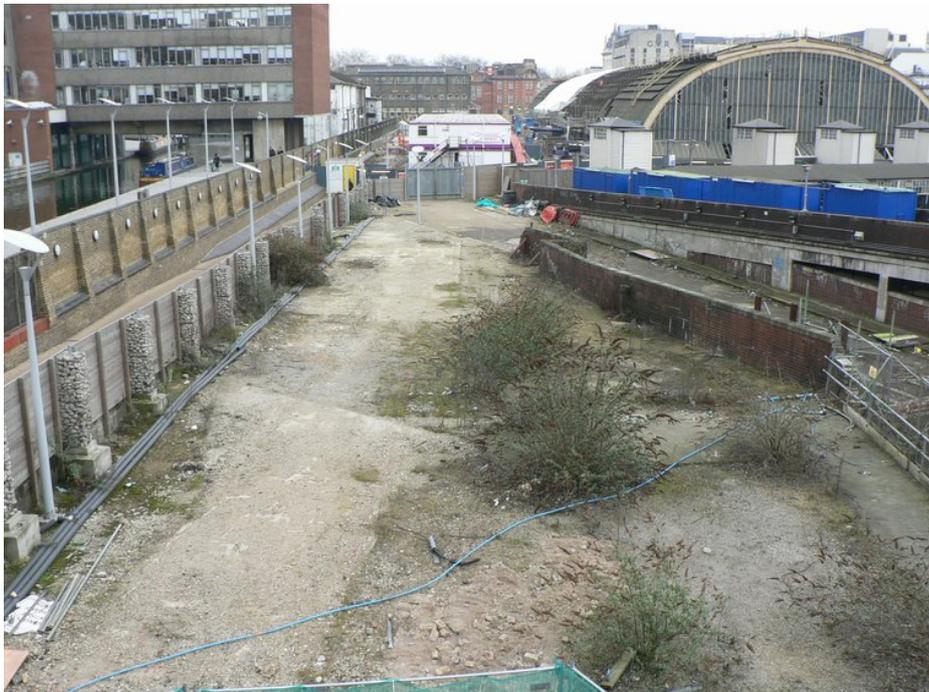
Plate 2 View towards Upper Triangle site from Bishop's Bridge Road, note the shunt tunnel (obscured by concrete here) is located to the far end of the picture near the parapet wall

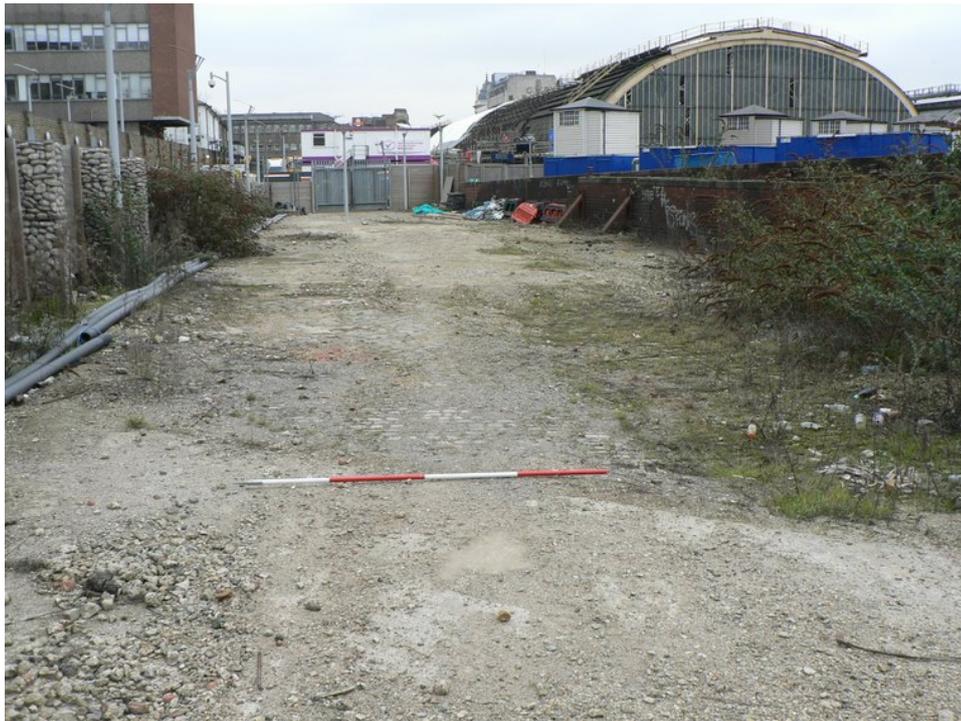
Plate 3 View across Upper Triangle site towards Paddington Station

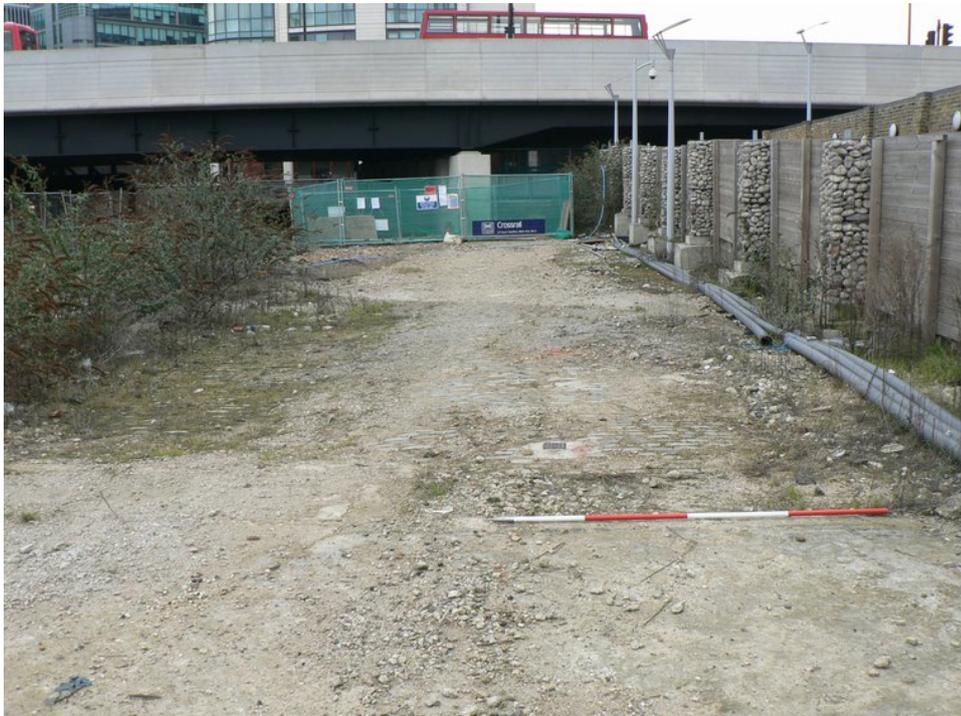
Plate 4 View across Upper Triangle site towards Bishop's Bridge Road

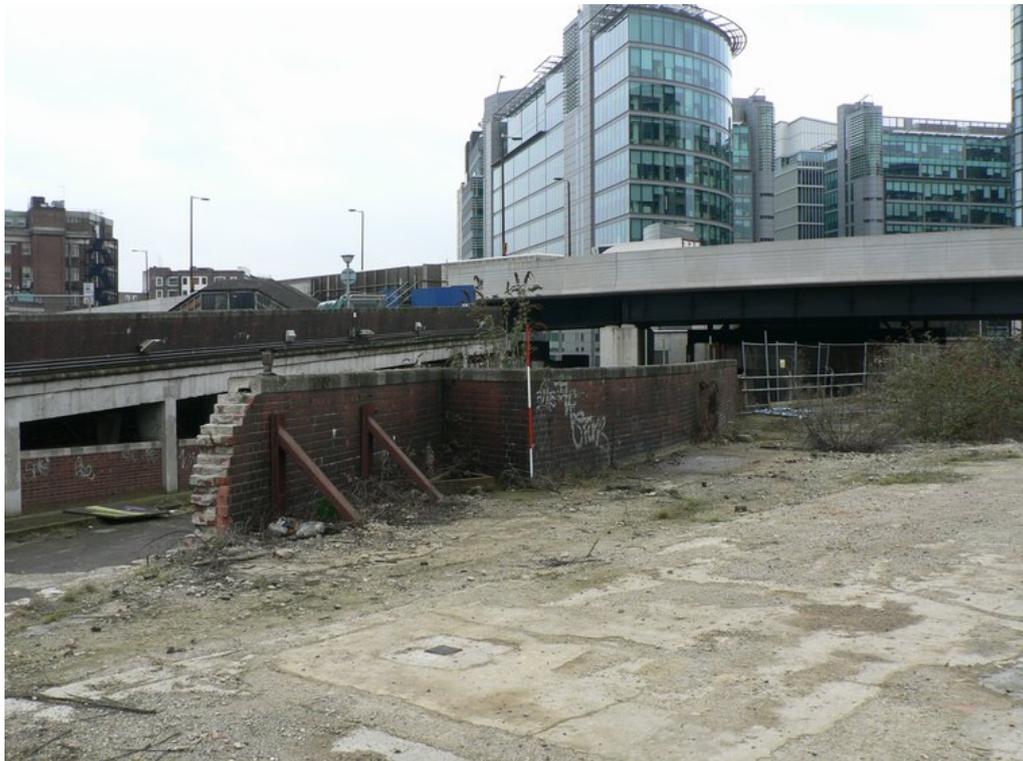
Plate 6 – View towards good ramp showing parapet wall and concrete base to former police station

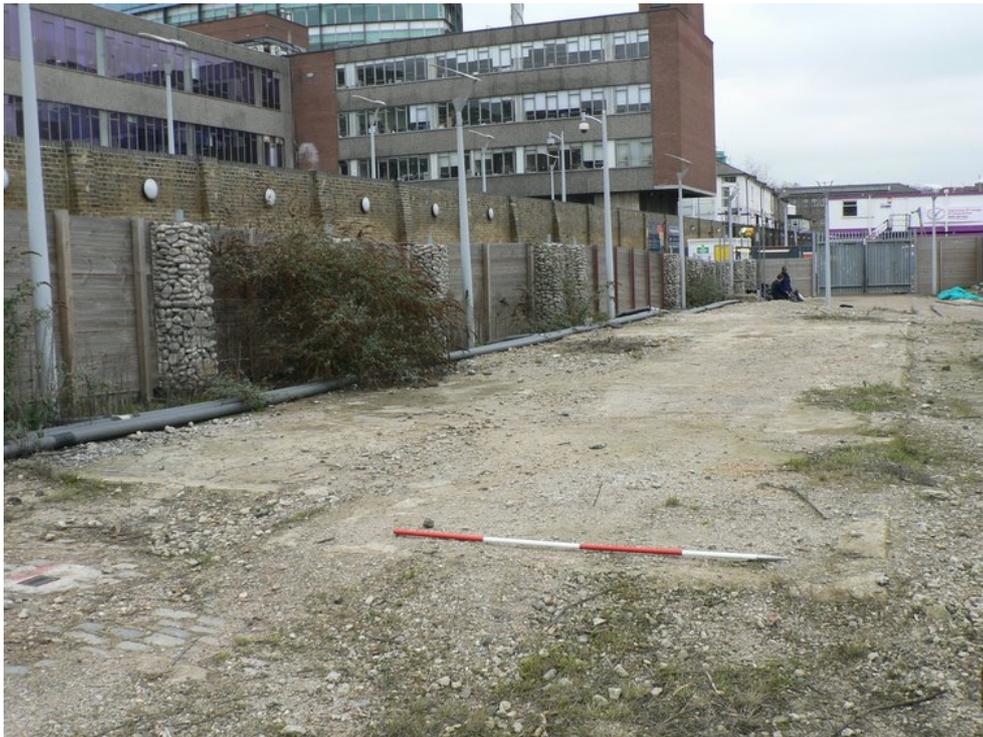
Plate 7 – Upper Triangle site showing concrete base to former police station and granite sets to front of photograph

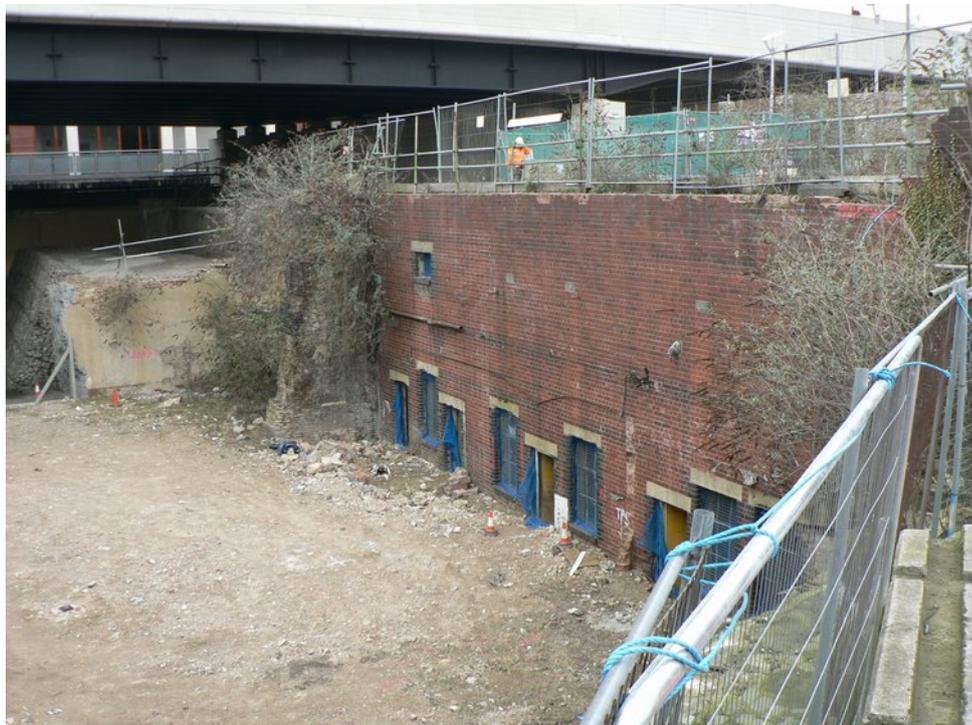
Plate 8 – View from Goods Ramp towards truncated vaults

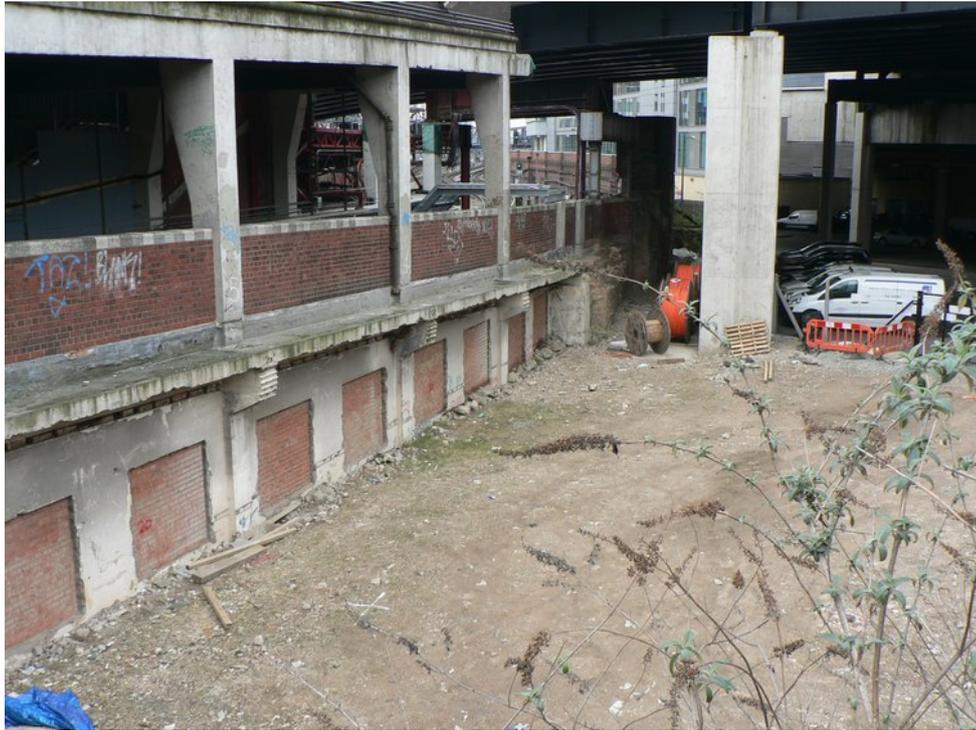
Plate 9 – View from Goods Ramp showing Lower Triangle site

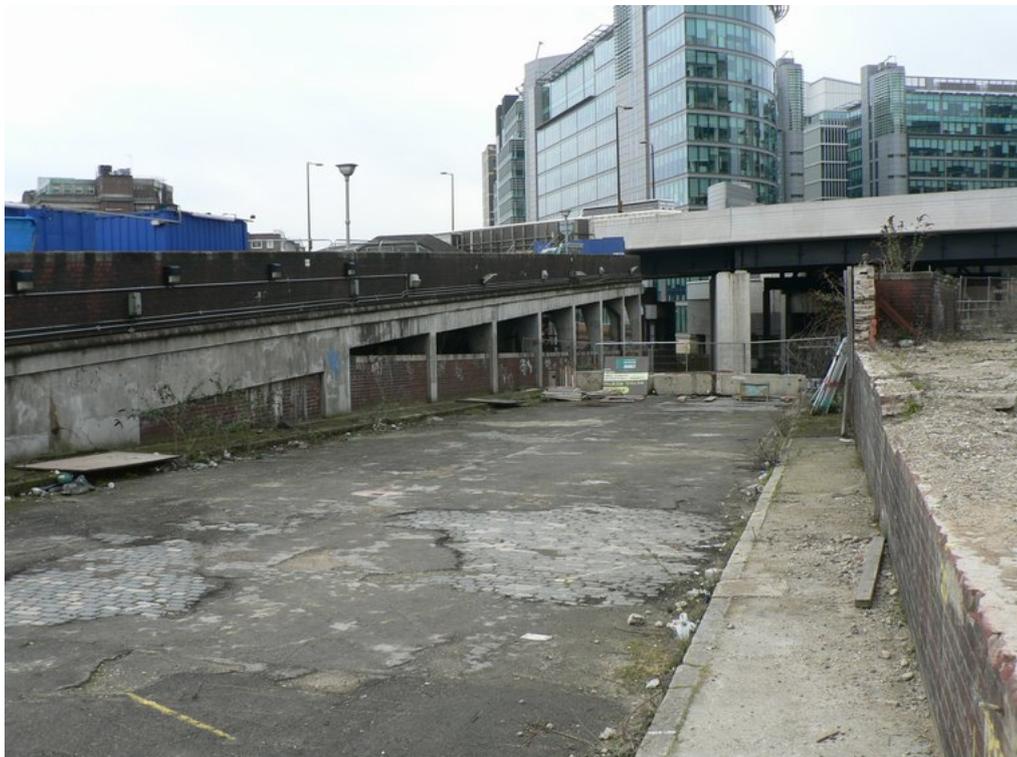
Plate 12 - View down Goods Ramp towards Lower Triangle site

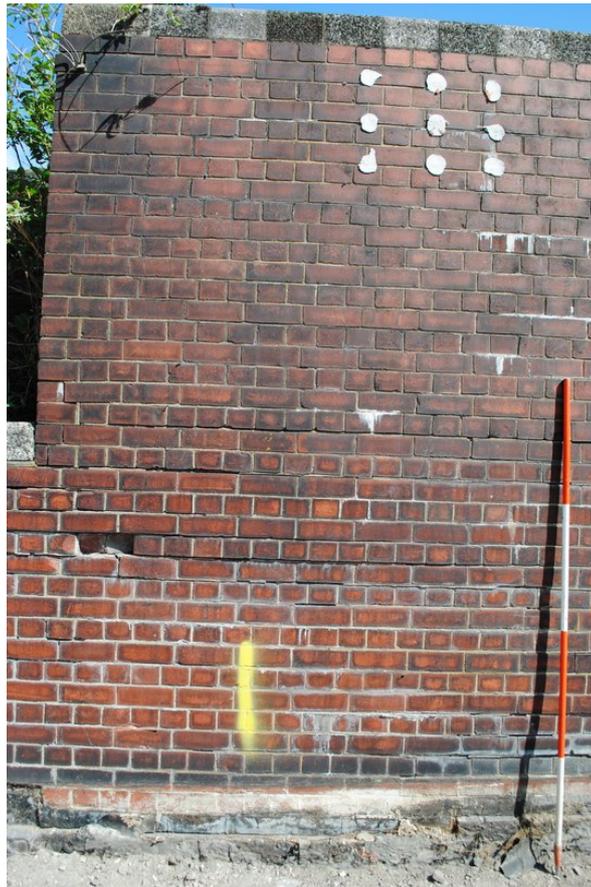
Plate 13 – View of parapet wall from Goods Ramp

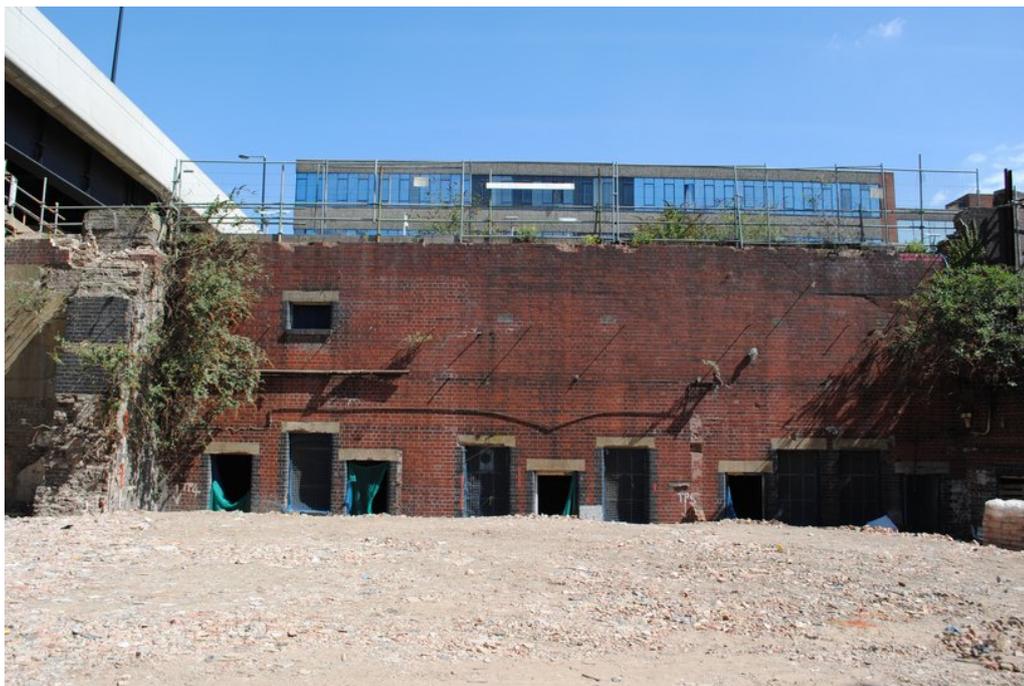
Plate 14 – View towards truncated brick vaults

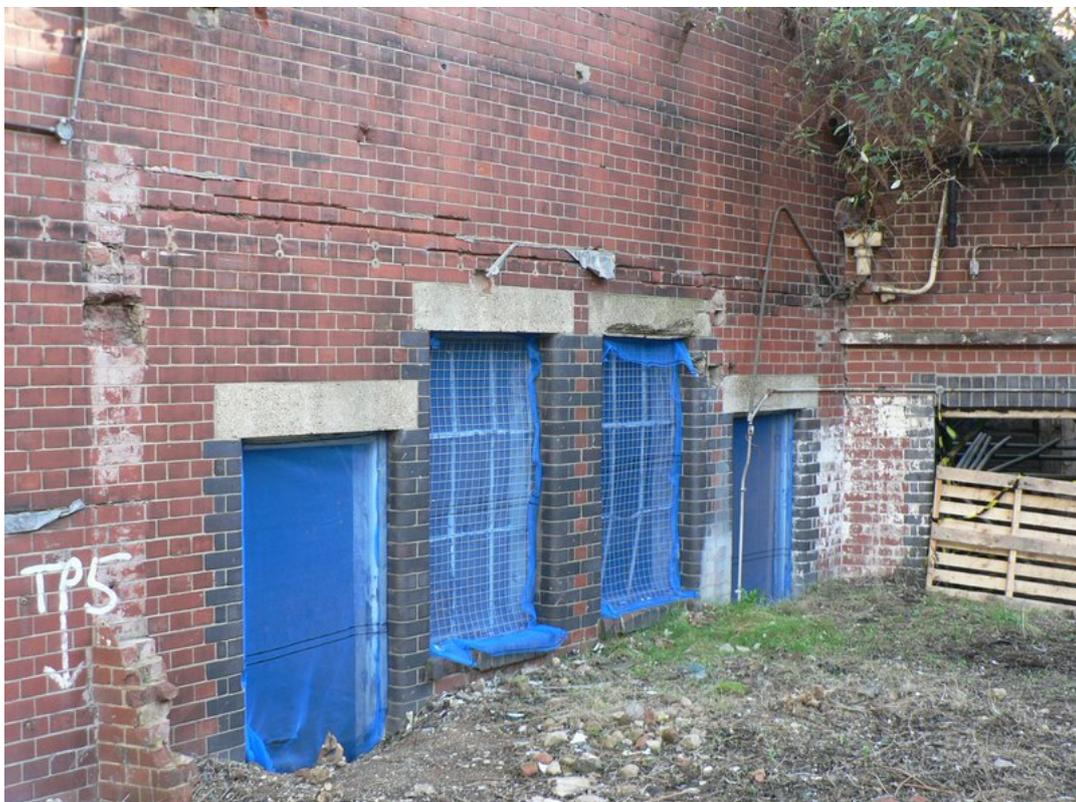
Plate 16 – Detail of openings to Vault 3

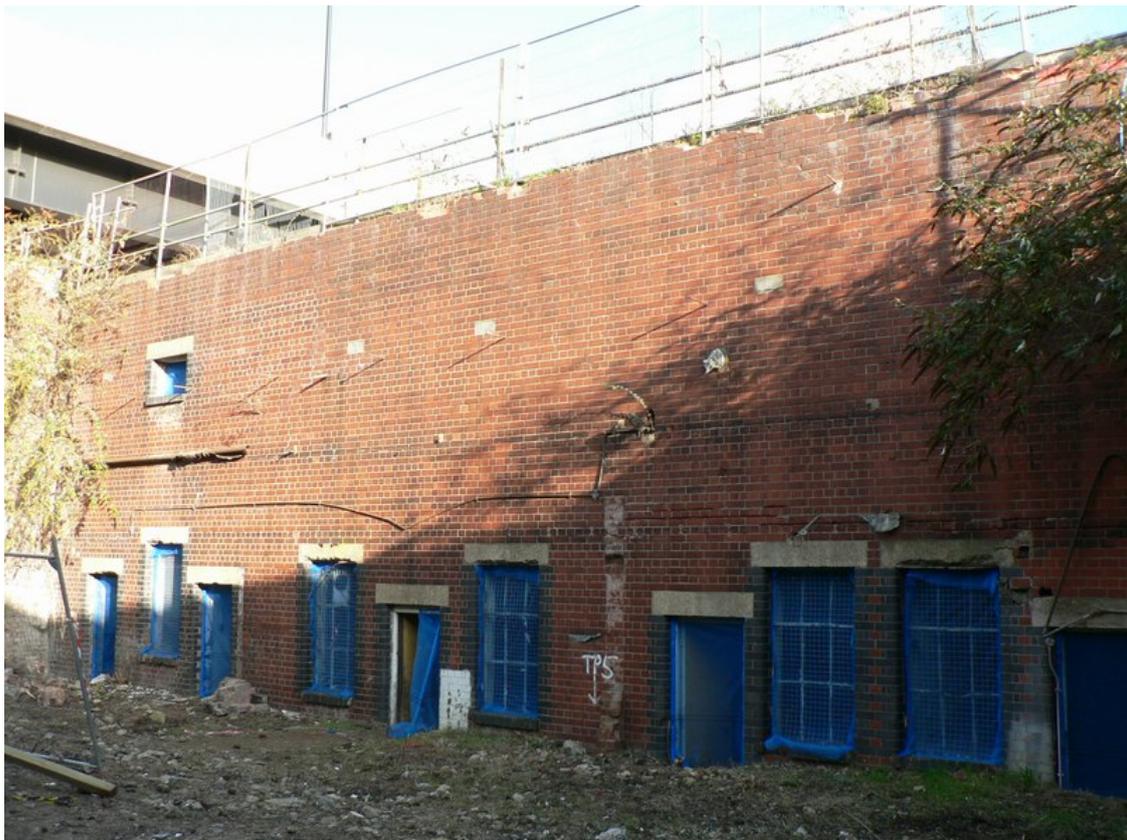
Plate 17 – Facade of refaced and truncated brick vaults

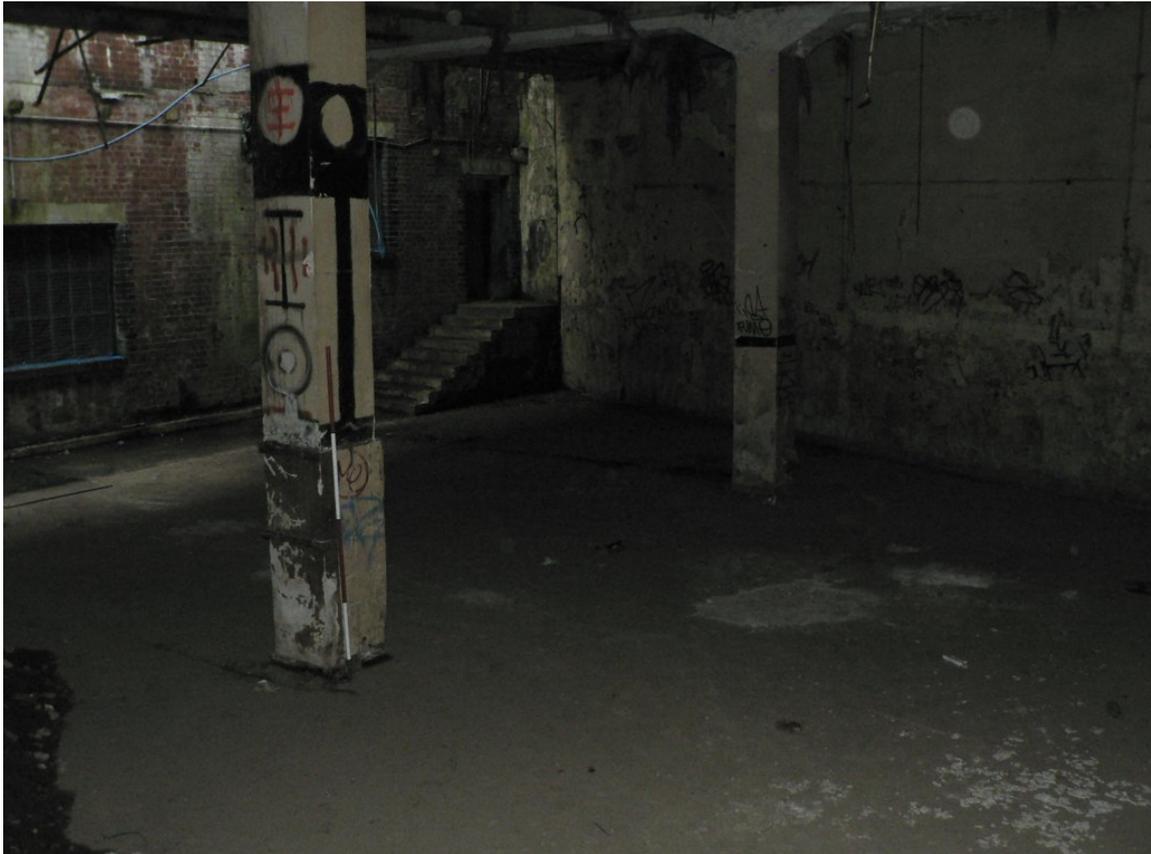
Plate 20- View towards Vault 6 taken in former dining room

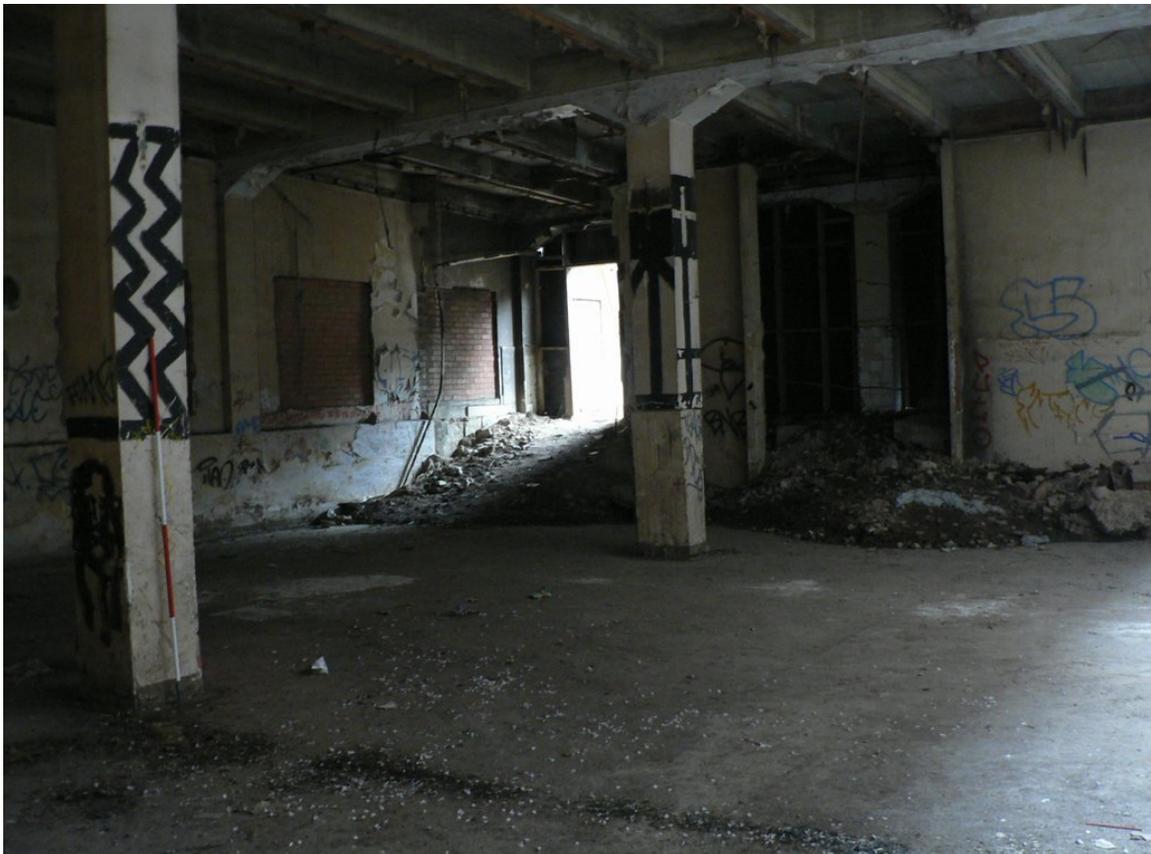
Plate 21 – View from Vault 6 through dining room

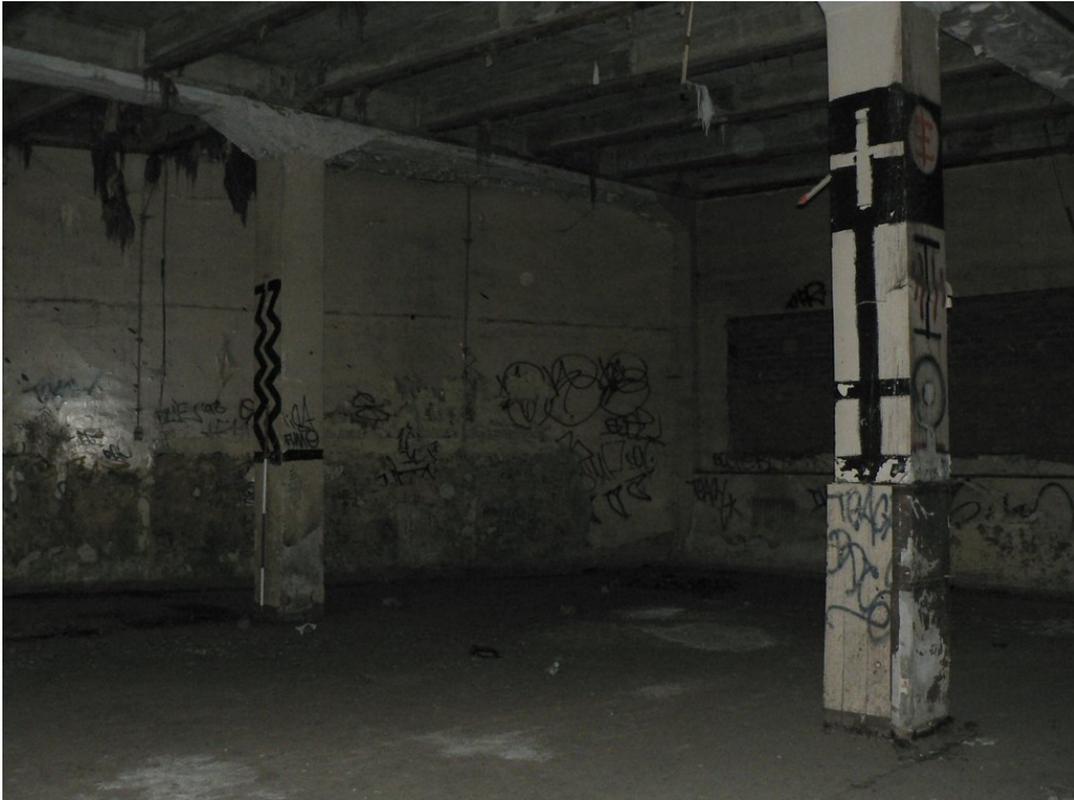
Plate 22 – View showing internal stanchions of dining room, far wall to left lies western section of Vault 7

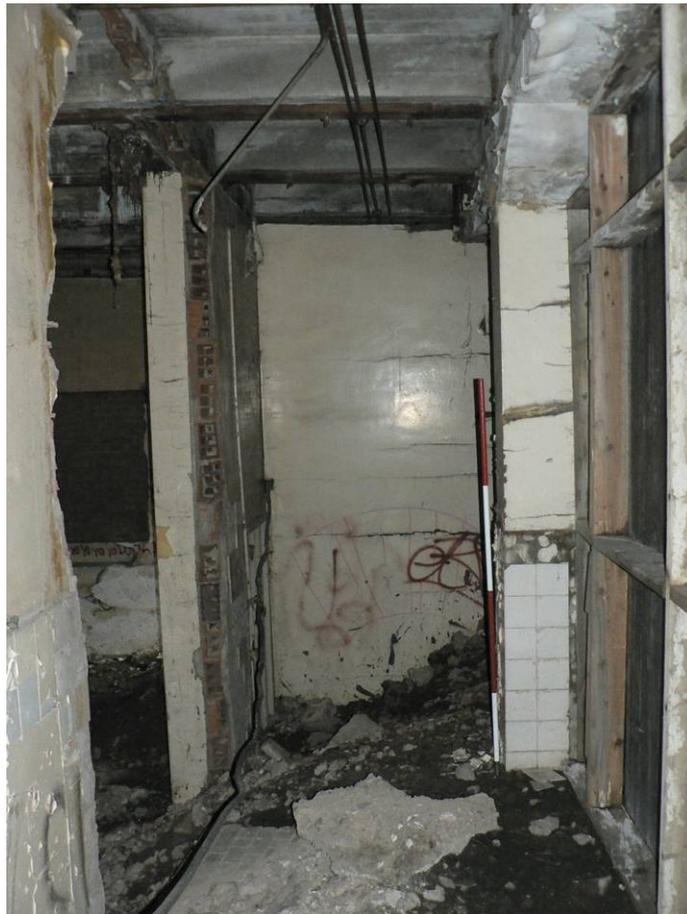
Plate 24 – Former 1930s office space to west of dining room

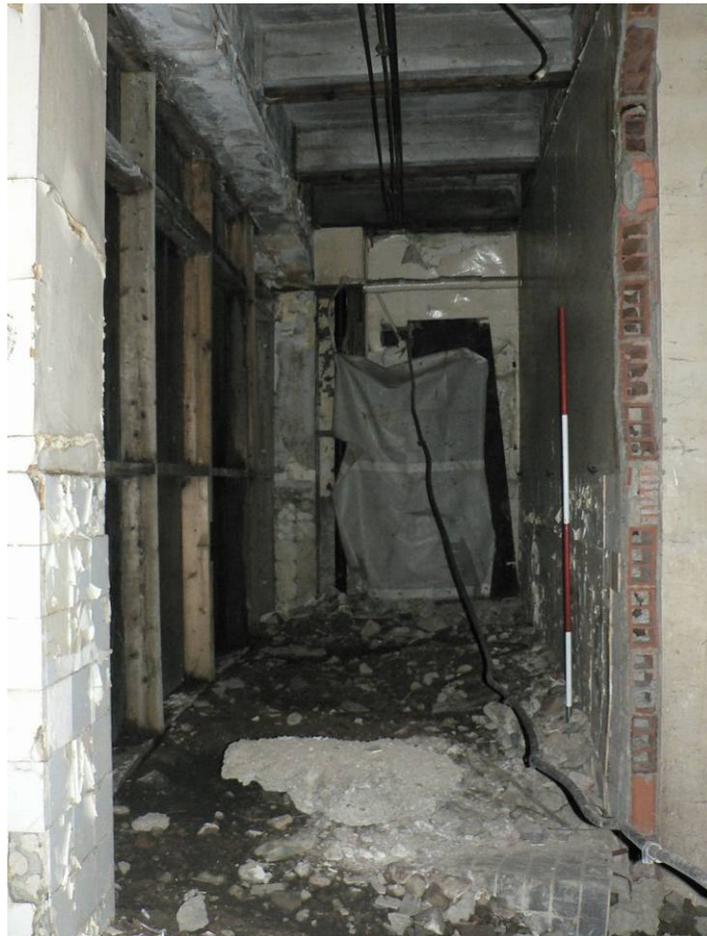
Plate 25 - Former 1930s office space to west of dining room

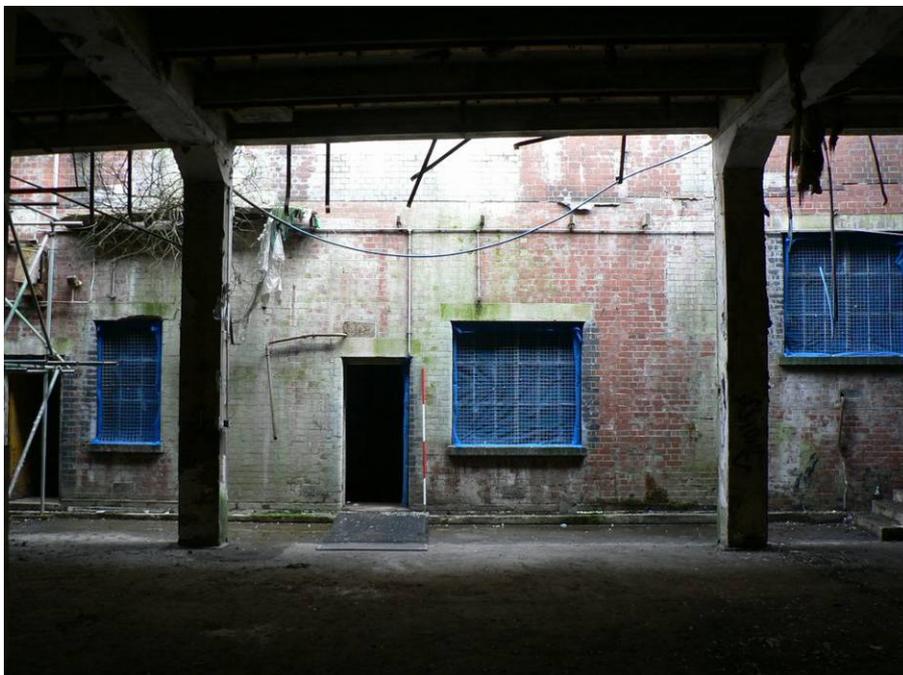
Plate 27 – Façade of Vault 5

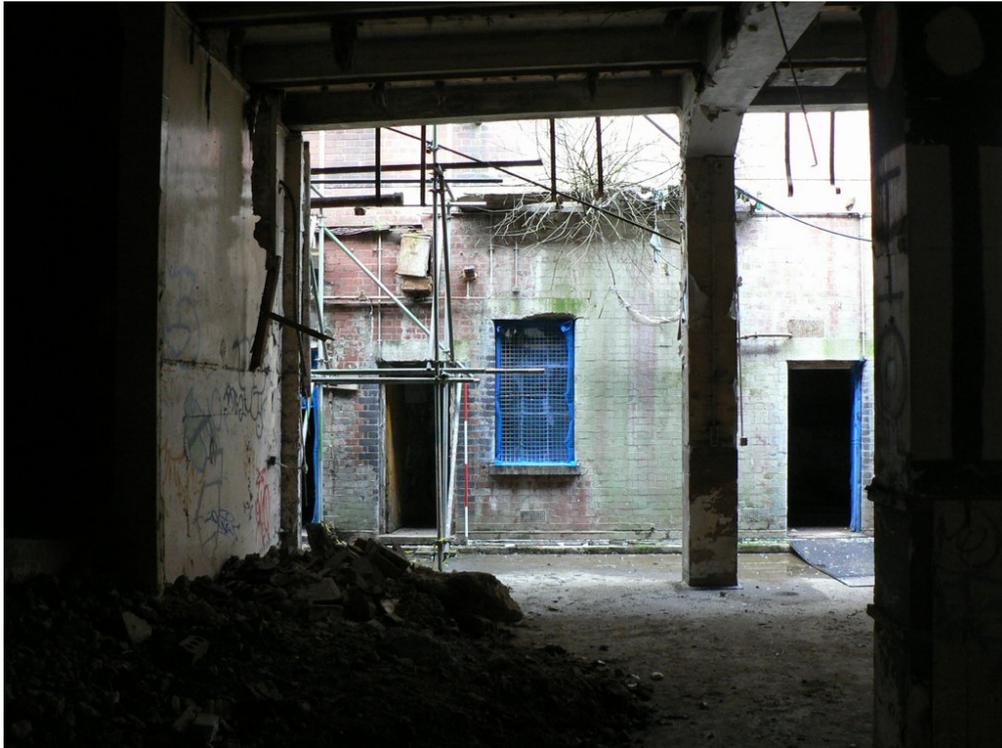
Plate 28 – Façade of Vault 4

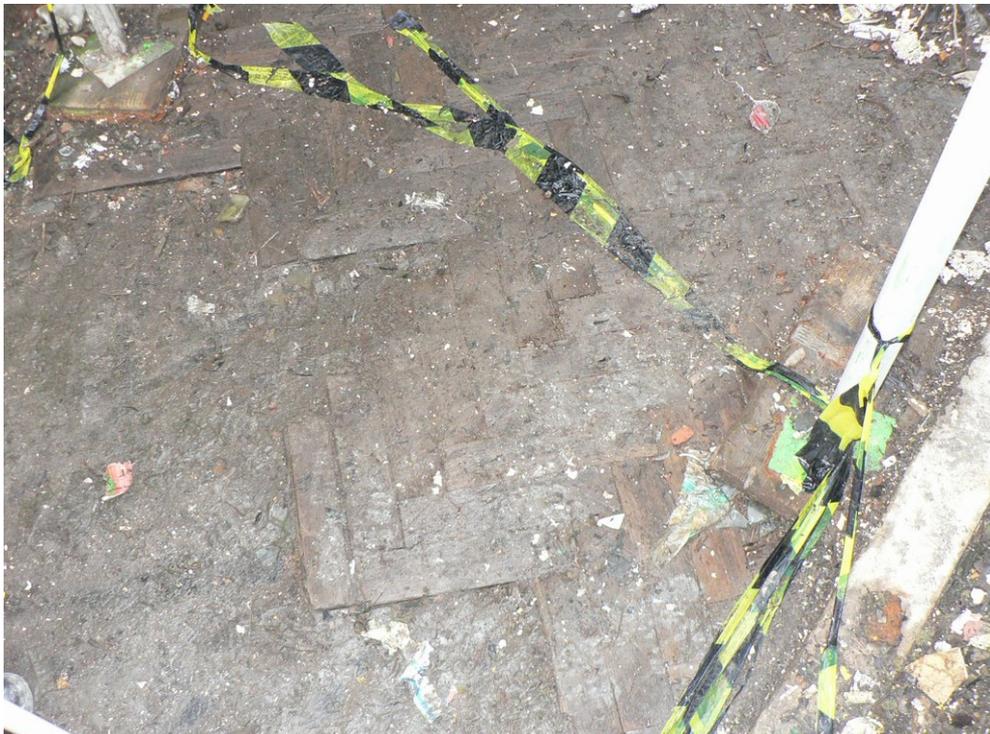
To the north of the dining area are further brick fronted vaults of the same design as the ones fronting onto the open yard (plates 26-28). Vault 6 is visually different to the others vaults however in that it features a relatively wide stairway to its entrance door. Other items of note in this area include remnants of parquet flooring outside vault 4 (plate 29).

Plate 29 – Parquet flooring outside Vault 4

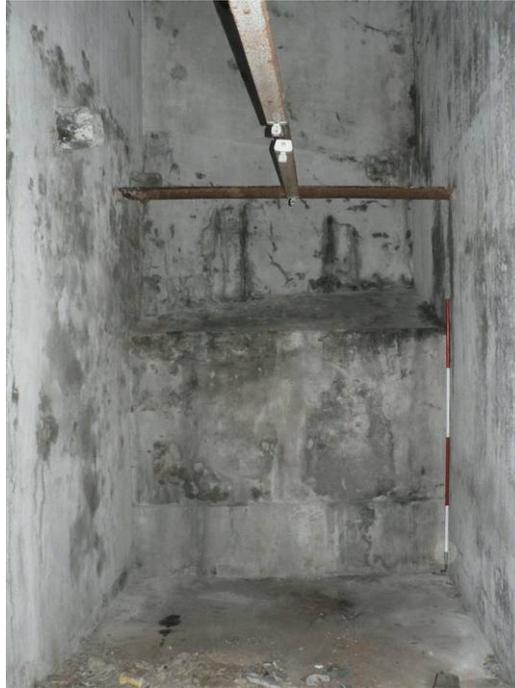
Vault 1 is partitioned into a western and eastern room. The western room had been completely encased in concrete and retains some ceiling fixtures dating the mid 20th century. Historic plans show this room to have been used as a store after the 1930s conversions (Figure 11), although there was a heating system still extant within the room (plate 31). On its northern extent remain sections of a truncated semicircular horizontal buttress, and on its western elevation a number of corbels were still visible (plate 30).

Plate 30 – Concrete lined western section of vault one, note corbel to left and horizontal buttress to rear

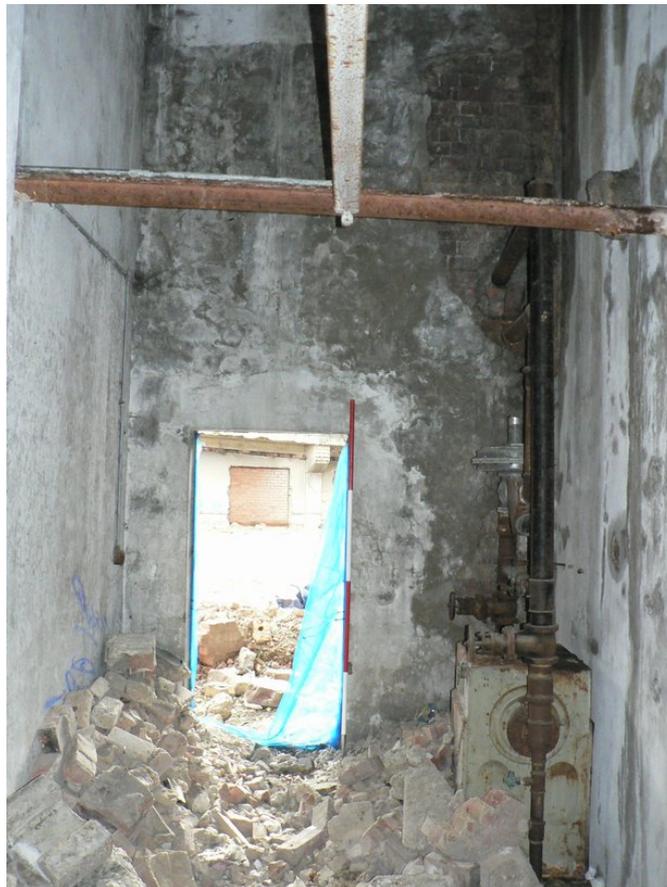
Plate 31 – View towards door in western section. Note heating apparatus to right of picture

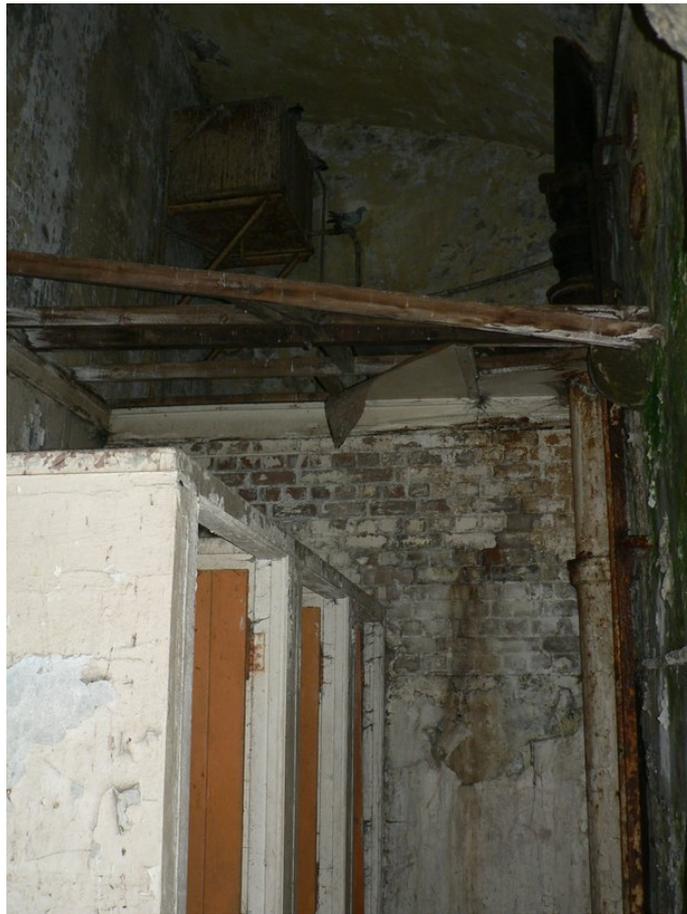
Plate 32 – Eastern section of vault showing modern fixtures and toilet facilities

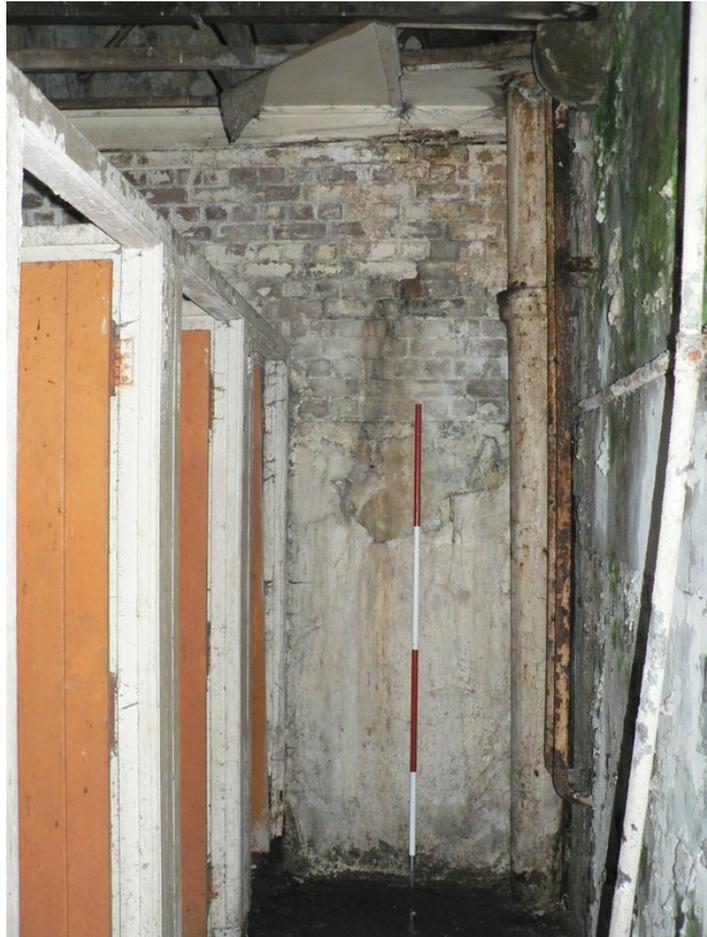
Plate 33 - Eastern section of vault showing modern fixtures and toilet facilities

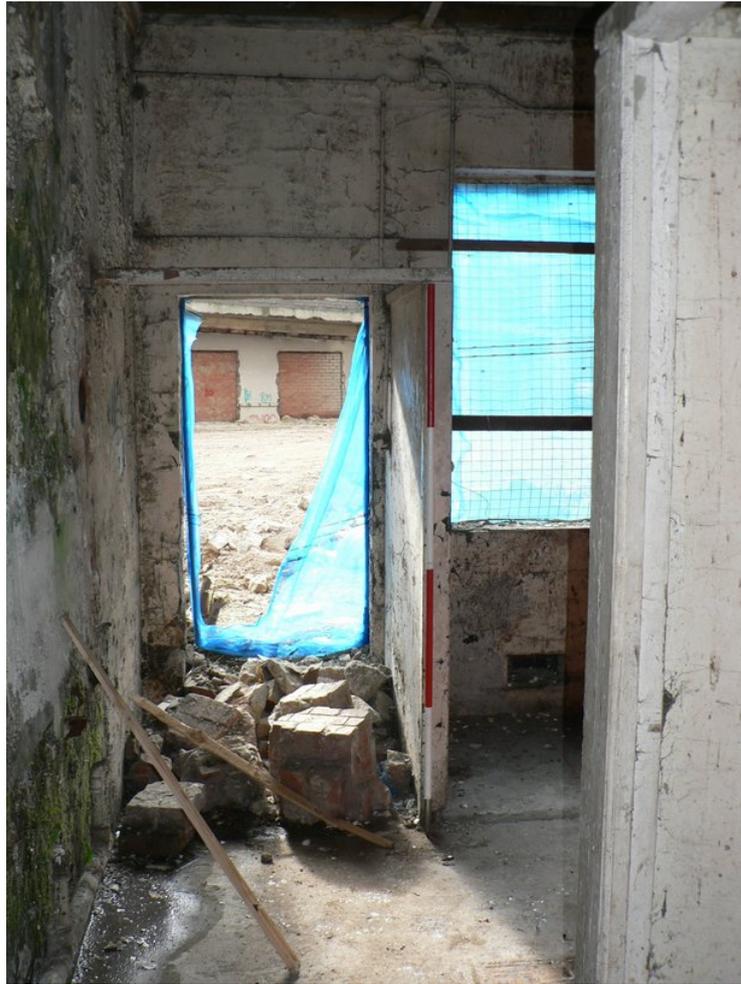
Plate 34 - Eastern section of vault looking towards door

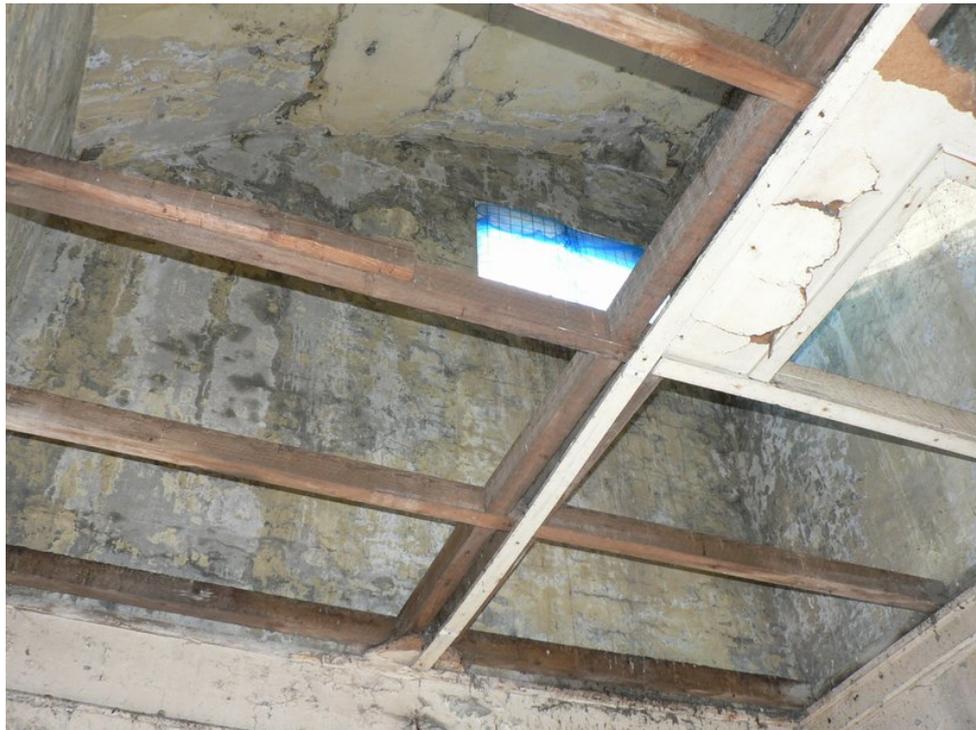
Plate 35 - Eastern section of vault showing ceiling detail and opening for previous upper storey

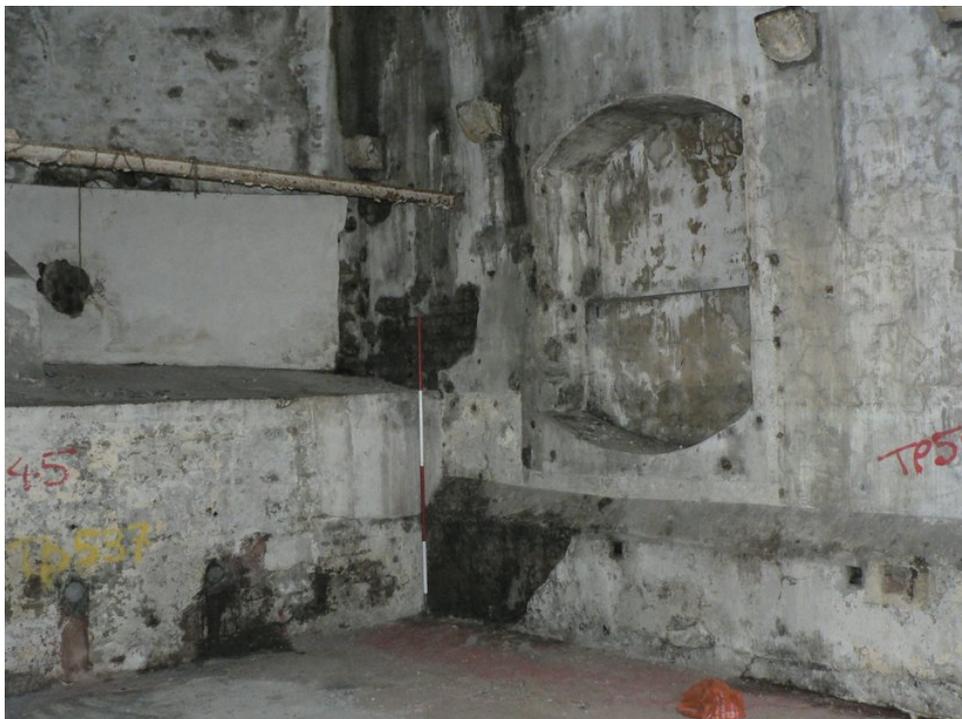
Vault 2 was a much larger space than vault 1 due to there being no partition wall truncating the room. The lack of such wall provided a clearer view of the room's structural arrangement. Again, the room had been entirely cased in concrete obscuring much of the original fabric of the structure. To the north a semicircular horizontal buttress was clearly visible, to the centre of which was located a vertical buttress (plates 36 & 39). Flanking either side of the room on the east and western elevations were two sets of niches. Two of which contained segmental heads and flat bases (plates 38-39), one of similar composition but taller in height (plate 37 & 41) and another with an inverted arch to its base (plate 36). An existing core hole that had penetrated one of these niches showed that the niches were in fact openings originally (plate 40). This is supported by documentary evidence (Figure 11). Also extant in this room were original corbels that would have supported a ceiling structure (plates 36-37).

Plate 36 – View towards inverted niche and buttressing

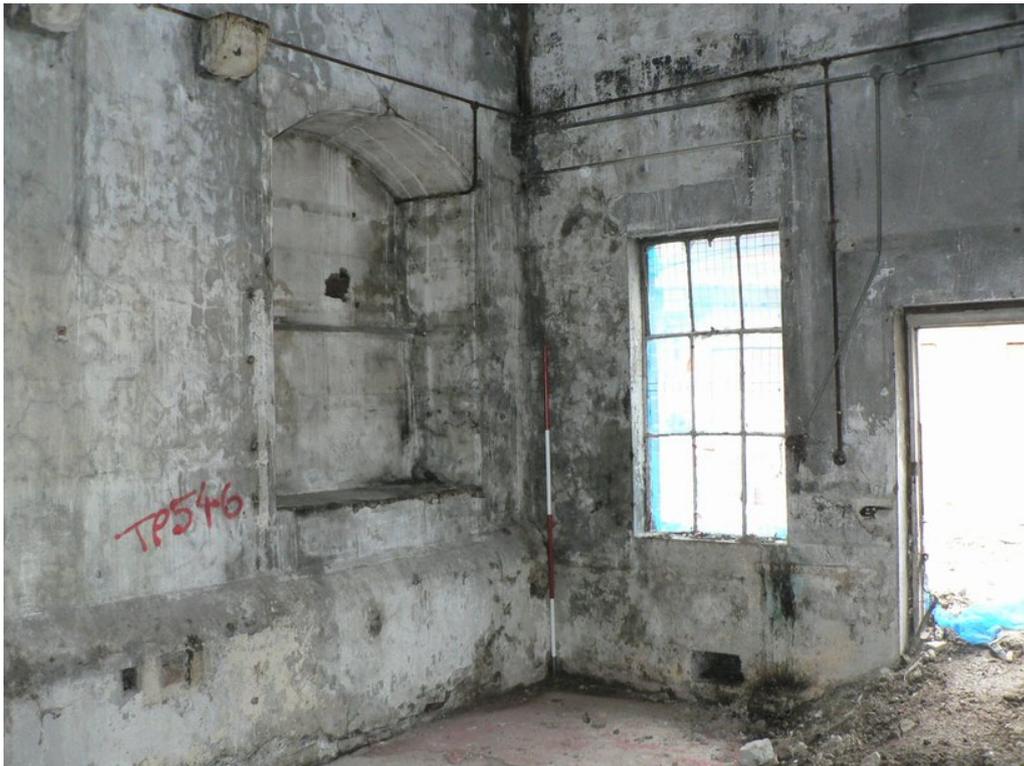
Plate 37 – View showing niche and corbels

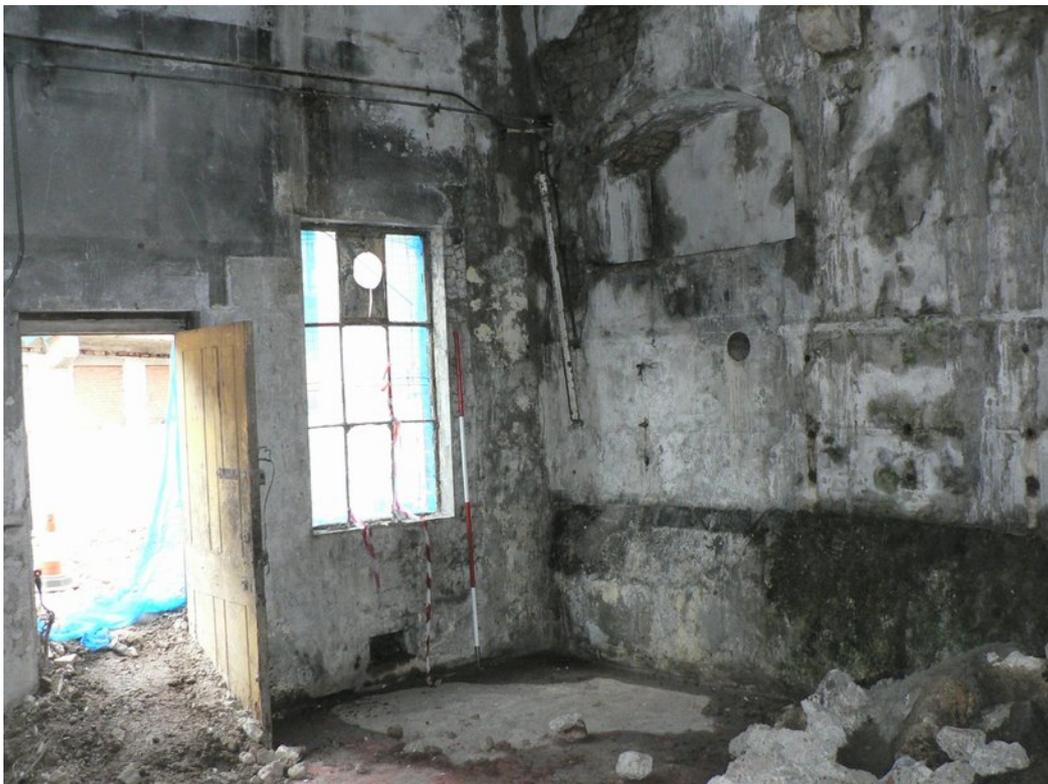
Plate 38 – View showing partially blocked niche and metal 9 paned window
