C131 - PADDINGTON INTEGRATED PROJECT

HISTORIC BUILDING RECORDING – PIP TRIANGLE SITE

Document Number: C131-MMD-T1-RAN-B071-00002

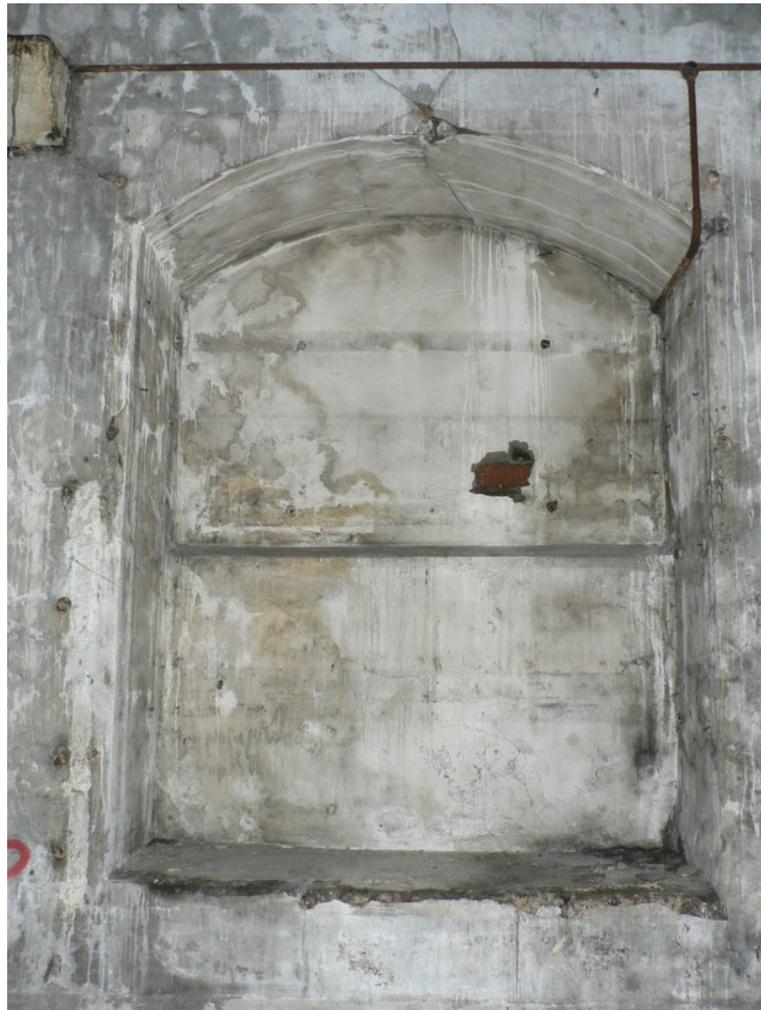
Plate 41 – Niche with internal ledge

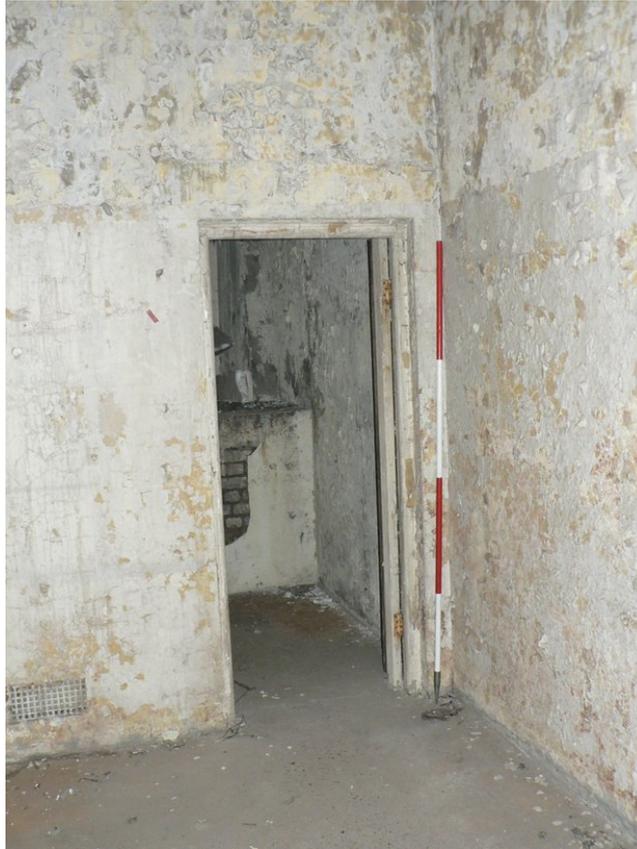
Vault 3 presented a room that has been divided into an east and west section by a partition wall. The western section of this room is further divided into two rooms by a partition wall running west to east (plate 42). To the northern section of the room a section of the vertical buttress was visible as were some historic bricks to the horizontal buttress where the render above had flaked off revealing an English bond in stock bricks. The walls within both rooms showed evidence of having been previously wallpapered supported by historic plans that showed the room as being used as tea store and counting room (Figure 11). Corbels were also present within the room (plate 45) as was a 1930s four panelled door (plate 44). The eastern room was more enclosed with the retention of its 1930s suspended ceiling which was supported by the original stable corbels (plates 46 & 48). Two niches were also extant in this room, one with an inverted arch and one with a flat base (plates 47-48).

Plate 42 – Modern internal partition wall

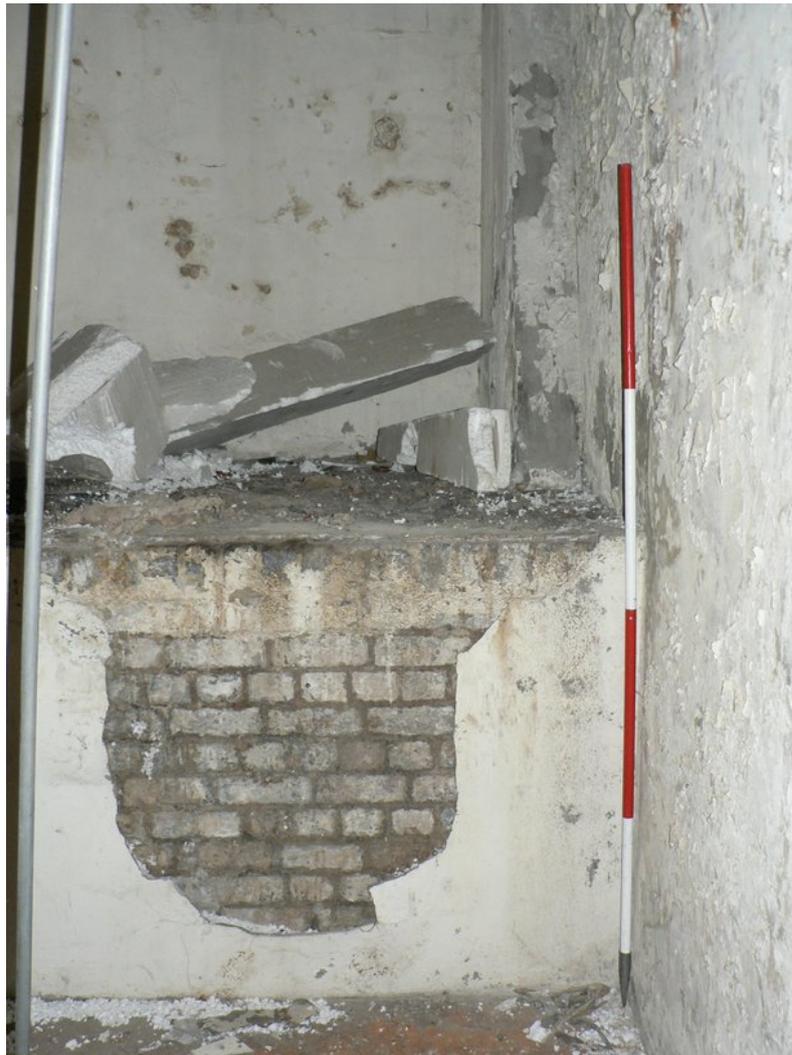
Plate 43 – Exposed brickwork in English Brick Bond

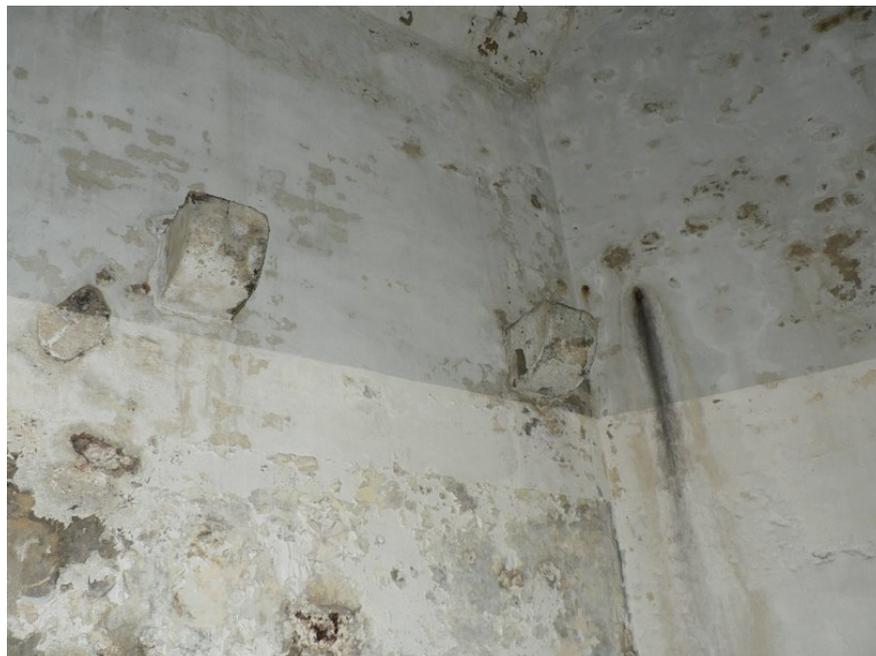
Plate 45 – Corbel brackets

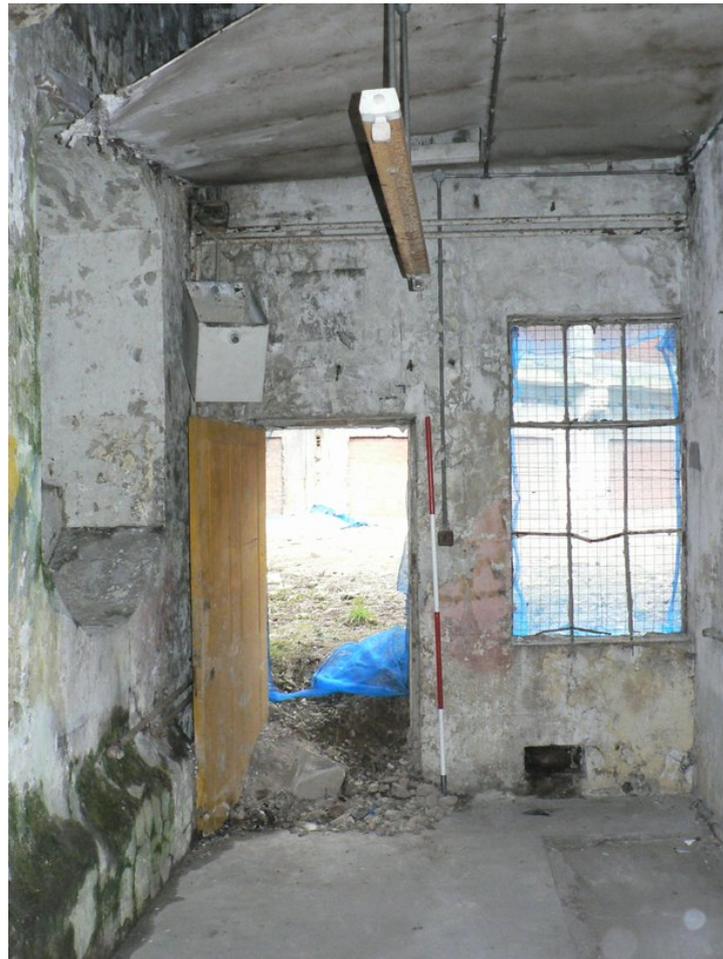
Plate 47 – View towards doorway and niche to left

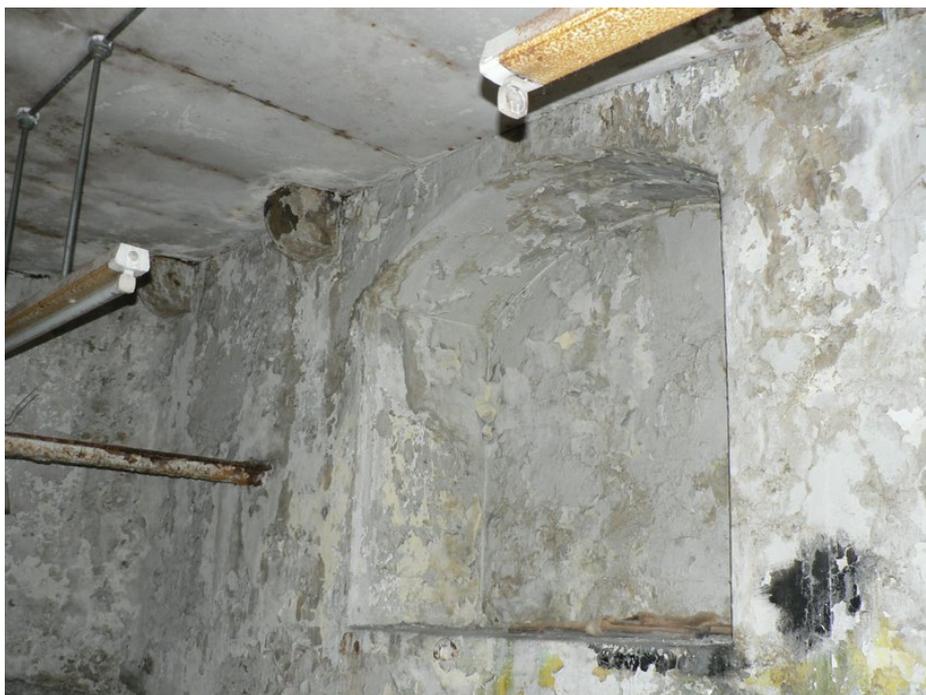
Plate 48 – Detail showing niche and corbels

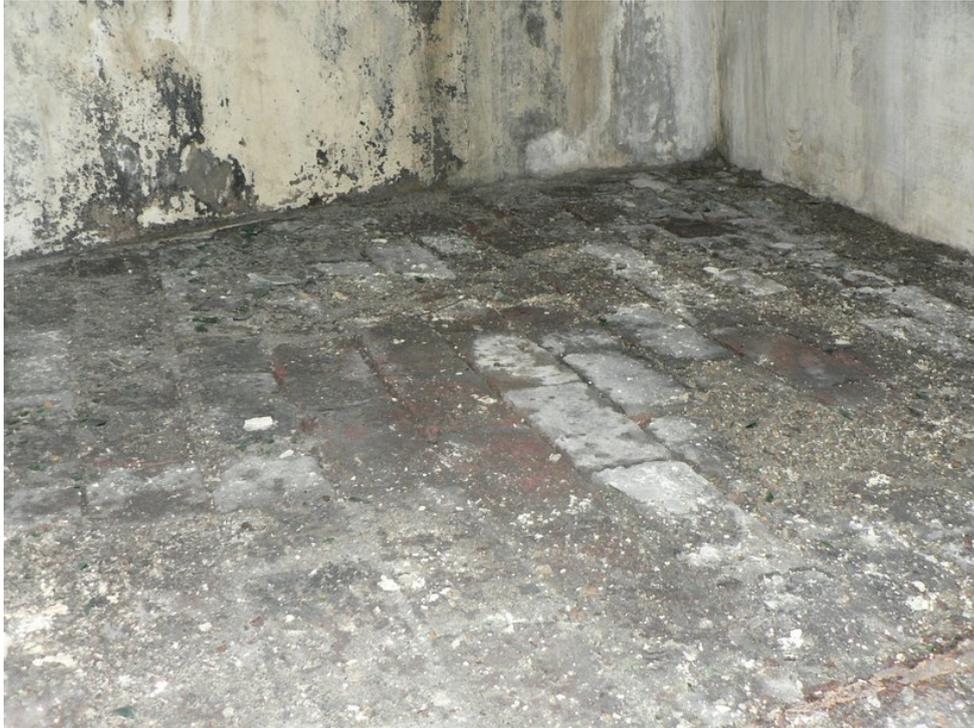
Plate 49 – The only vault to have exposed paviors to vertical buttress surround

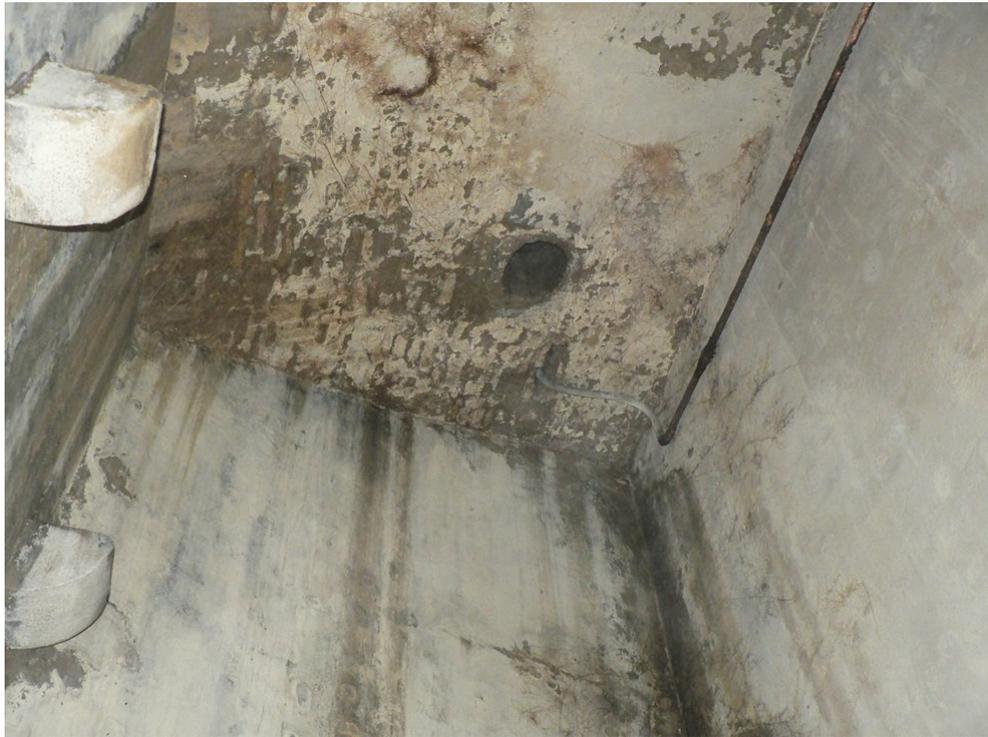
Plate 51- Former coal shute

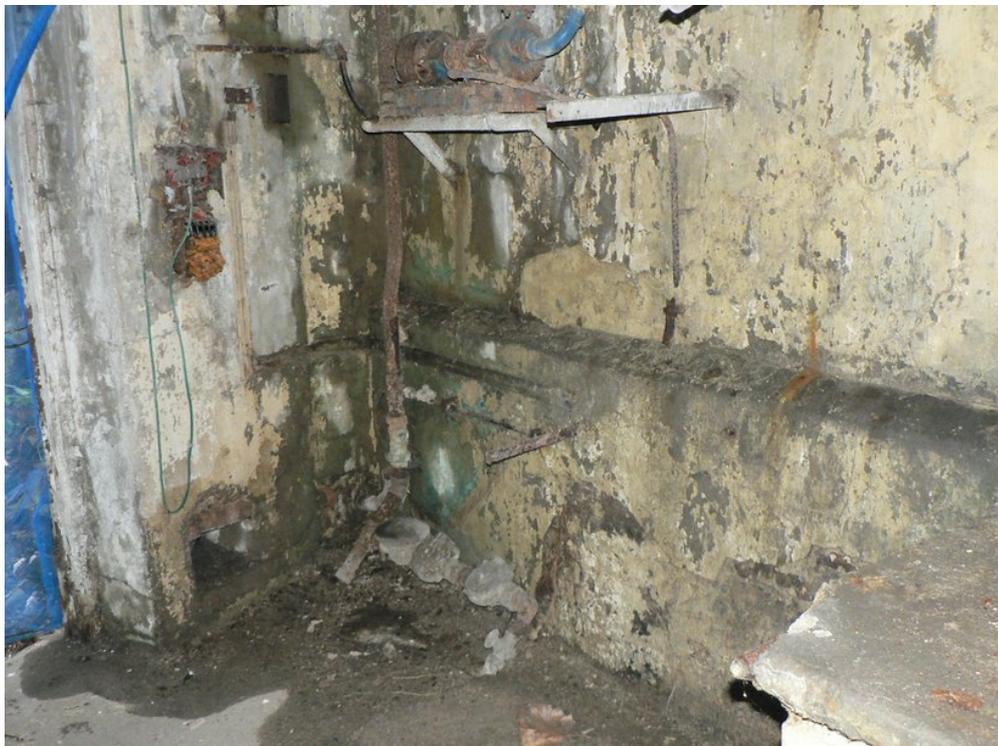
Plate 52 – Former boiler apparatus beneath chimney flue

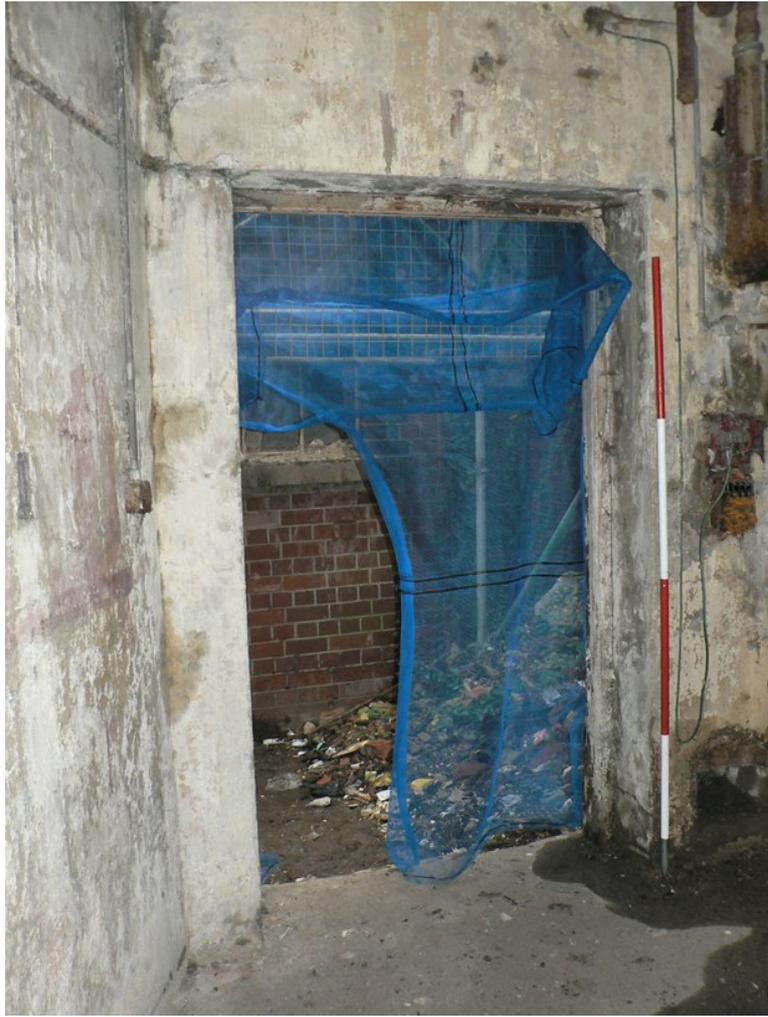
Plate 53 – Door surround

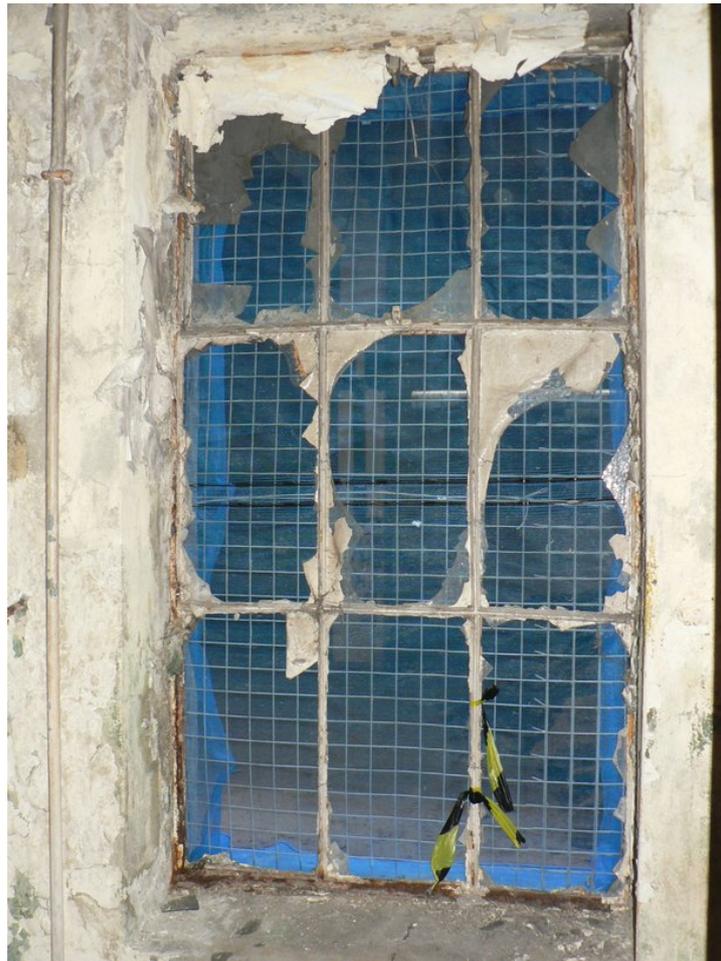
Plate 55 – Typical metal window detail

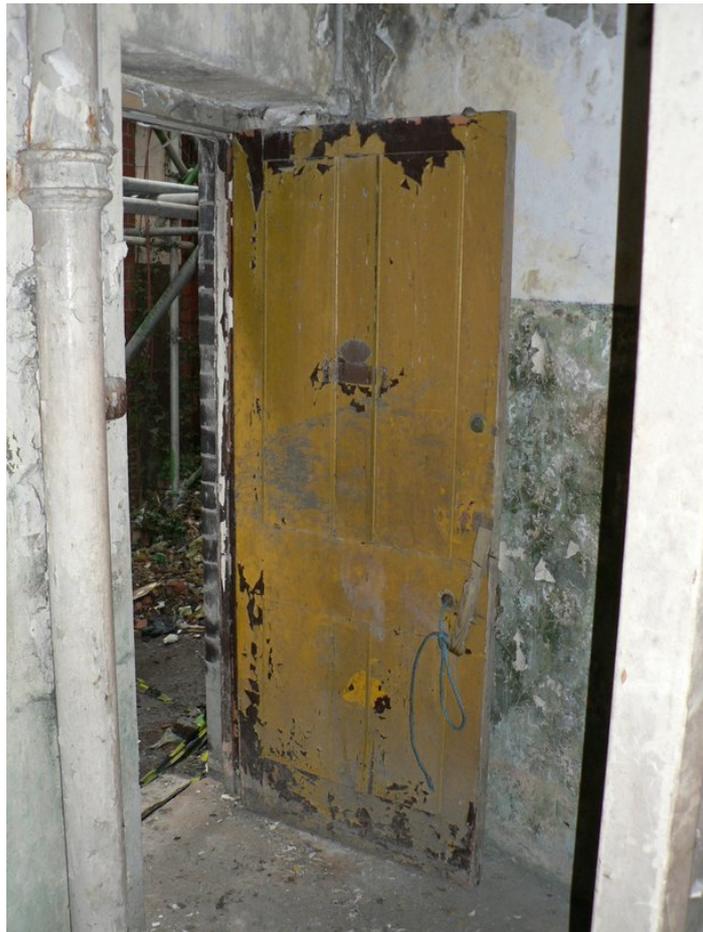
Plate 56 – Modern timber four panel door

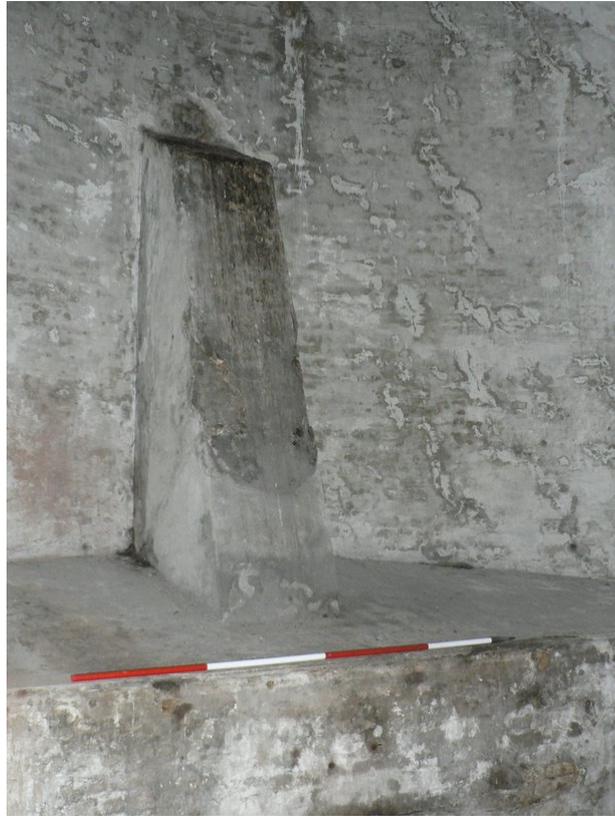
Vault 5 was a similar composition to Vault 2 being open with no central partition wall. At the northern end a vertical buttress surrounded by a horizontal buttress were visible (plate 58), a

Plate 58 – Buttress and surround

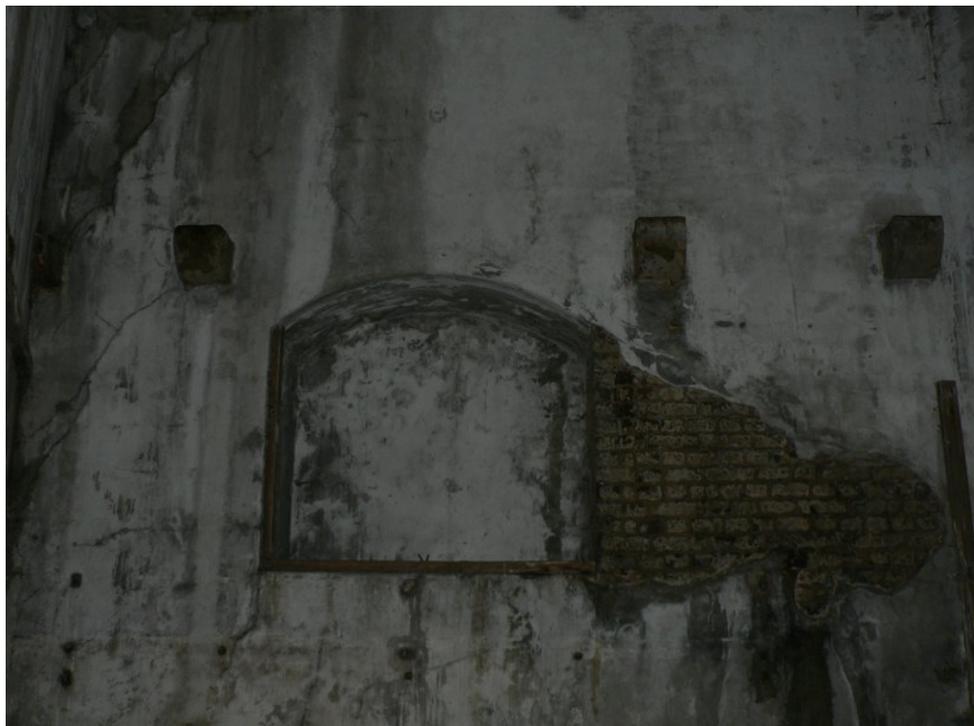
section showing the form of these units is provided in figure 12. The western elevation showed exposed brickwork in the same bond and brick as those exposed in the other vaults (plates 59-60). Another set of four niches were visible in the room, all evidence of previous openings (plates 59-61). Further corbels were extant providing evidence of a previous ceiling structure (plates 59 & 61). An 18 paned metal fixed window was also visible within the room (plate 62).

Plate 59 – Niche and corbels above

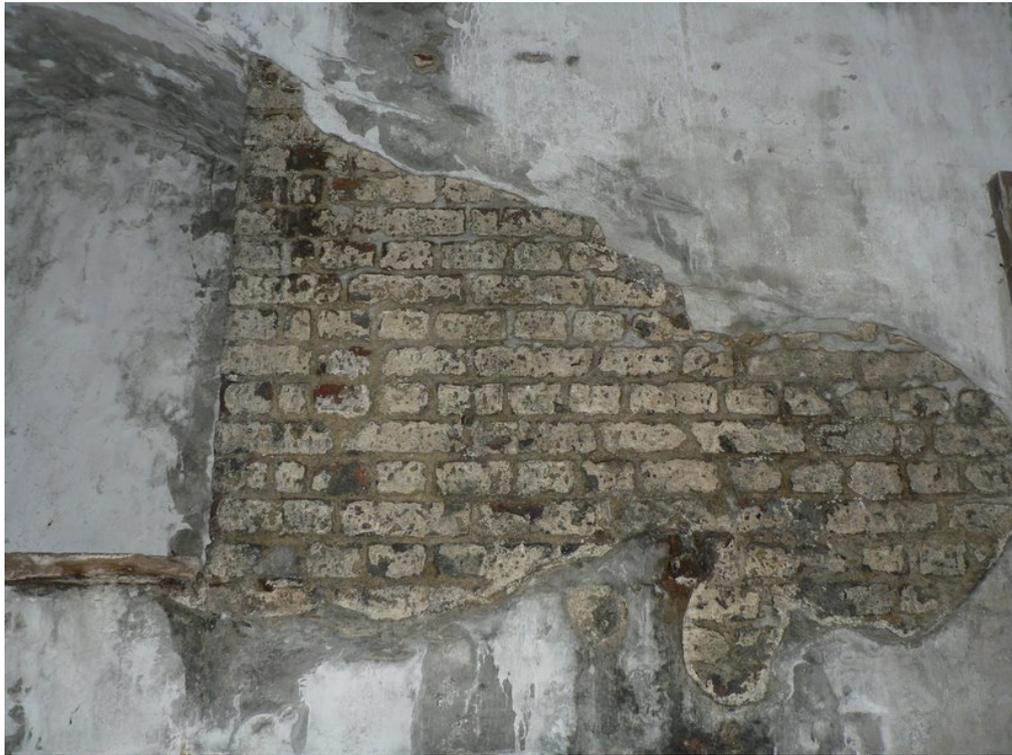
Plate 60 – Exposed brick work showing English Bond

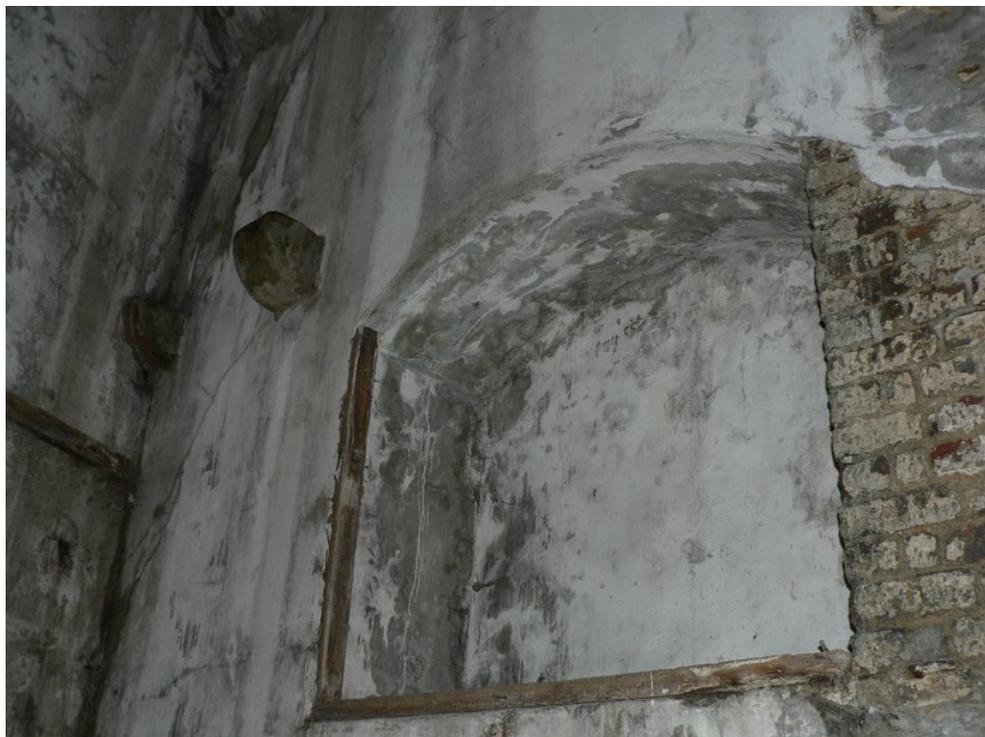
Plate 61 – Niche and corbel detail

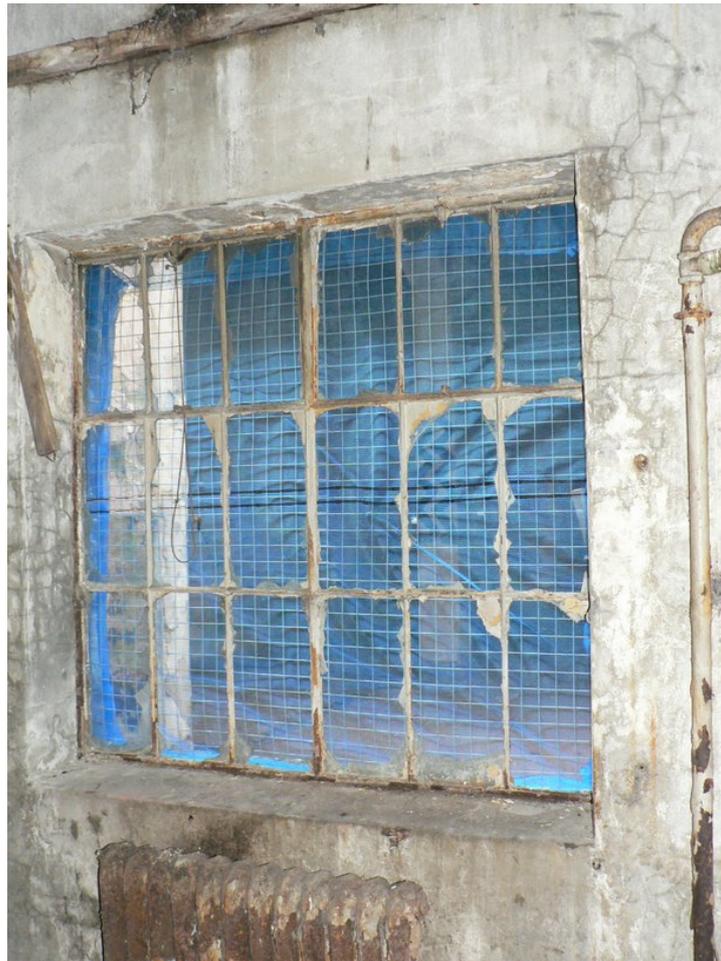
Plate 62 – Typical window detail, here with 18 panes

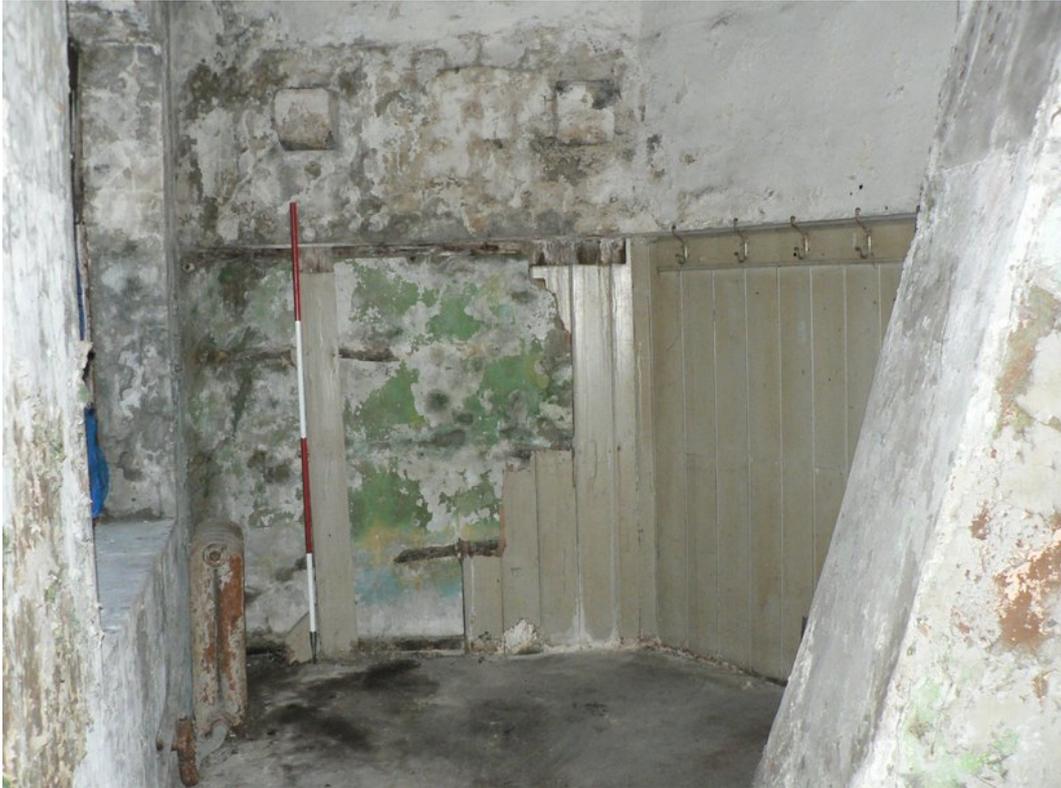
Vault 6 is the smallest of the vaults and also at a much higher level than the previous units being accessed via an external stairway (plate 63). No documentary evidence survives detailing the nature of the room, although from its internal makeup it would appear to be a cloak room, with panelled walls and coat hooks still surviving (plates 63 & 64). As with the other vaults, a vertical buttress and corbels are visible (plates 63 & 64). Other items of note include two small stands that may have been used as a storage unit as part of the 1930s conversions. Like Vault 5, the room also features a plain 18 paned window (Plate 66) and corbels.

Plate 63 – Vault with surviving wood panelling and coat hooks

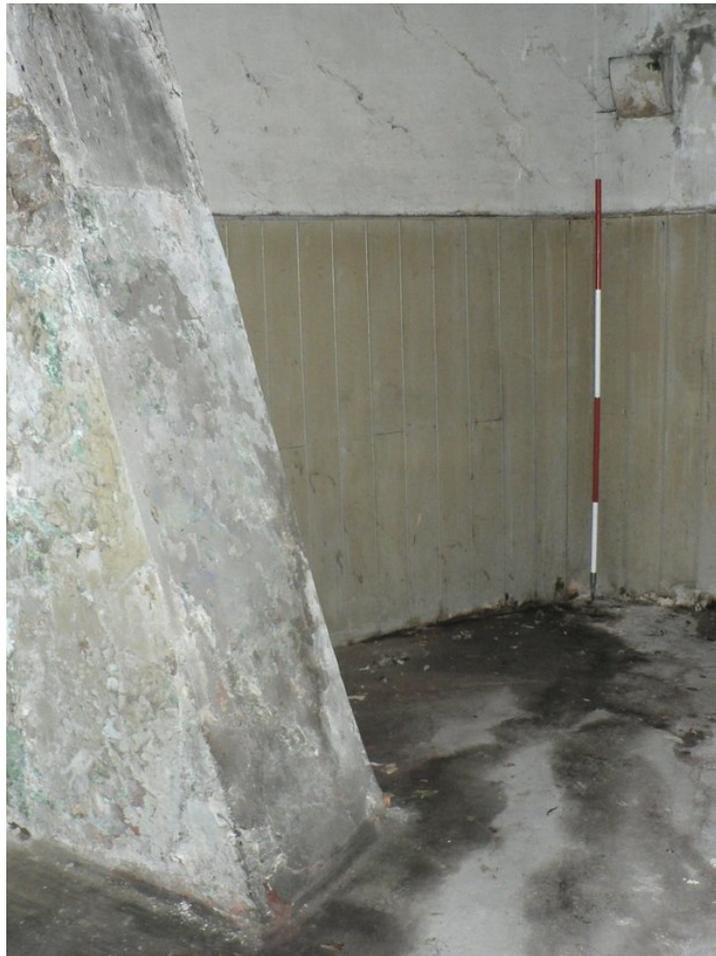
Plate 64 – Concrete rendered buttress and panelling

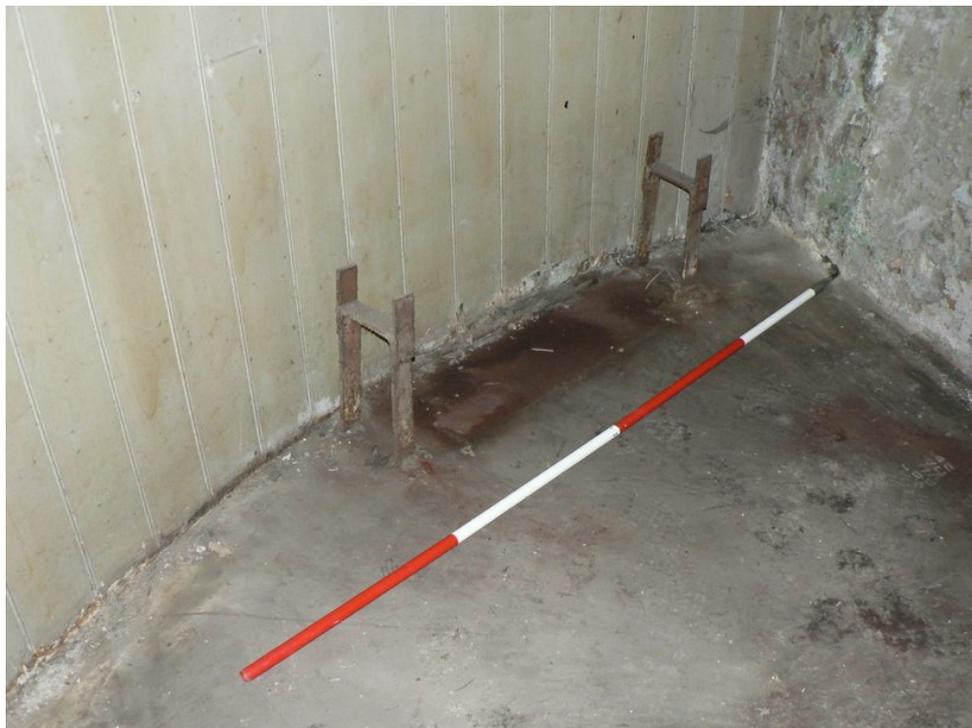
Plate 65 – Former stand holders

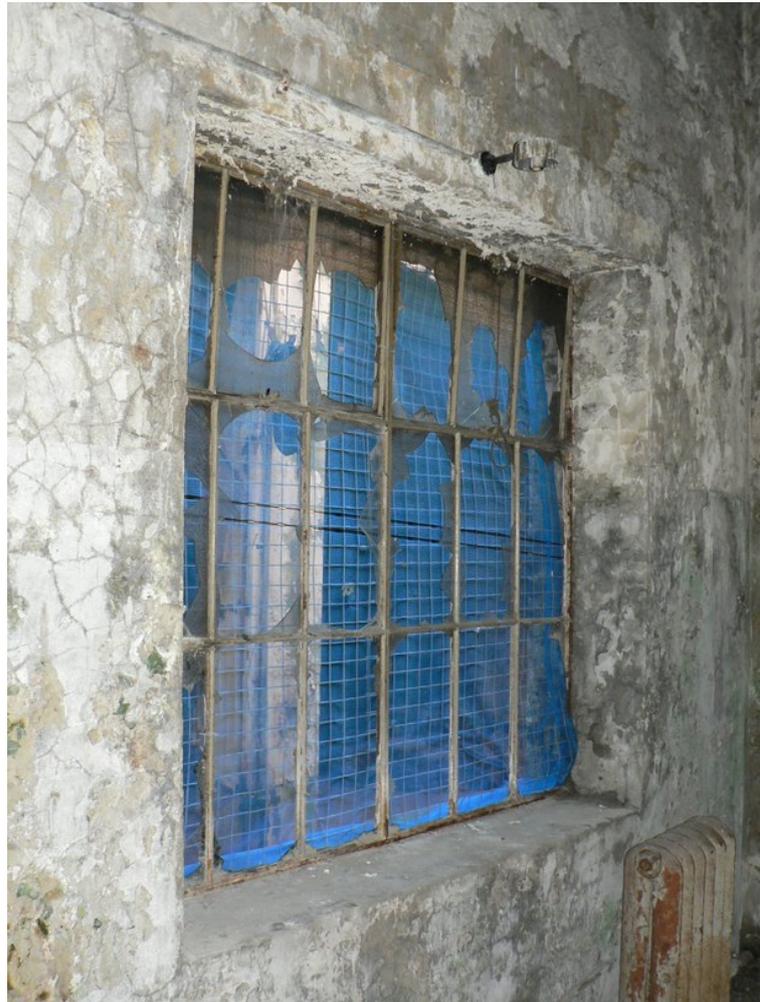
Plate 66- Typical metal window, here with 18 panes

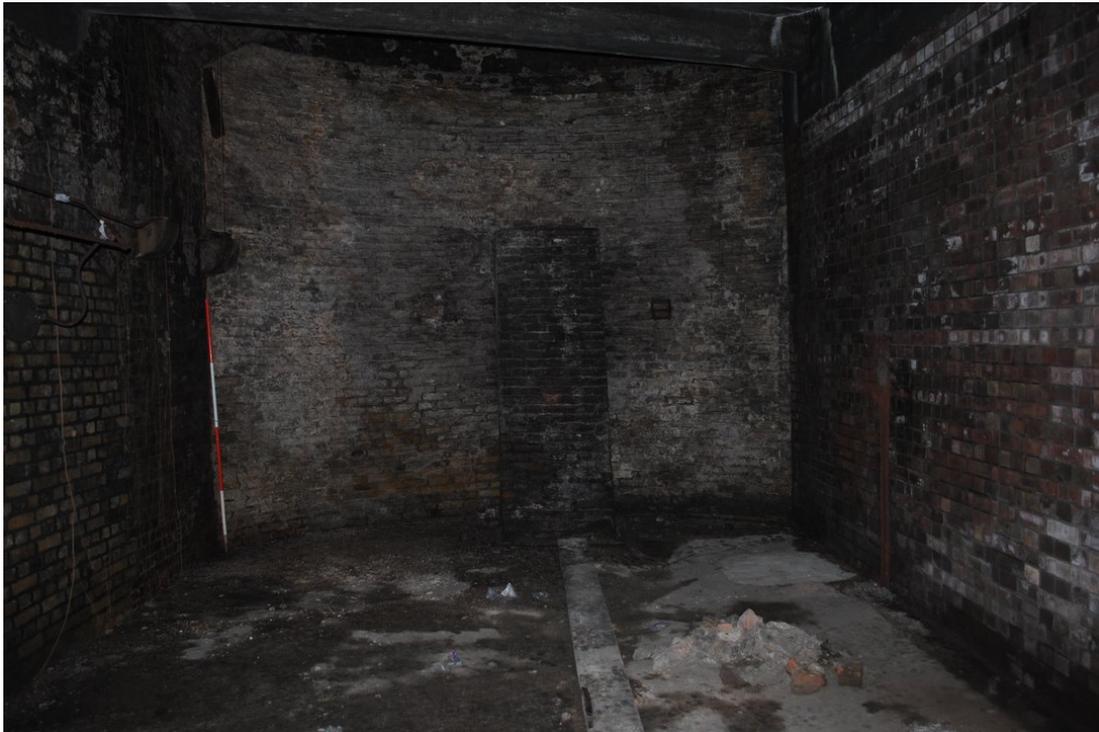
Vault 7 is of interest because it was not converted to store rooms or internally lined with concrete in the 1930s works (plates 67-70). However, the insertion of the new Goods Ramp necessitated the removal of the majority of its ceiling with a concrete structure and the insertion of modern bricks to its eastern facade (plates 71 & 73) and parts of its south western façade (plates 70-72). The southern façade has also been truncated with a new front in red brick and a timber plank and batton door opening out onto the railway tracks (plate 72). Although all the floor surfaces have been removed, much of the original brick work survives to the northern and western extents as does the buttress that characterises many of the other vaults (plates 67-70). Of interest here, on the western facade are two blocked up apertures (plate 69) that are of a similar form to those niches identified in the other vaults. Half way down the room there are also straight joints apparent in the wall, and a change in the height of the floor level, suggesting the room was originally divided into two (plate 70).

Plate 67- Vault showing exposed brickwork and buttress

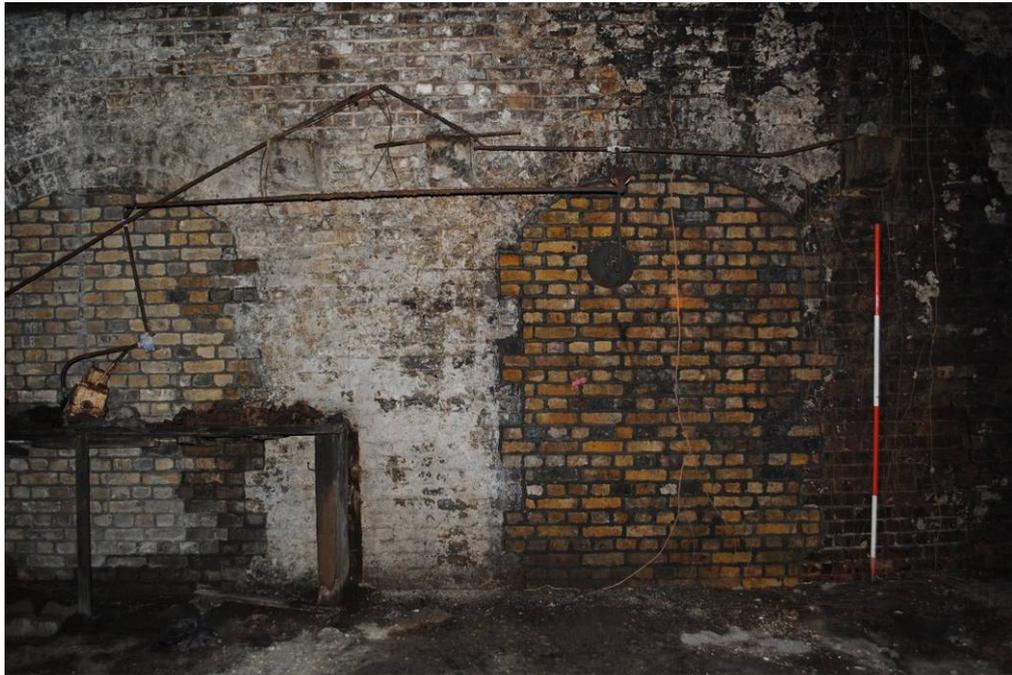
The blocked up niches that were visible in Vaults 1-7 were originally open (Figure 11) and likely used to provide a means of ventilation between the stable rooms, they may have also been used as a means of access for stable works or provided a means of transporting hay between each unit. These niches are likely to be of a similar form and composition to those exposed in Vault 7 (plate 69).

Plate 69 – Blocked up former archways

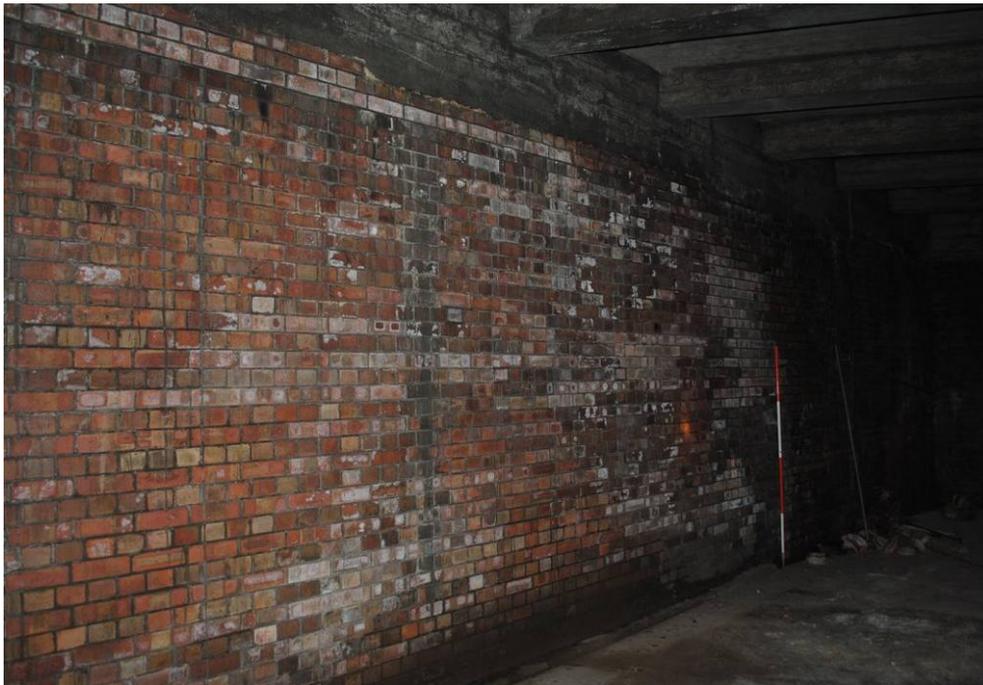
Plate 71 – Eastern elevation of vault

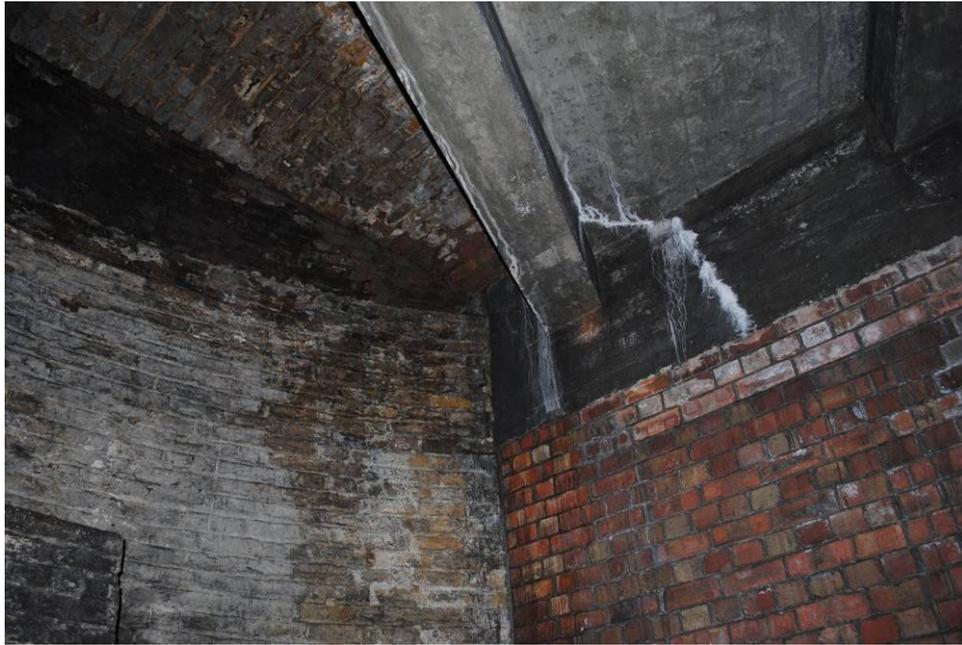
Plate 73 – Ceiling detail showing inserted concrete frame

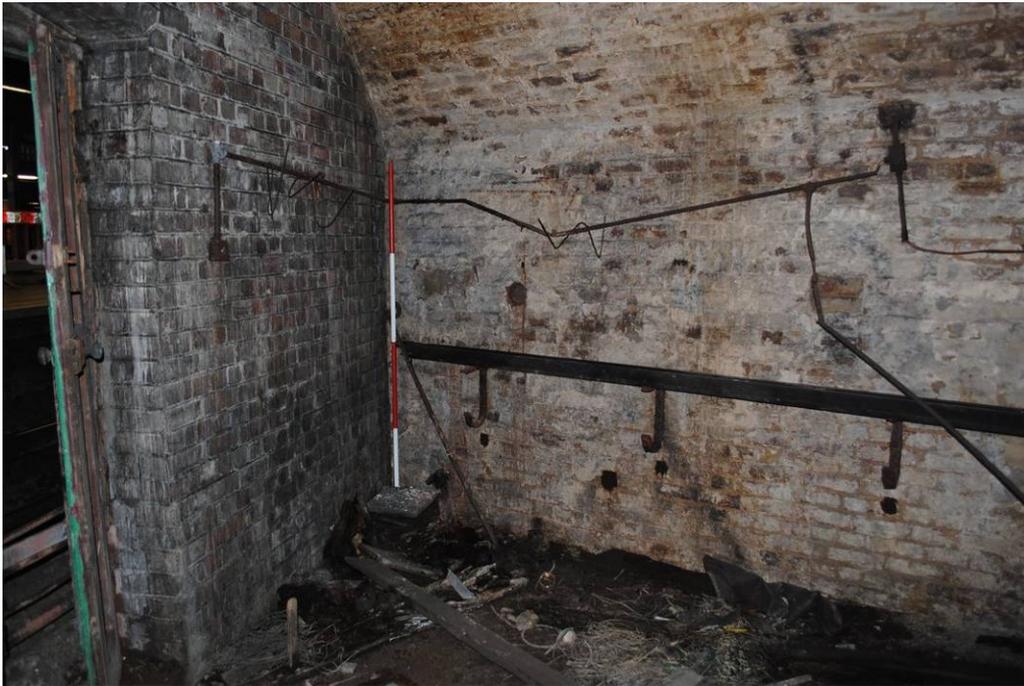
Plate 75 – Note lack of corbels

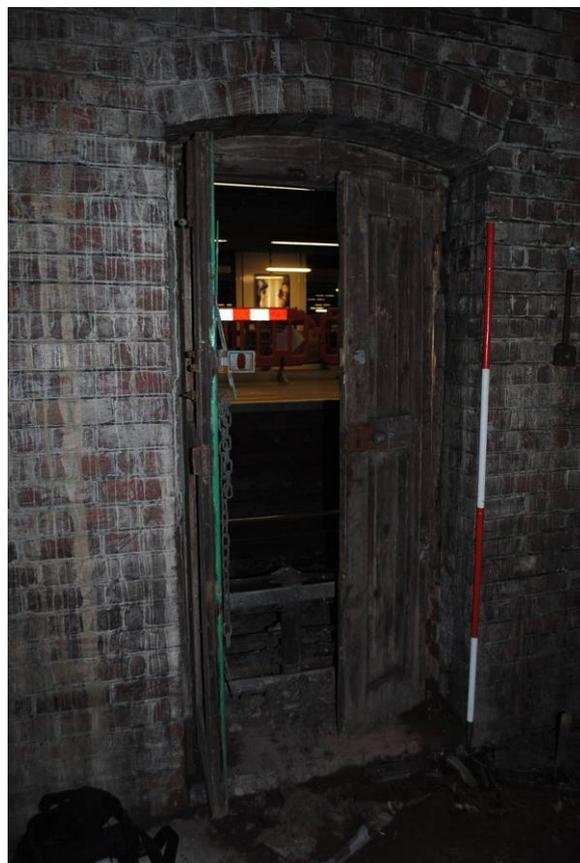
Plate 76 – Doorway to trackside

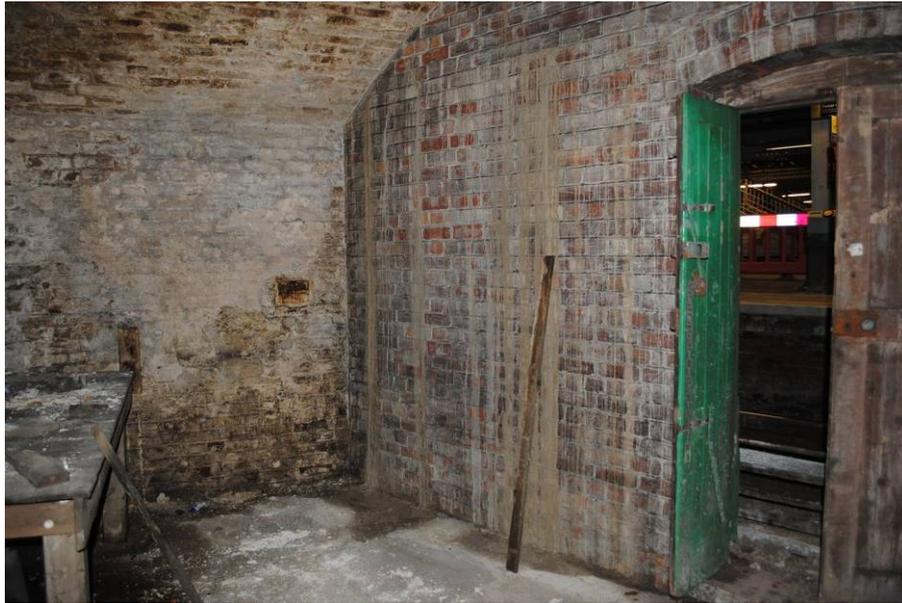
Plate 77 – View towards trackside

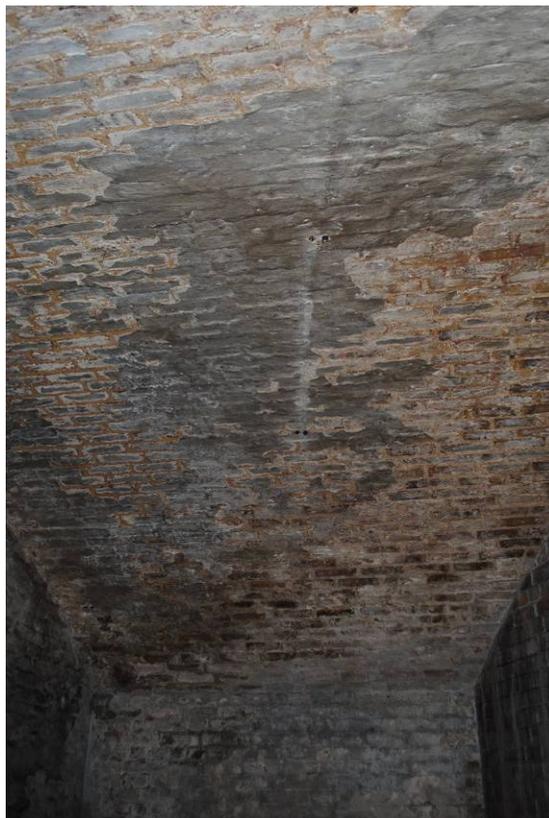
Plate 78 – Brick ceiling detail

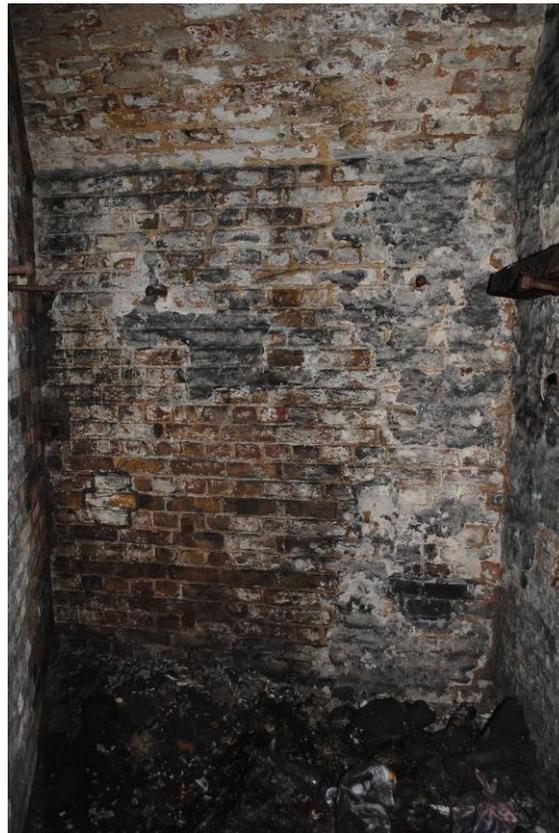
Plate 81 – Brick detail to side of vault

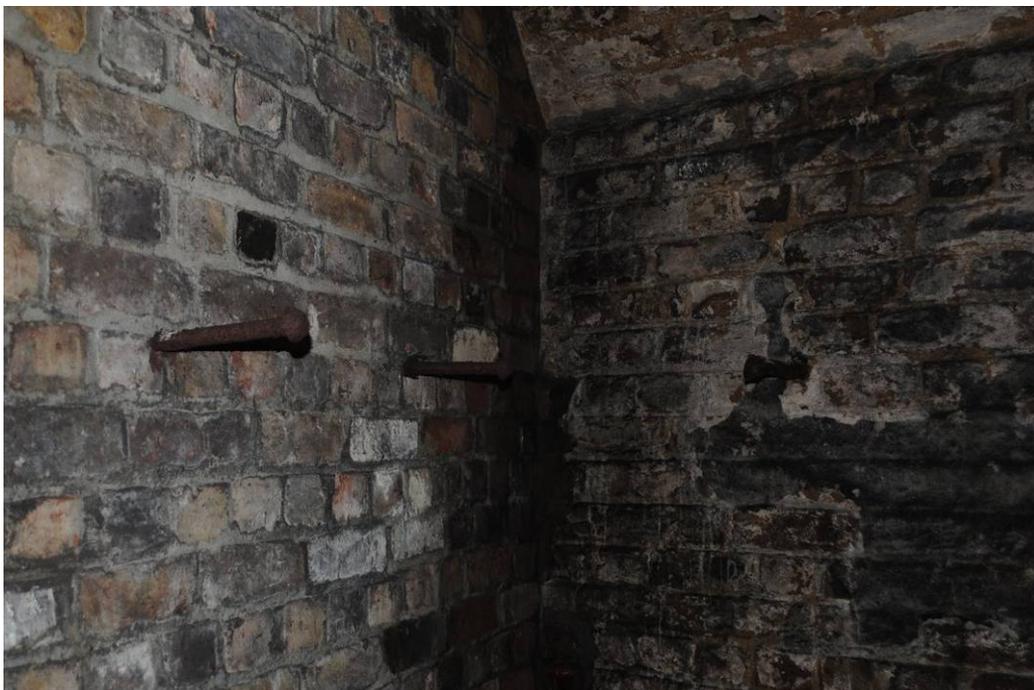
Vault 9 is very similar to Vault 8 in its make up but is far smaller. There appeared to be new brickwork to its eastern elevation and it featured a similar plank and batten door similar to that of Vault 8 (plate 80 & 83). In addition to this there were heavy sulphur deposits to the arched ceiling (plate 8) and remnants of historic nail pegs in the masonry (plate 82). As with Vault 8 this room featured no corbels due to its relatively low ceiling height.

Plate 82 – Former nail hooks within vault
