C131 - PADDINGTON INTEGRATED PROJECT

HISTORIC BUILDING RECORDING – PIP TRIANGLE SITE

Document Number: C131-MMD-T1-RAN-B071-00002

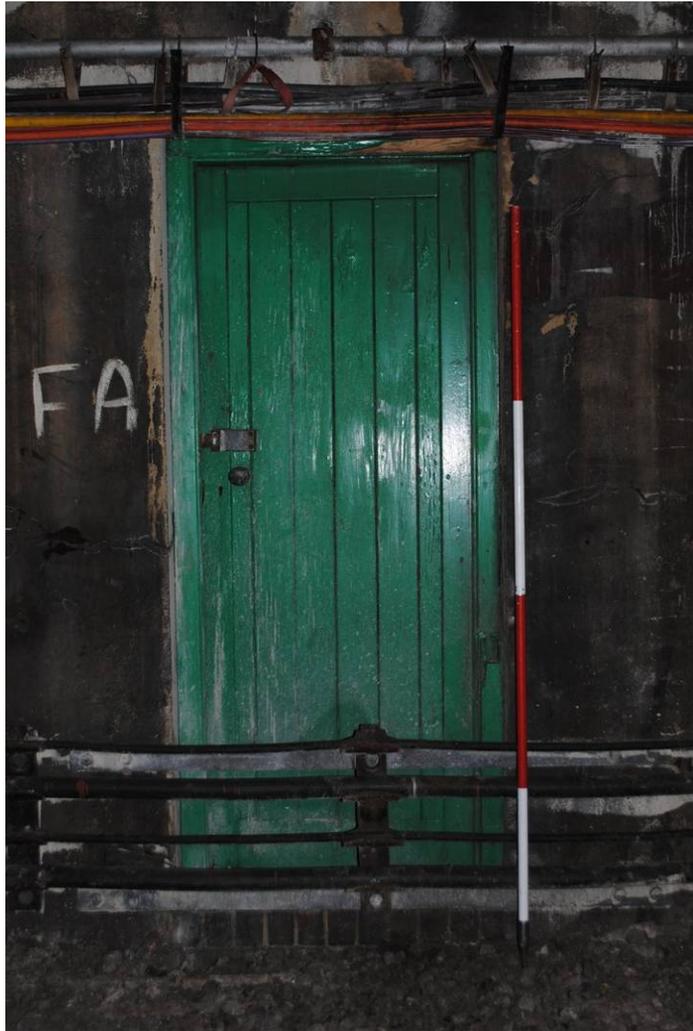
Vault 9 is very similar to Vault 8 in its make up but is far smaller. There appeared to be new brickwork to its eastern elevation and it featured a similar plank and batten door similar to that of Vault 8 (plate 80 & 83). In addition to this there were heavy sulphur deposits to the arched ceiling (plate 8) and remnants of historic nail pegs in the masonry (plate 82). As with Vault 8 this room featured no corbels due to its relatively low ceiling height.

Plate 83 – Plank and batton door from trackside

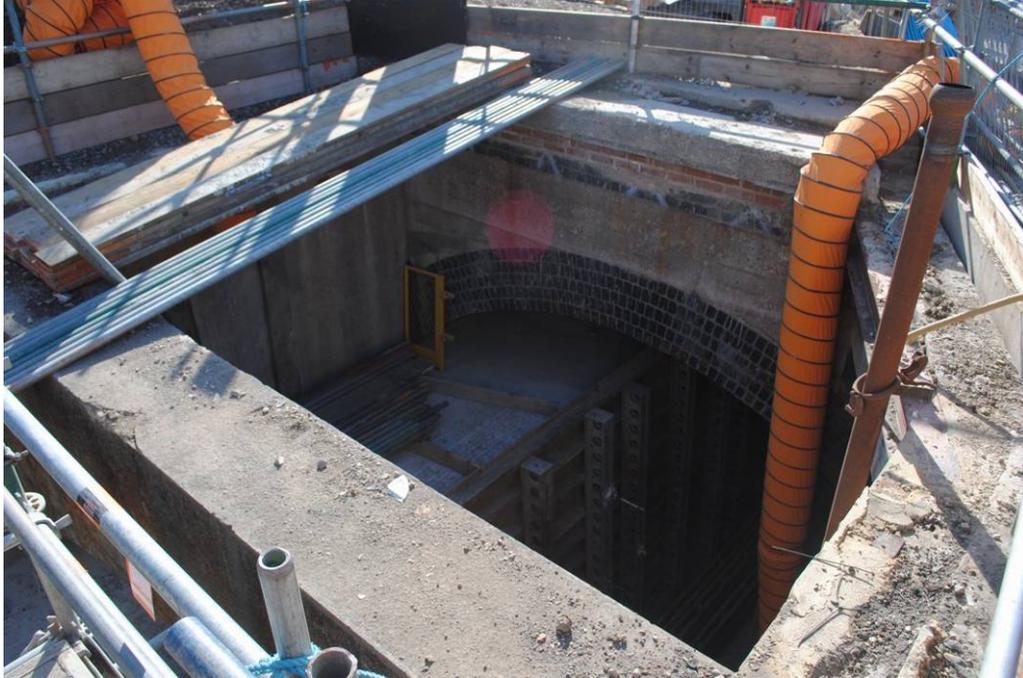
(plate 84). The structure itself was fairly plain in character being made up of engineering bricks on its external envelope (plate 85) and red bricks internally to its ceiling (plates 86-87). A large proportion of its historic fabric had been obscured by concrete render to the south and a modern day retaining wall to the north (plate 87). The shunt tunnel had been divided into two with a partition wall, with the section to the east not being demolished as part of the works (plate 88).

Plate 84 – Opening to shunt tunnel from Upper Triangle

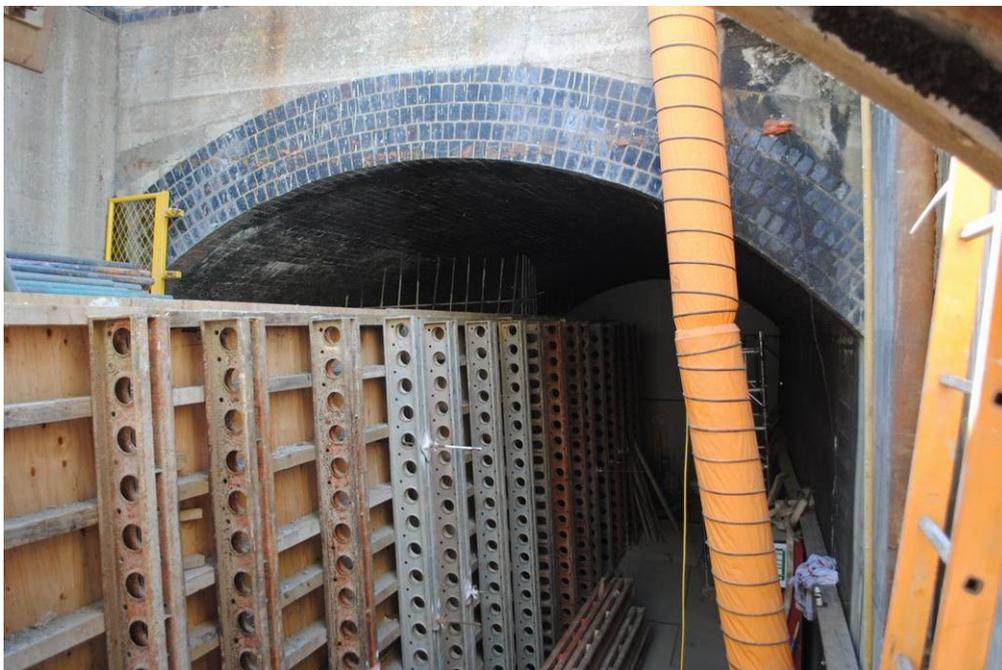
Plate 85 – Entrance to shunt tunnel from the west, showing retaining structure

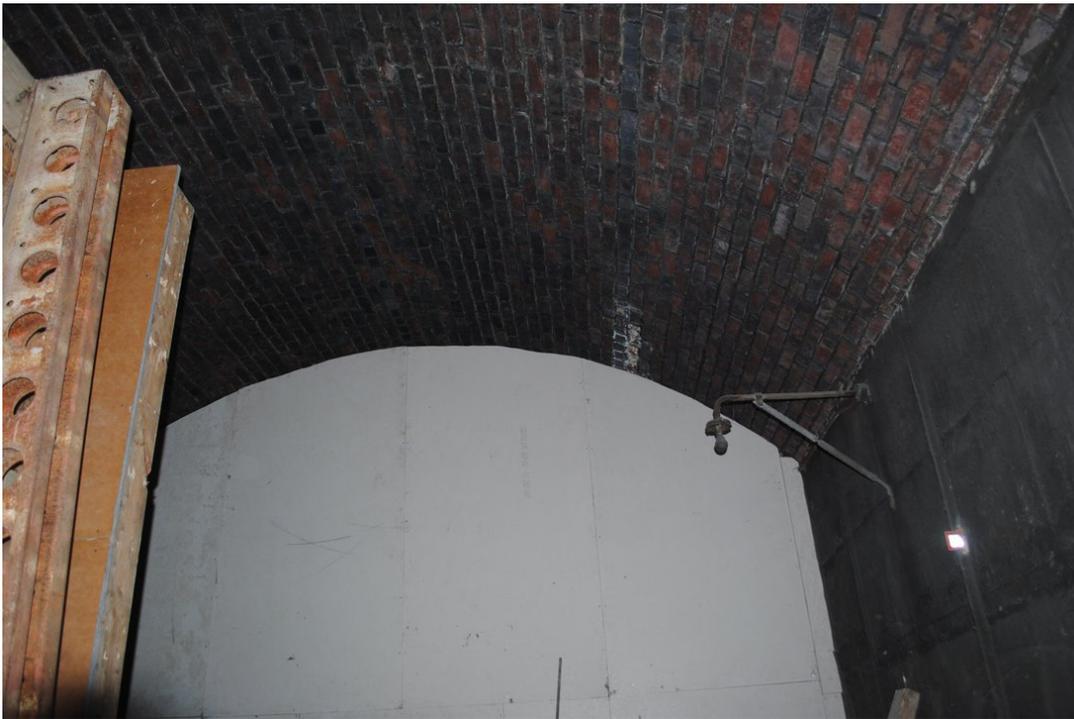
Plate 86 – View of ceiling with electric light to right

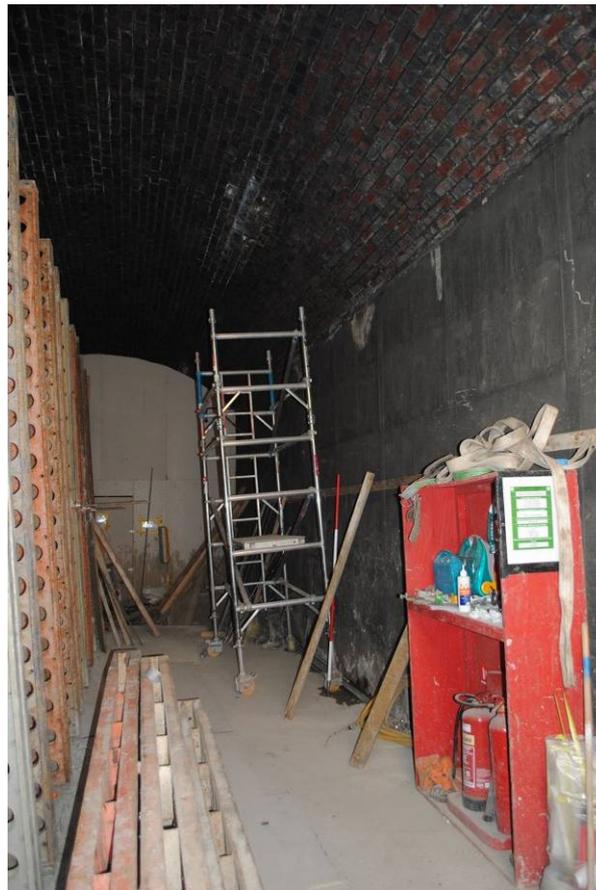
Plate 87 – View of shunt tunnel

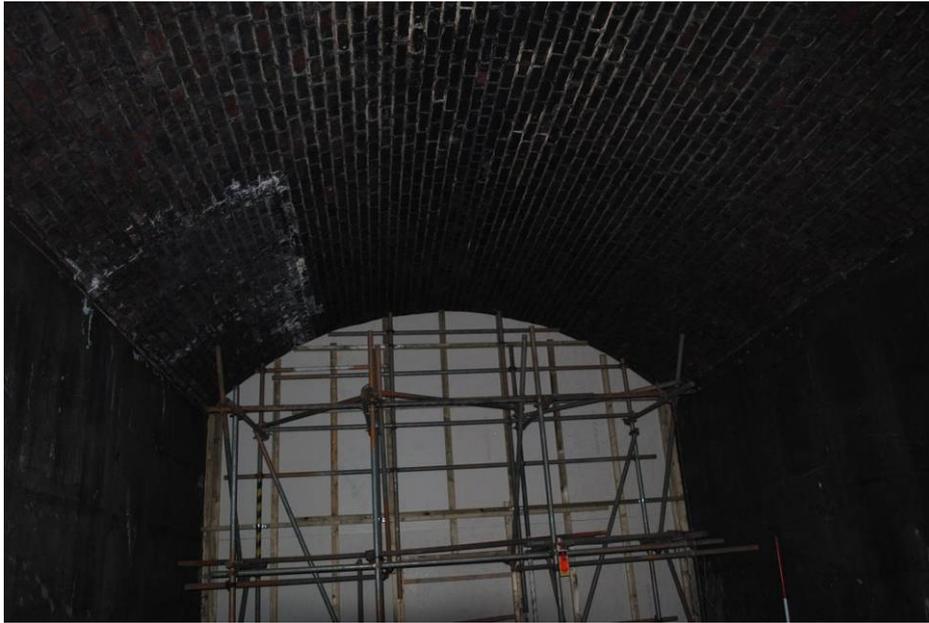
Plate 88 – View west of shunt tunnel, this section is to remain
